Whitingham Flood Resiliency Scoping Study

Reach M02, Halifax

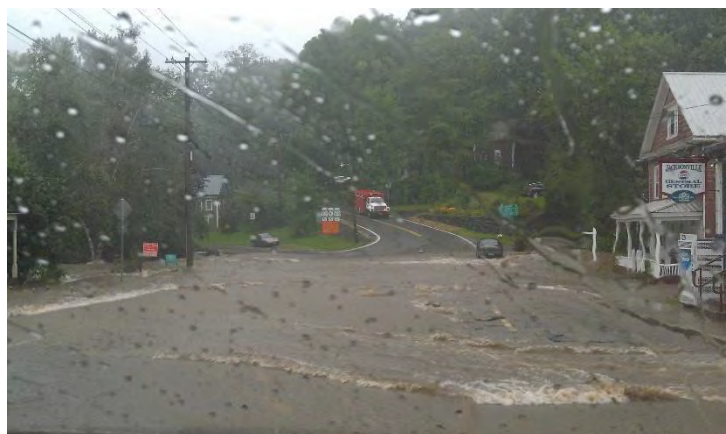
Figure 1.5: Floodwaters spilled out of the channel of the East Branch North River and flowed down VT 100 through Jacksonville, VT during Tropical Storm Irene in 2011 (Photo courtesy of G. Havreduk).

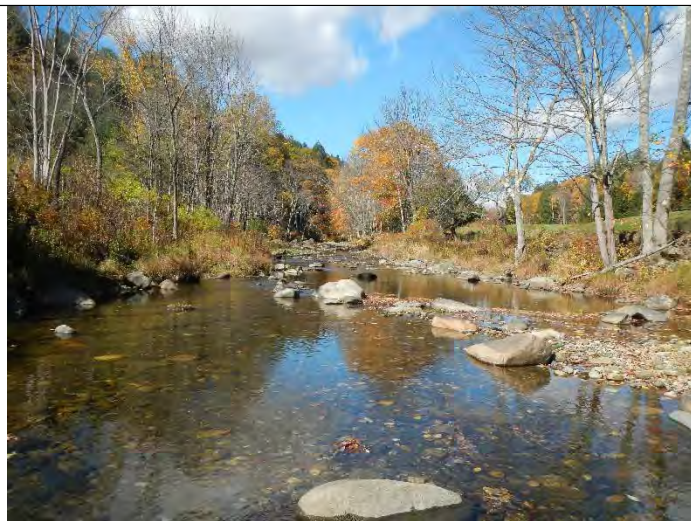
Reach Highlights: Historically this reach was incised due to straightening and encroachment along VT 112. A large alluvial fan is located in the upper portion of the reach, downstream of the confluence with Branch Brook. We assessed this reach as Stage II due to channel incision, but widening in some areas suggests it may be transitioning into a stage III reach. The stream departed from a C to a F-type channel due to incision and entrenchment.

Historically incised and straightened F-type channel.

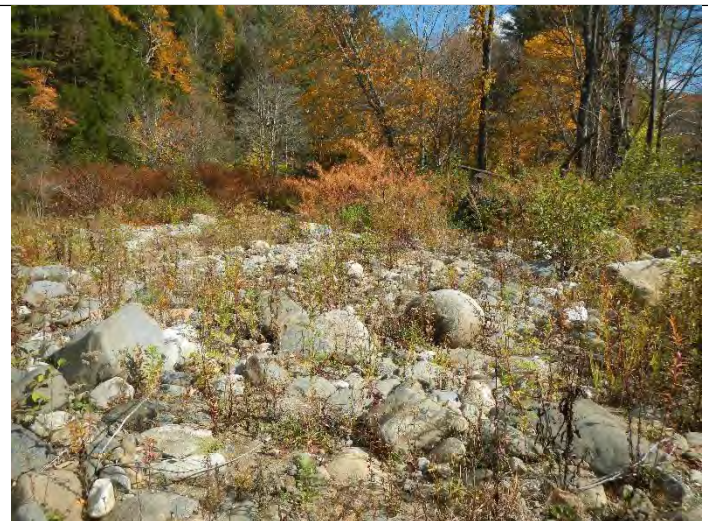
Alluvial fan deposits in the upper portion of the reach.

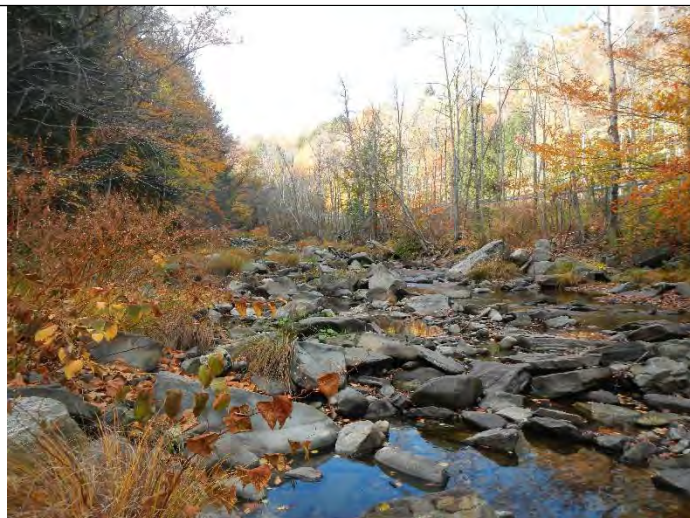
Reach Highlights: Historically this segment was incised due to historic straightening and encroachment along Rt 112. Moderate bank scour and bankfull widths typically greater than the predicted curve width indicate that the reach may be widening. Further incision is also unlikely due to grade control and large substrate. We assessed the reach as early Stage III with limited potential for further widening or planform adjustment due to the road encroachment.

Historically straightened and incised F-type channel.

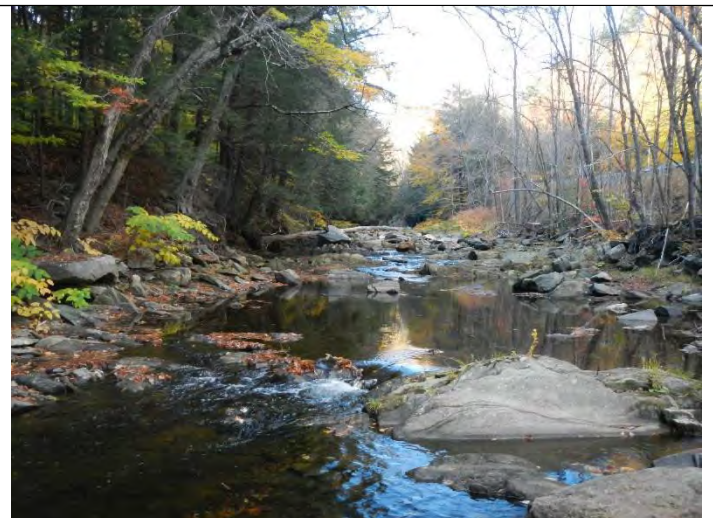
Grade controls in the upper portion of the segment, approaching a bedrock gorge.

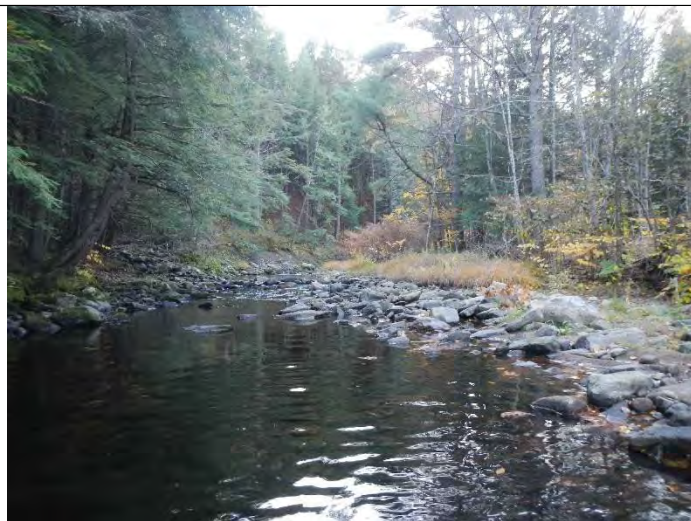
Reach Highlights: This segment is set back from VT 112 upstream of Halifax Falls and therefore was less incised due to encroachment and armoring than nearby reaches and remains a C-type channel. Within the broad valley, the channel maintains the ability to move and access large floodplains. We assessed this segment as Stage IV due to the presence of multiple large flood chutes and evidence of aggradation occurring in some areas.

C-type channel with floodplain access.

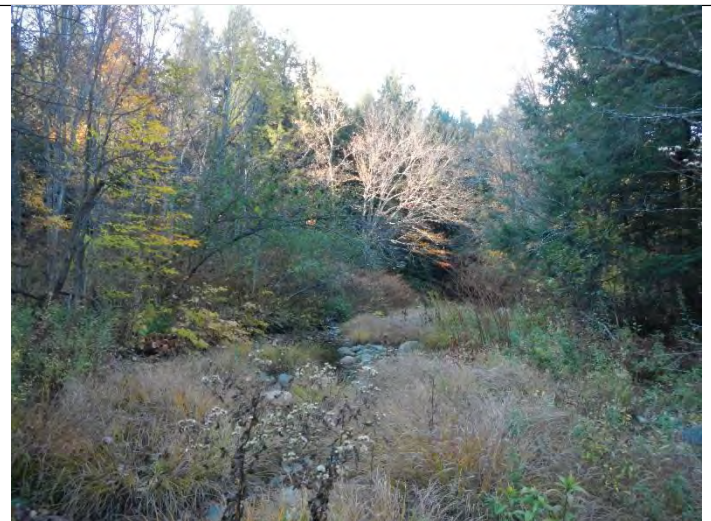
Large flood chute.

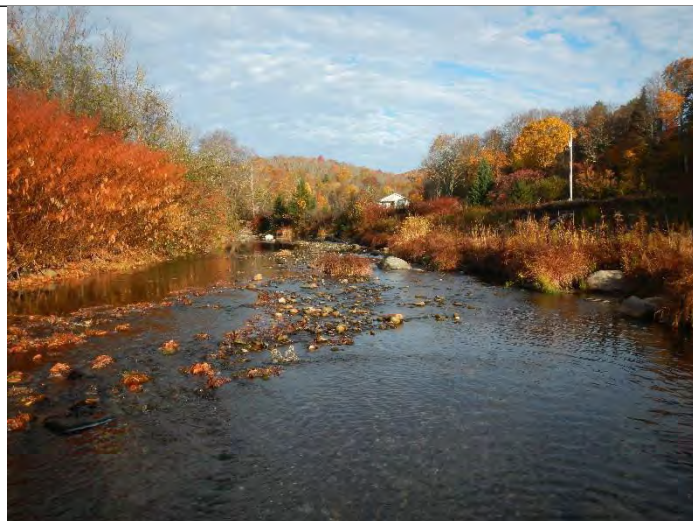
Reach Highlights: Historically this segment was incised due to straightening, armoring and encroachment along VT 112, which caused a stream type departure from a C to a F-type channel. We observed evidence of ongoing aggradation and recent widening. We assessed the segment as recently transitioning to Stage III, however widening and planform adjustment potential is limited due to road encroachment.

Segment upstream of beaver activity, with evidence of historic incision.

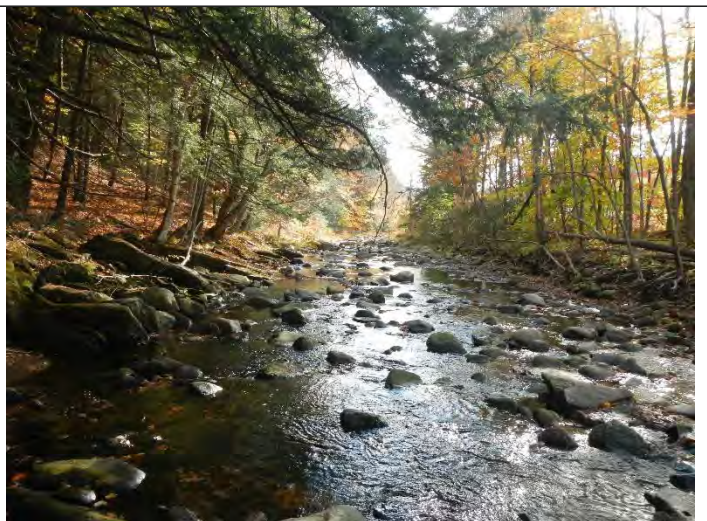
F-type channel near the top of the segment, historically incised due to straightening and encroachment.

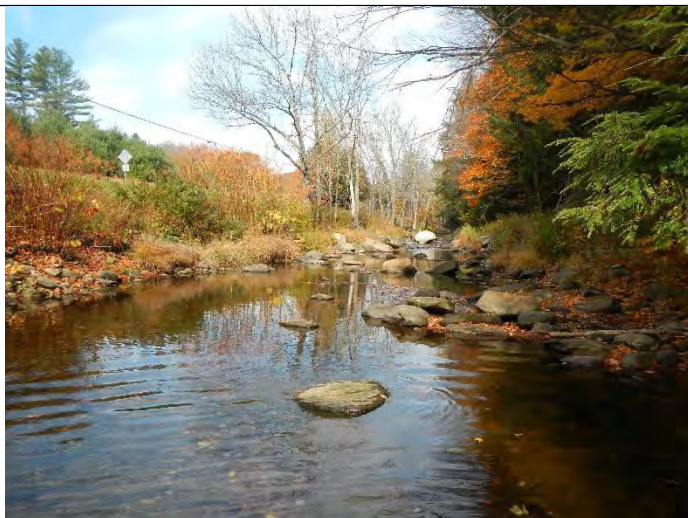
Reach Highlights: Historically this reach was incised due to straightening, armoring, and encroachment along Rt 112. We assessed this reach as Stage II because incision and entrenchment that caused a stream type departure from a C to a F-type channel. The presence of several large flood chutes and splits in the channel suggest the channel maintains some ability to adjust planform within its valley.

F-type channel due to historic straightening and armoring.

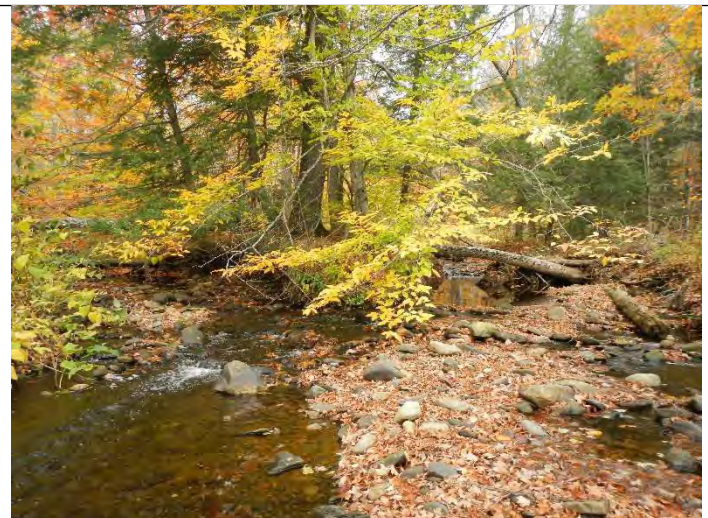
Channels converge downstream of a bifurcation.

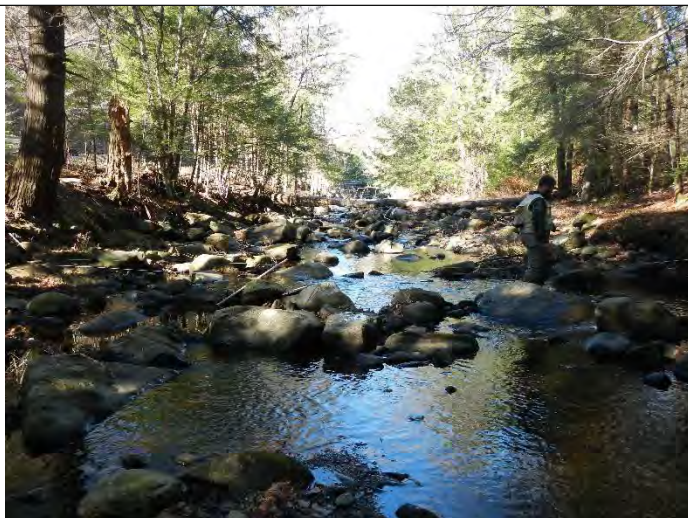
Reach Highlights: Historically this reach was incised due to straightening as well as armoring and encroachment along Branch Road. There was some evidence of channel widening with recent bank scour from T.S. Irene. The lower portion of the reach, near the confluence with North River, had several large flood chutes. Processes associated with incision were representative for most the reach and contributed to our assessment of the reach as Stage II.

F-type channel due to straightening and encroachment

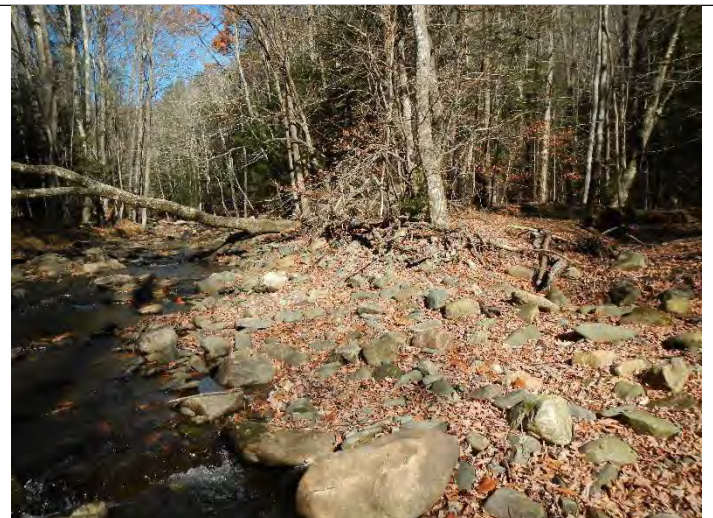
Large flood chute rejoining the channel near the confluence of Branch Brook and the North River.

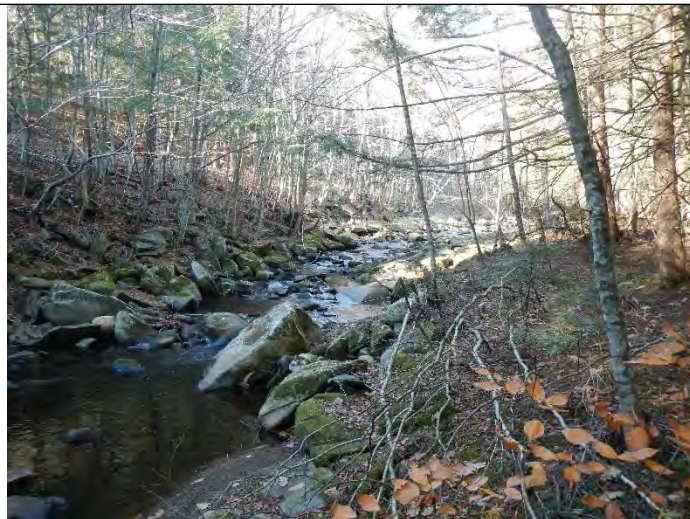
Reach Highlights: Historically this reach was incised due to straightening and development, as well as armoring and encroachment along Branch Road. Based on extensive scour we suspect that the channel incised during T.S. Irene. Further incision is very limited due to the presence of numerous grade controls and very large substrate throughout the reach. We observed some evidence of widening however this will be limited due to extensive road armoring and natural armoring along the banks. We assessed the reach as Stage II but it is likely slowly progressing to Stage III.

F-type channel due to straightening and encroachment.

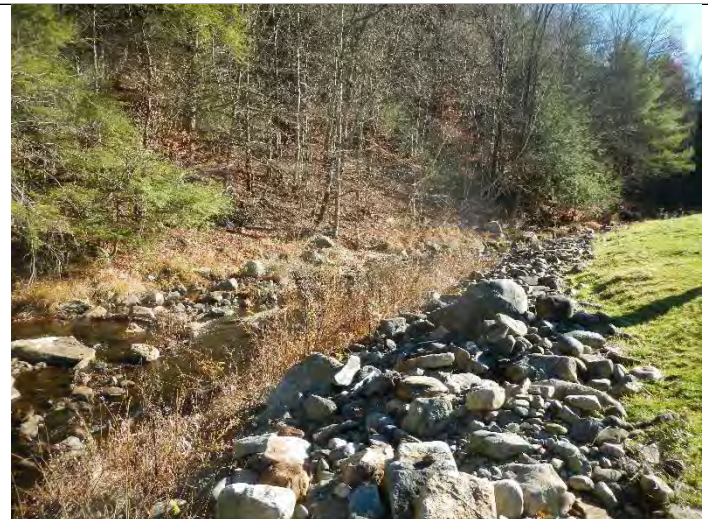
Bank straightening and armoring along cow pasture.

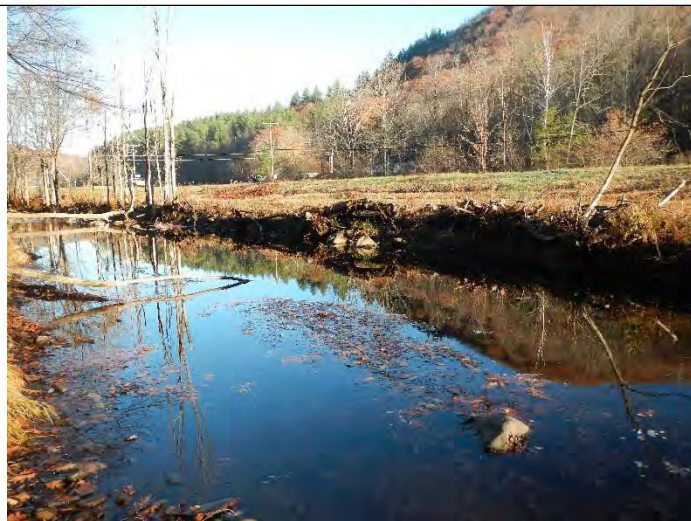
Reach Highlights: Historically this reach was incised due to straightening and encroachment along VT 112. We did not see evidence of much widening, aggradation or planform adjustment. Processes associated with incision contributed to our assessment of the reach as Stage II. The stream departed from a C to a B-type channel due to incision and entrenchment.

F-type channel due to historic straightening and encroachment.

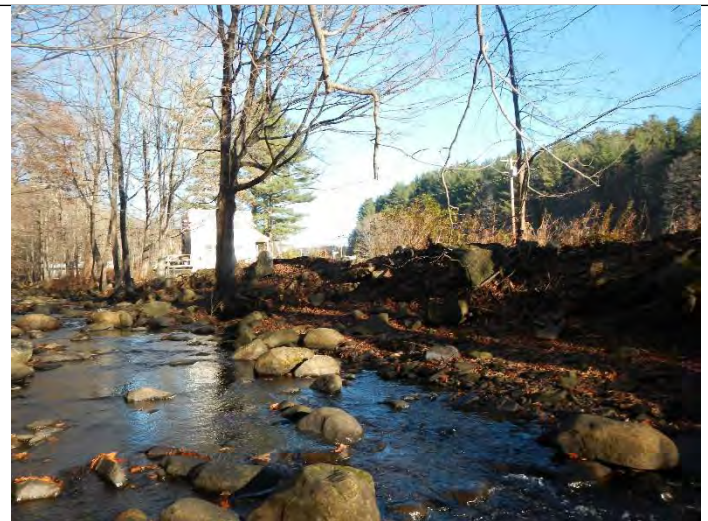
Historically straightened channel with an old berm on the left bank.

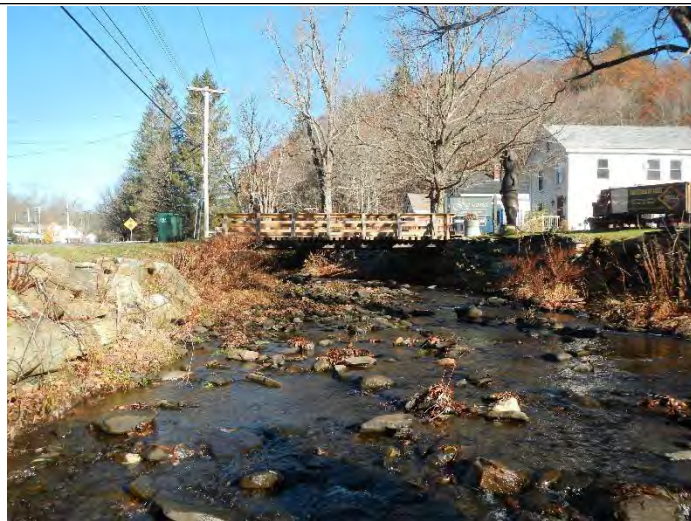
Reach Highlights: Historically this reach was incised due to straightening and encroachment along VT 112, as well as extensive armoring through the village of Jacksonville. The armored banks prevent widening and planform adjustment. Extensive straightening has degraded channel bed features resulting in a plane bed stream. Processes associated with incision contributed to our assessment of the reach as Stage II. The stream departed from a C to a F- type channel due to incision and entrenchment.

F-type channel due to straightening and armoring.

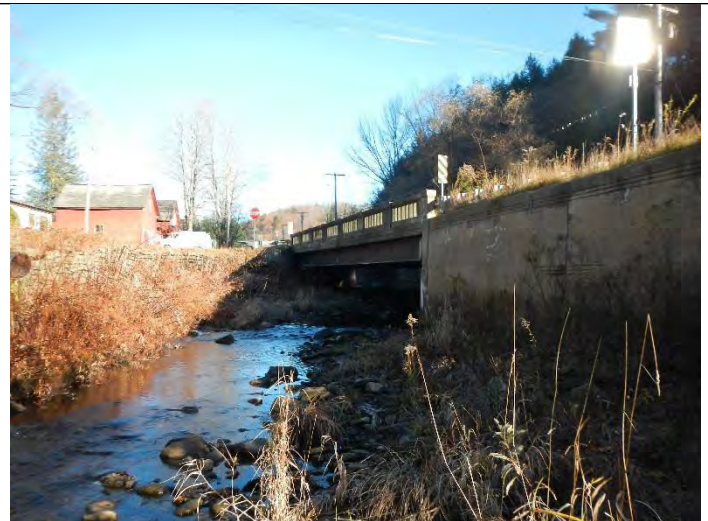
Incised channel at the intersection of VT 112 and Holbrook Road.

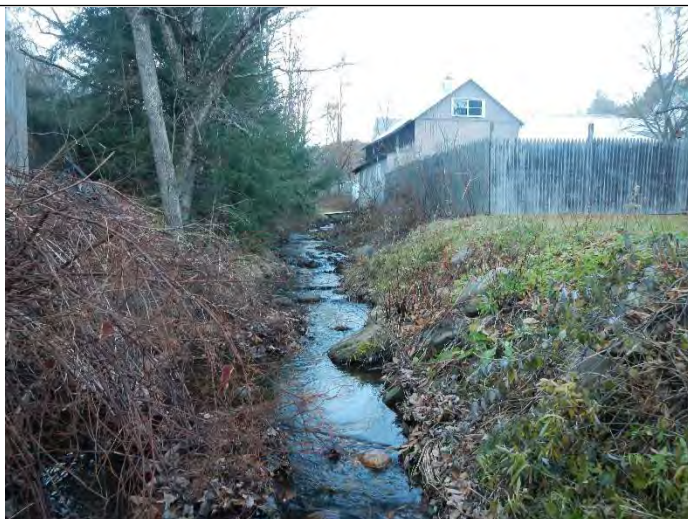
Reach Highlights: Historically this segment was incised due to straightening and encroachment along VT 100, as well as extensive armoring through the village of Jacksonville, VT. The armored banks prevent widening and planform adjustment. Extensive straightening has degraded channel bed features resulting in a plane bed stream. Processes associated with incision contributed to our assessment of the segment as Stage II. The stream departed from a C to a F-type channel due to incision and entrenchment.

F-type channel due to historic straightening, encroachment, and armoring.

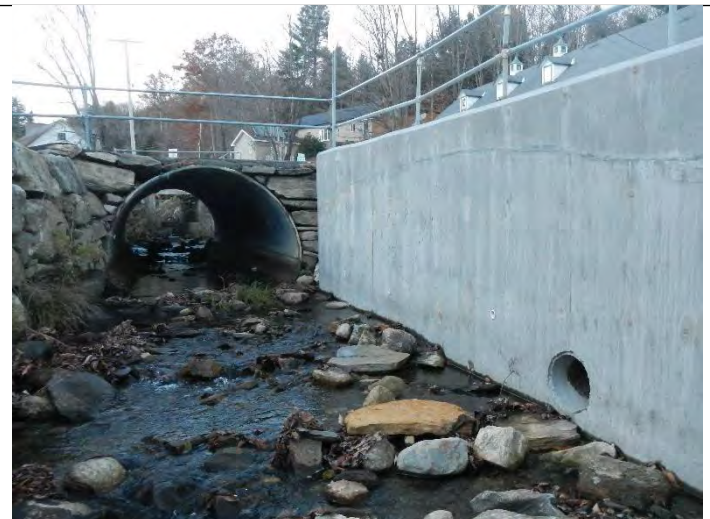
Bank armoring and constrictions at the Whitingham Municipal Complex.

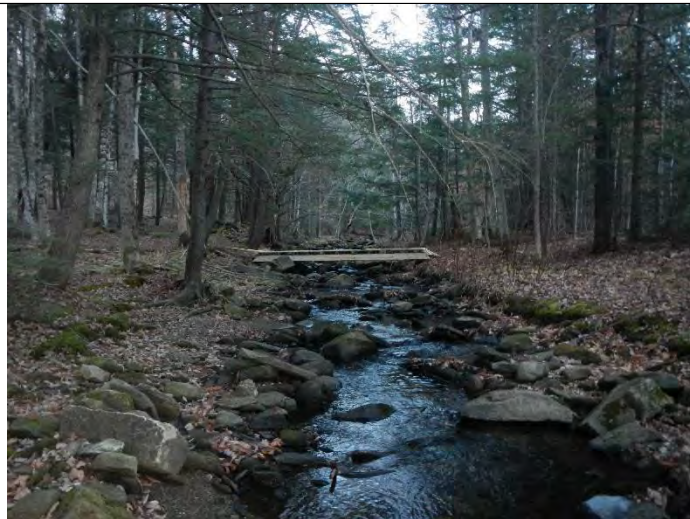
Reach Highlights: Historically this segment experienced some encroachment from VT 100. The channel is slightly incised and widened but has retained floodplain access and appears stable. Further incision and widening is limited by the large substrate present along the banks and channel bed. We observed increased sand and gravel through the segment, likely coming from upstream bank erosion or mass failure. The relative stability of the reach following a recent significant flood event supports our assessment as Stage I.

C-type channel in very broad valley.

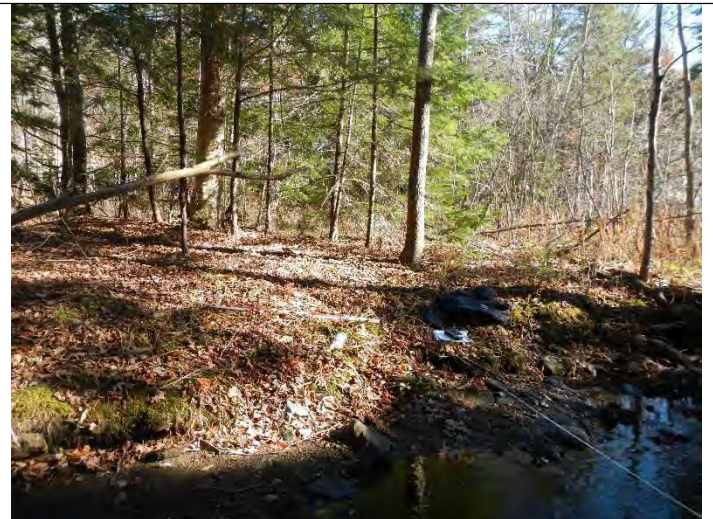
Floodplain access along channel.

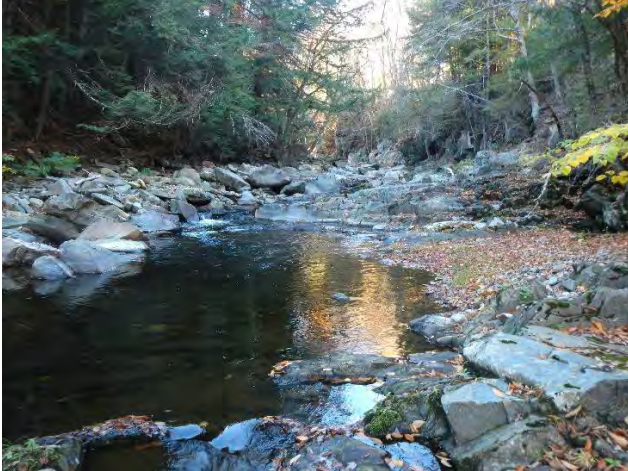
Figure 4.6: Grade controls in segment M03.B.

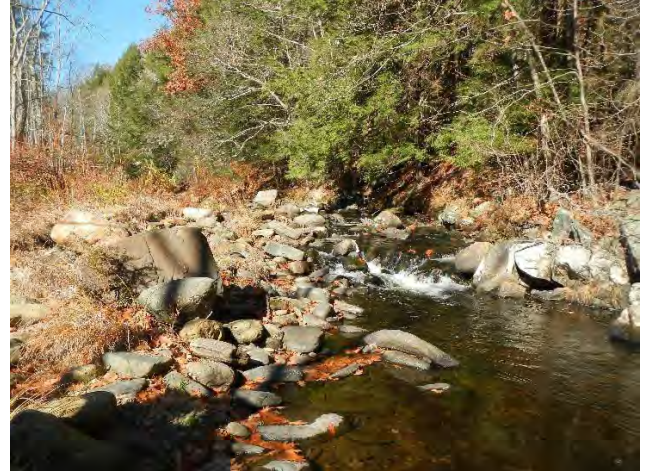
Figure 4.7: Grade controls in reach M05.

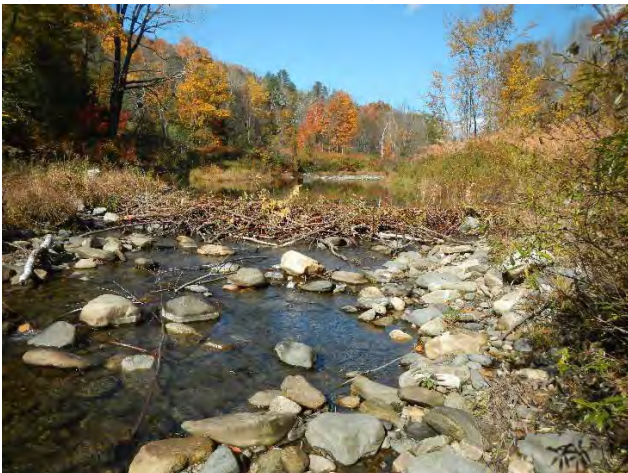
Figure 4.8: Beaver dam in reach M02.

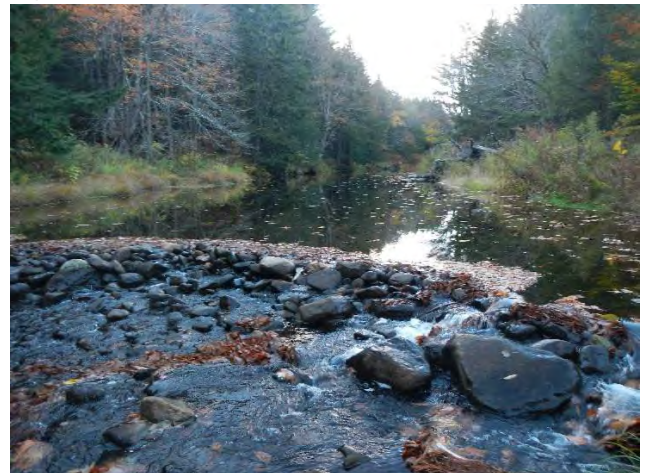
Figure 4.9: Small boulder & cobble impoundment to enhance a swimming hole in segment M03.C.

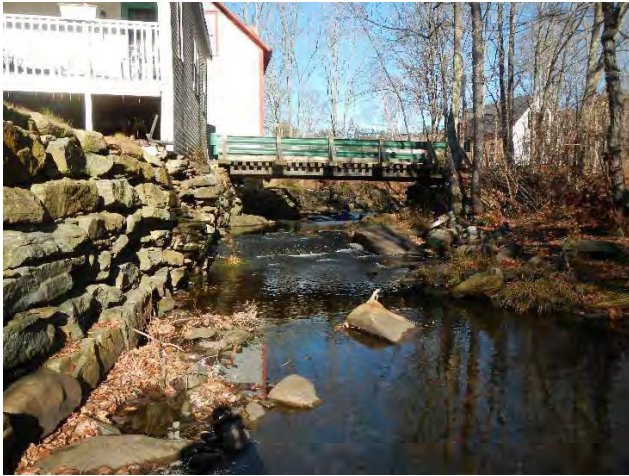
Figure 4.10: Extreme bank armoring on reach M06.B.

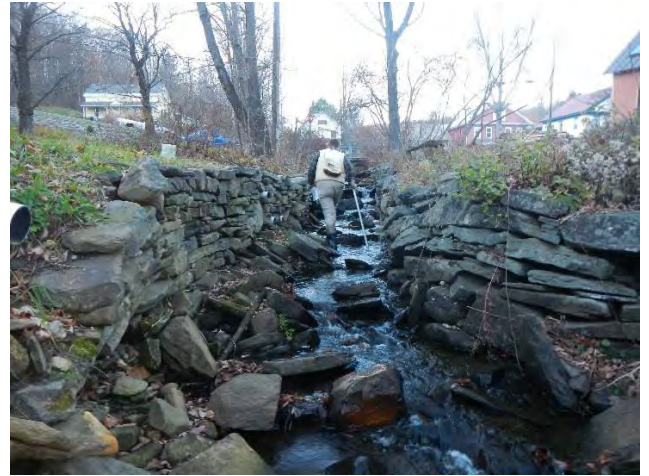
Figure 4.11: Extreme bank armoring on segment M07.A.

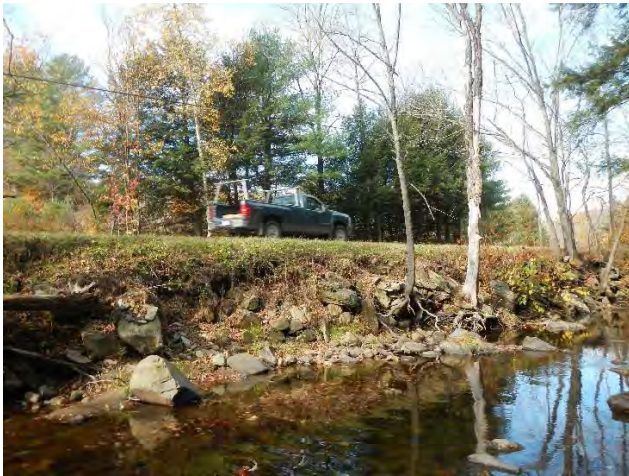
Figure 4.12: Bank erosion and failing armoring along VT 112 on reach M05.

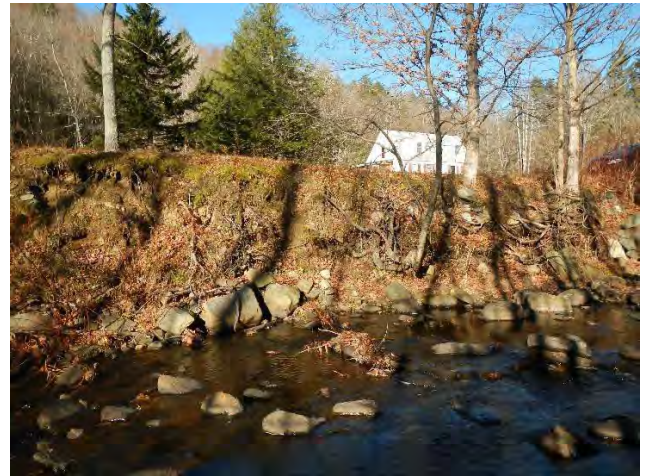
Figure 4.13: Bank erosion near Holbrook Road on segment M06.A.

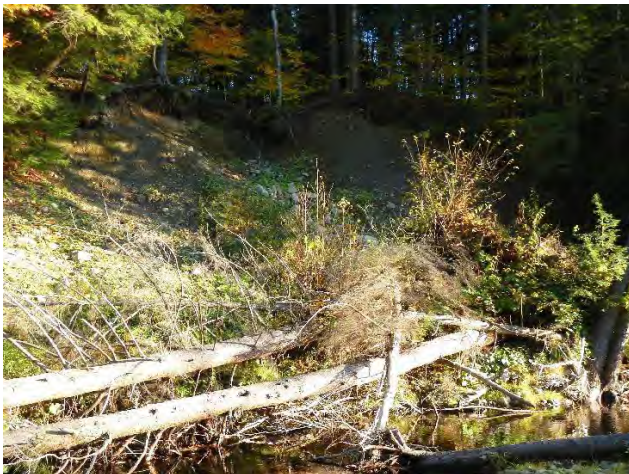
Figure 4.14: Mass failure on segment M03.C.

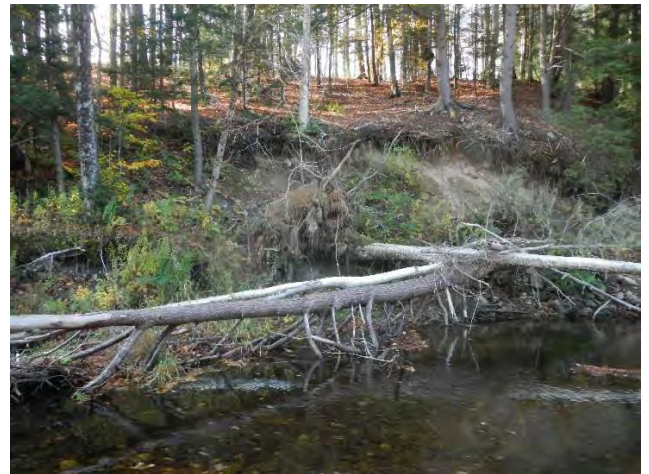
Figure 4.15: Mass failure on reach M05.

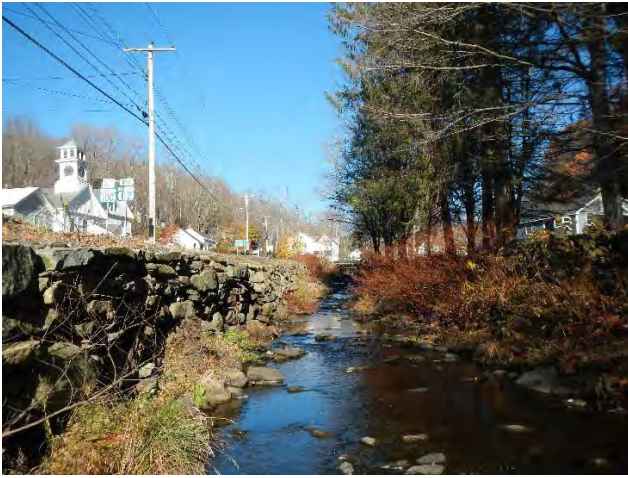
Figure 4.17: Extreme straightening along segment M06.B.

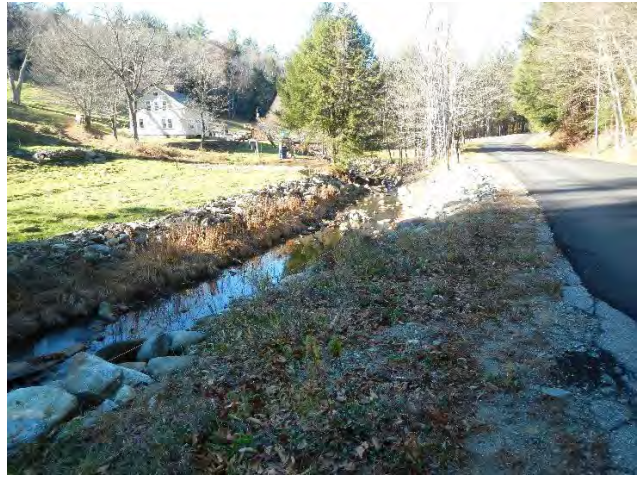
Figure 4.18: Bank armoring, encroachment, and straightening on reach T1.02.

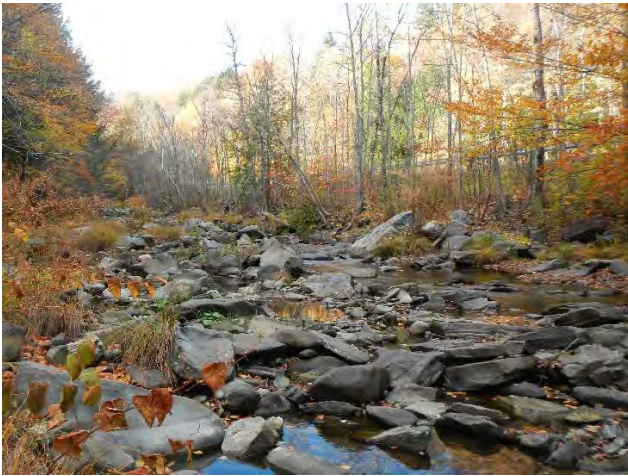
Figure 4.19: Extreme encroachment along VT 112 on segment M03.A.

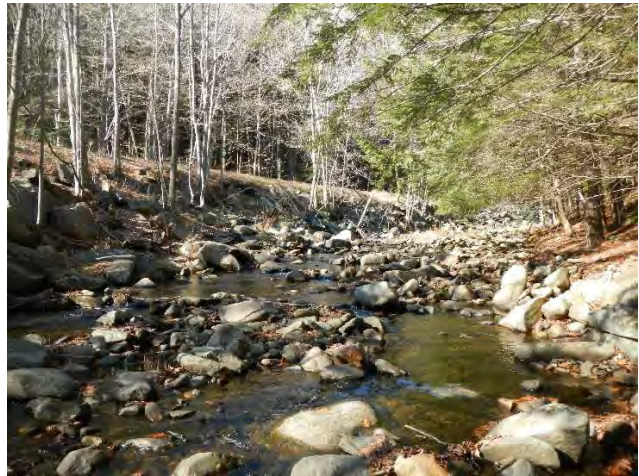
Figure 4.20: Extreme encroachment along Branch Road on reach T1.01.

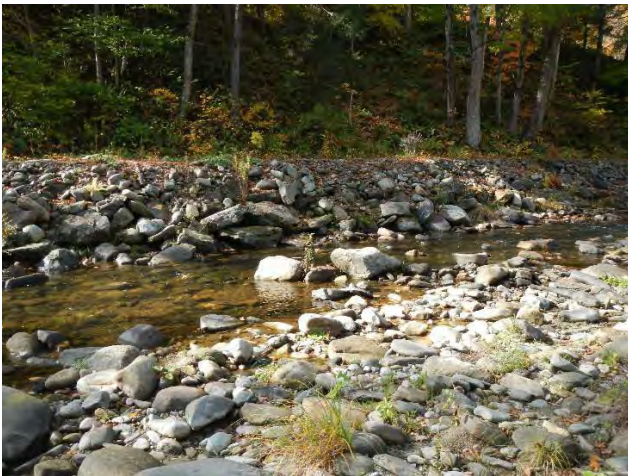
Figure 4.21: Dredging and windrowing on reach M02.

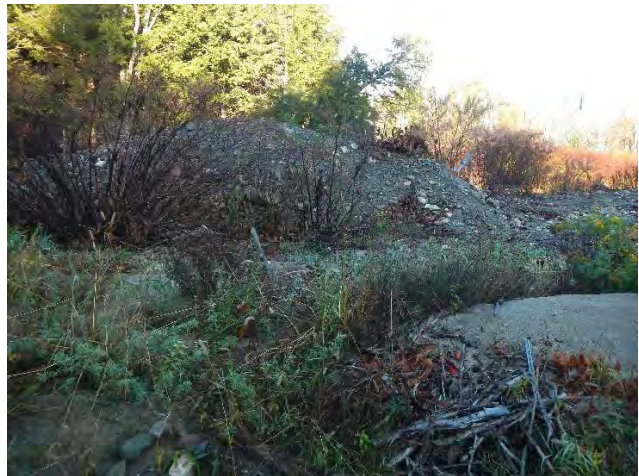
Figure 4.22: Dredging spoils on segment M04.A.

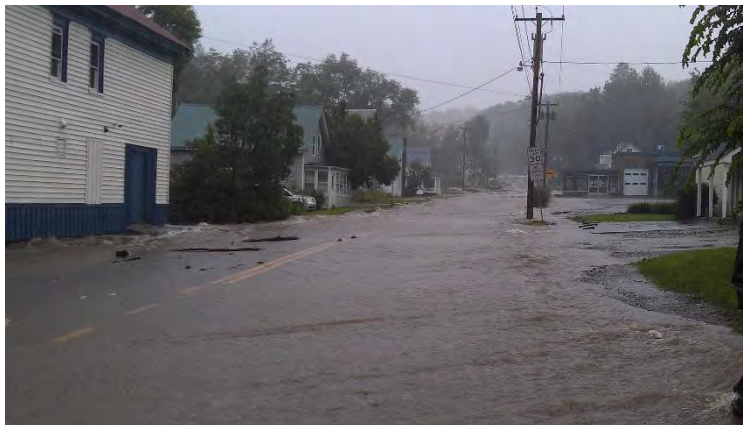
Figure 5.1: Tropical Storm Irene floodwaters overtopping the culvert and bridge at the Whitingham Municipal Center and flowing south down VT 100 (photo courtesy of G. Havreduk).
