**APPENDIX F:**

**East Branch North River Project Development Summaries  
Halifax and Whitingham, Vermont**

## River Corridor Plan for the East Branch of the North River - Project Development

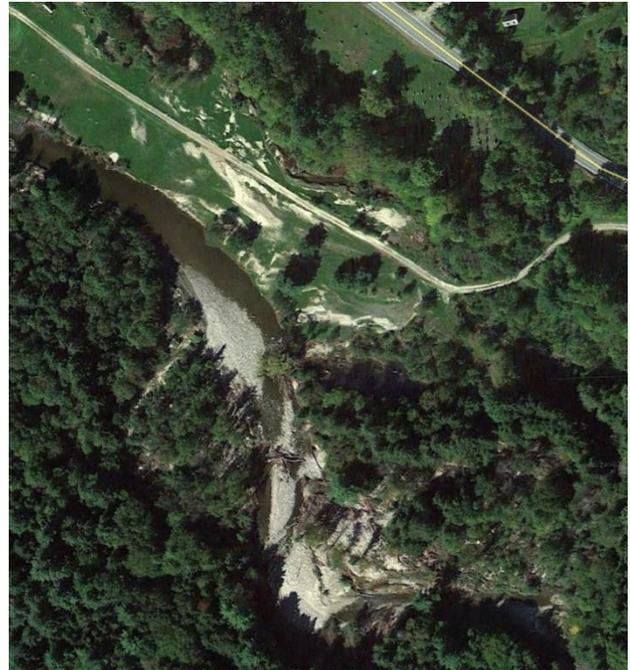
Tropical Storm Irene sent large volumes of floodwater over both banks through the project area and caused moderate erosion and channel migration along the north bank into the Neubert property. The channel widened to 80-100 feet through most of the project area. The channel is carving a large meander through the downstream portion of the site before it becomes confined by steep forested banks with bedrock along Abbotts Glen. The low-lying floodplain along the north side of the sharp bend provided critical area for debris storage during T.S. Irene (Figure 1). Woody vegetation was scoured away and the site was recolonized by some native woody shrub species, but is primarily vegetated with Japanese Knotweed (Figure 2). The tributary to the north of the driveway spilled across the floodplain leaving large sand deposits. Some dredging occurred during 2011 flood recovery work, creating several large spoils piles, but no berms. The spoils piles do not significantly reduce floodplain access or available storage. An approximate 10-25 year flood in October 2017 accessed the lower floodplain areas and scoured away large areas of Japanese Knotweed; native woody vegetation remains limited. Significant volumes of sand and fine gravel spilled onto the grassed area between the tributary and the driveway (Figure 3).

**Figure 1:** Aerial photograph of T.S. Irene deposits and channel migration

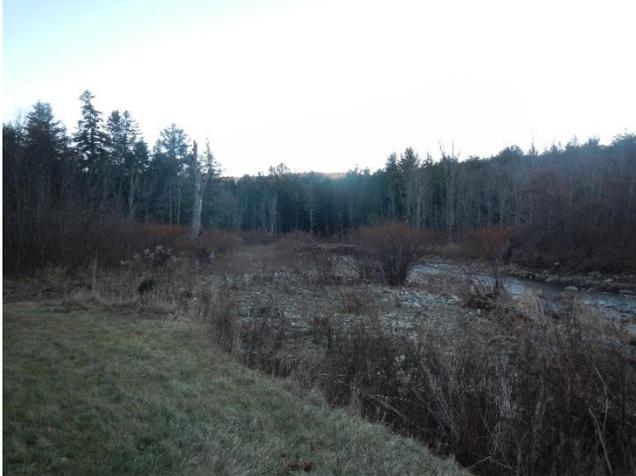
**Figure 2:** Coarse sediment deposits on the lower floodplain area

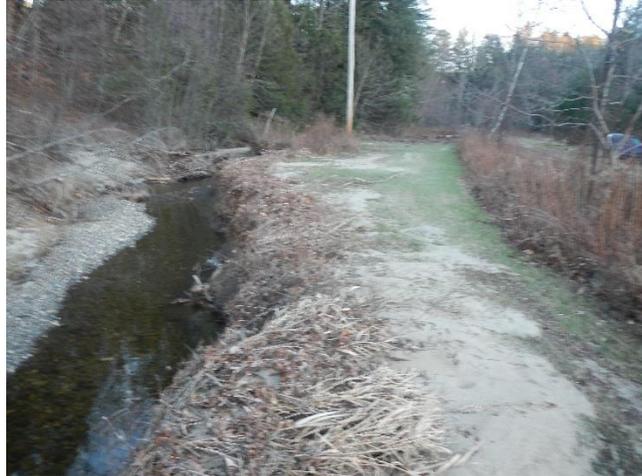
**Figure 3:** Sand deposits from the October 2017 flood along the tributary channel.

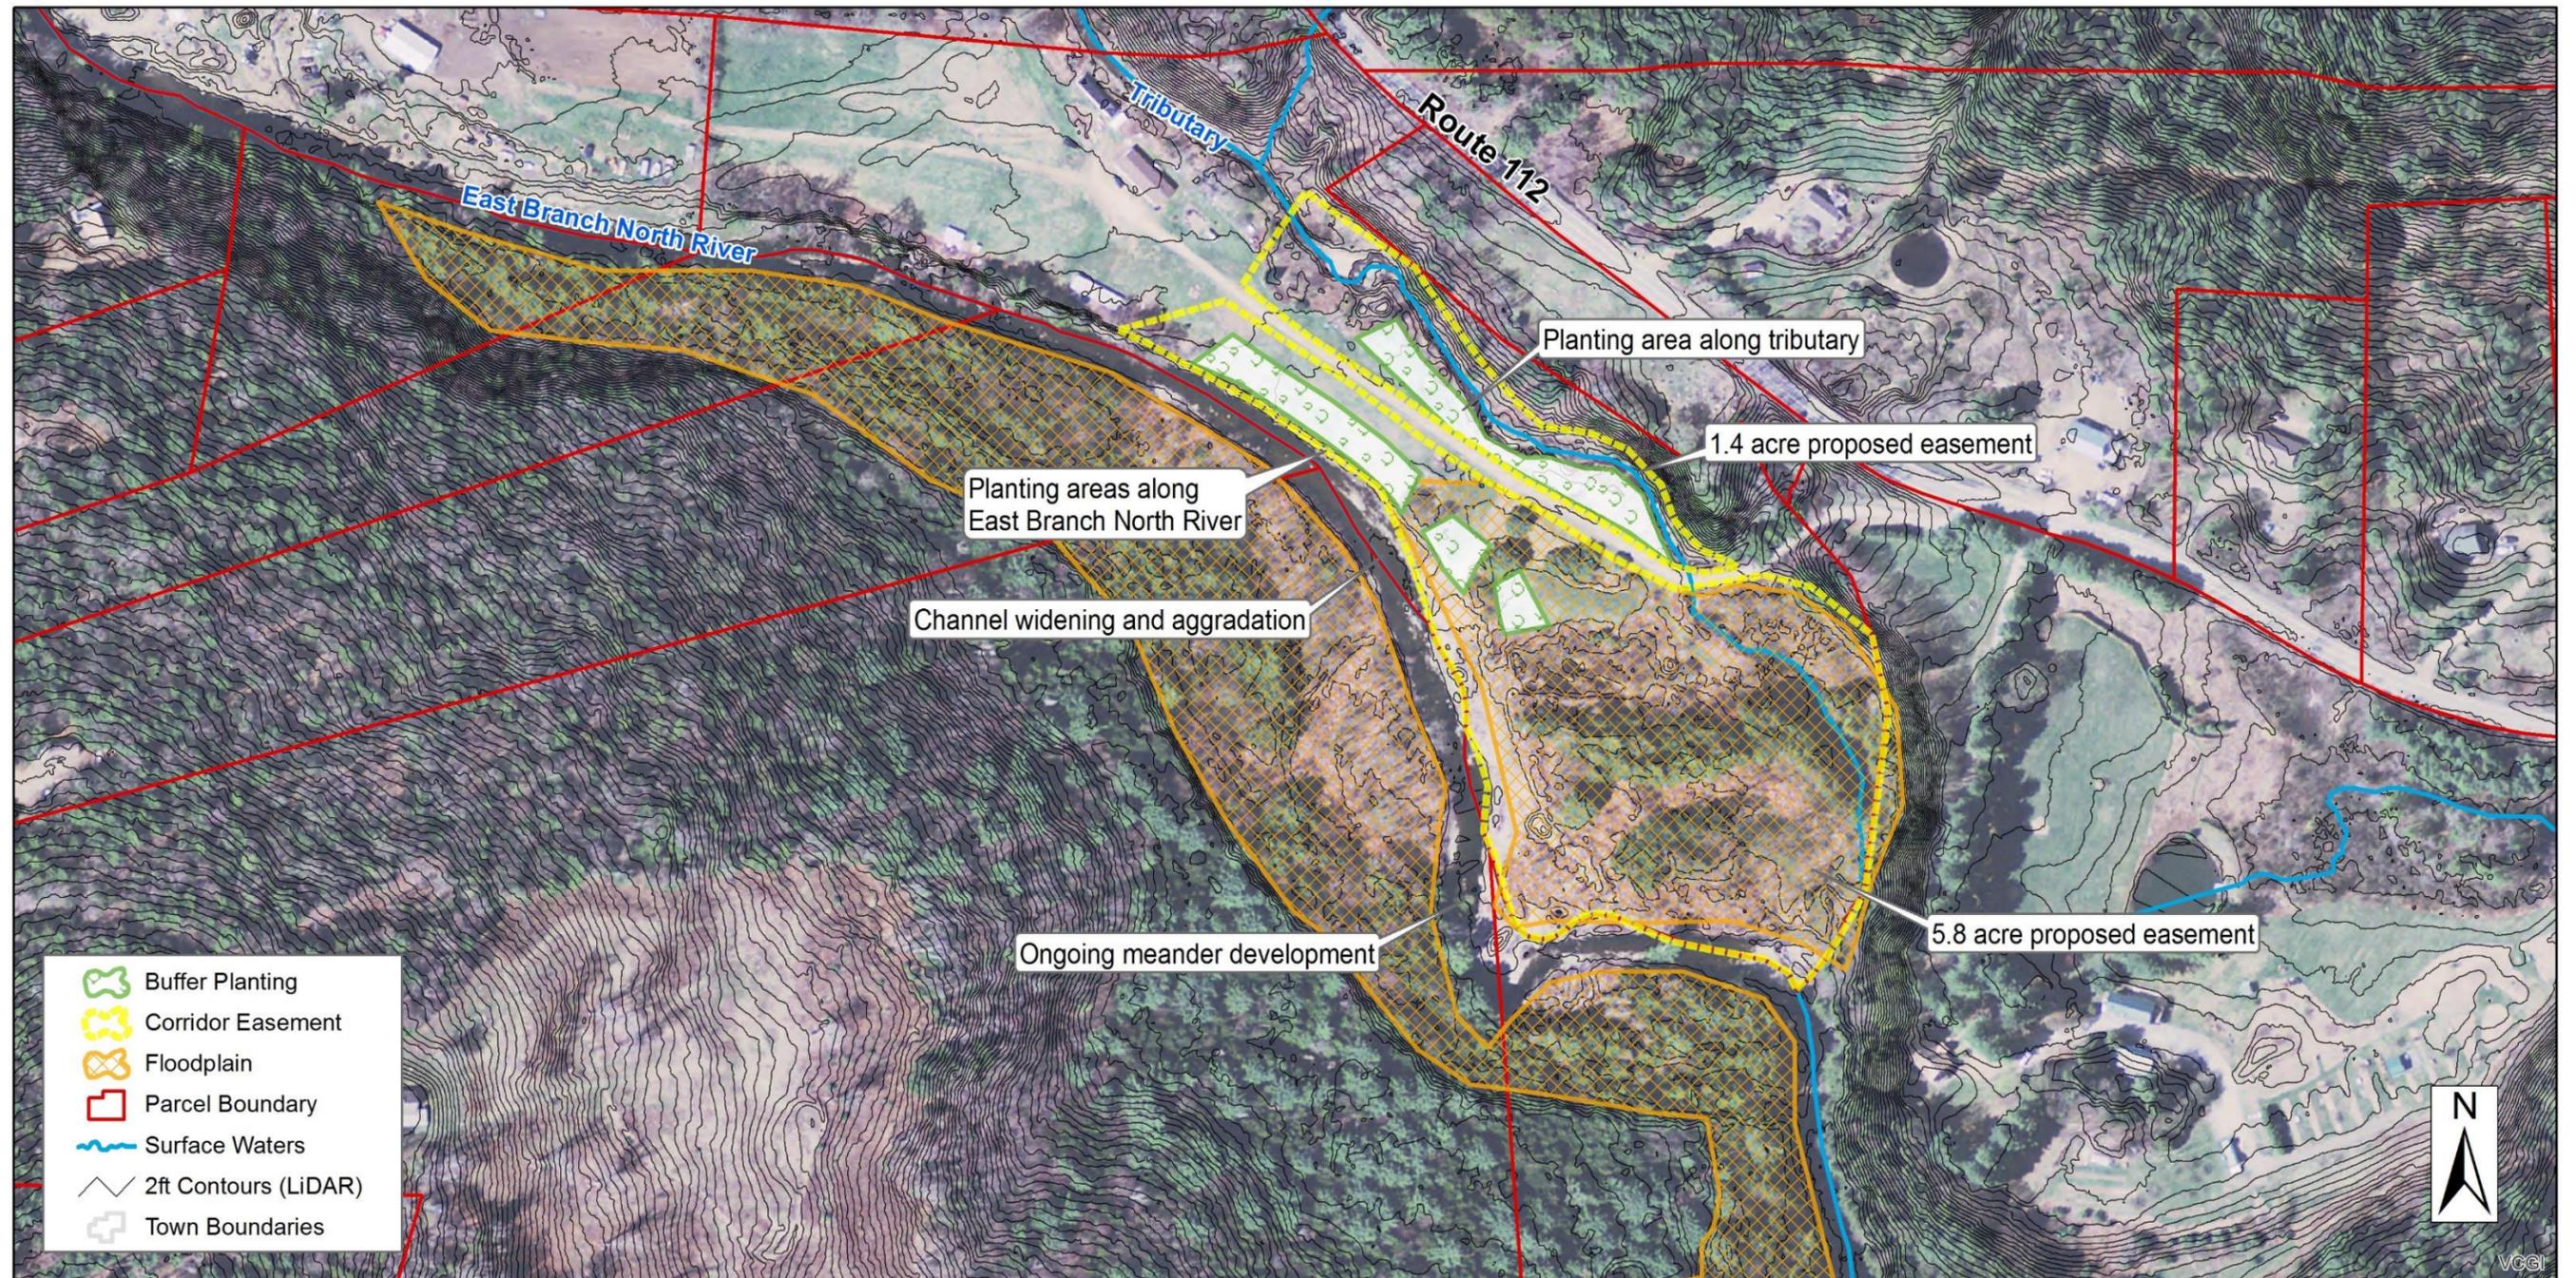
Figure 4: Proposed plantings and easements on the Neubert property in Halifax, VT.

Native woody trees and shrubs should be planted along the near-bank area of the North River and along the tributary to increase long-term stability and allow for slower and more natural rates of channel adjustment. **The buffer plantings along the East Branch North River should account for ongoing widening and planform adjustment. Plantings should be set back from the top of the bank and larger (and more expensive) plantings should be located further from the bank.**

Established woody vegetation will also increase floodplain storage and retention of sediment and debris, and improve shading along both waterways. Based on the current lack of a buffer along the river and the reduced buffer along the tributary, and an objective to create a minimum buffer width of 50 feet, the total planting area

would be approximately 0.8 acres (Figure 4). Assuming a target plant spacing of roughly 10ft on center, approximately 350 plants are needed for the site. If 1-gallon container stock trees and shrubs are used for the plantings, we estimate that the total project costs with labor will be \$4,000 to \$5,000. Planting costs could be reduced considerably with the use of bare root planting stock; however, the mortality would likely be much higher than container stock. Additional plantings could be distributed along the lower floodplain area, however the dense Japanese Knotweed growth with likely reduce the success of plantings in this area.

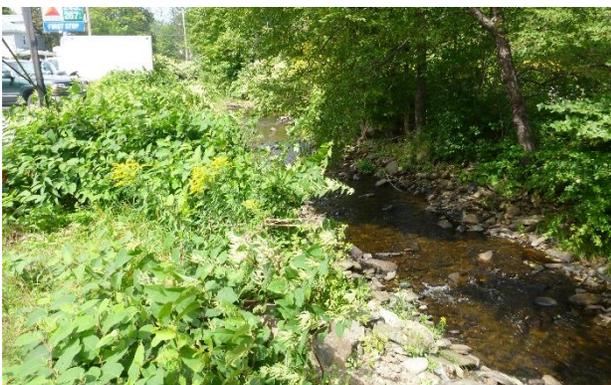
The channel is narrow and deeply incised as it flows past the First Stop convenience store and several commercial buildings before crossing under Route 112. The existing bank armor appears undersized (Figure 5). The floodplain across the channel from the gas station was accessed during T.S. Irene and is slightly lower in elevation (Figure 6). Replacing the existing bank armor on the west bank, near the gas station, with a stacked stone wall could increase slope protection and increase bankfull width. Reshaping the east bank to lower the elevation of the floodplain to increase accessibility could lower flood risk to the gas station and increase attenuation of floodwaters and sediment on the floodplain.

**Figure 5:** East Branch of the North River at the First Stop convenience store (right bank).

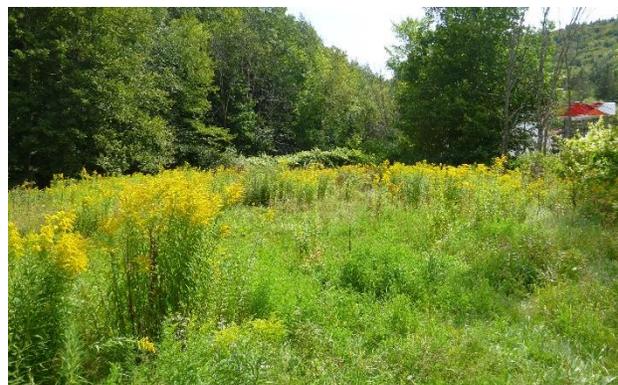
**Figure 6:** Floodplain on the left bank of the East Branch of the North River across from the First Stop convenience store.

A floodplain on the East Branch of the North River across from the First Stop Convenience Store was accessed in T.S. Irene and was slightly lower in elevation than the gas station, reducing damage to the property. Flood deposits stockpiled on the floodplain have raised the elevation and lessened the potential benefits during future floods. Reshaping the east bank to form a floodplain bench and lowering the elevation of the upper floodplain area could reduce the risk of flooding and erosion at the First Stop Convenience Store (Figure 27). The stability of the embankment along the west bank should be assessed and replaced with large stone armor if needed. The embankment could be reconfigured with a stacked stone wall to increase channel capacity. In the modeled alternative where the floodplain was lowered by 1-2 feet, flood depths were lowered by over 1-foot in the 500-year event and velocities were reduced by 20%. We estimated approximately 800 to 1,000CY of excavation and off-site trucking. Replacing the west embankment with a stacked stone wall would require approximately 100CY of placed stone armor. Based on unit costs of \$30/CY for excavation and trucking and \$50/CY for placed stone armor, we estimate that the total project costs will be between \$25,000 and \$35,000.

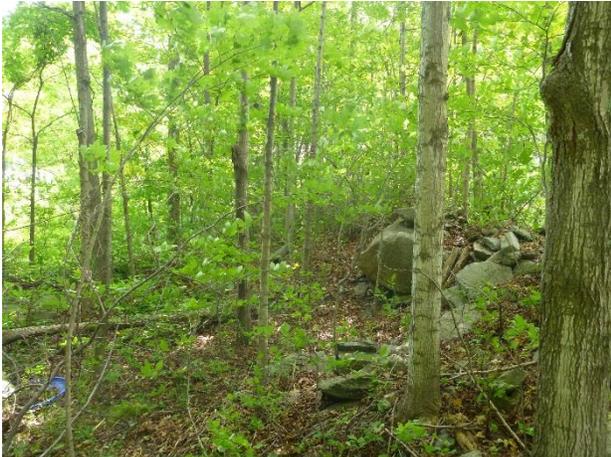
The steel driveway bridge located at the confluence of the East Branch of the North River and the Gates Pond drainage is a bankfull constriction at 55% of bankfull width. During the Irene flood, the constriction at this bridge caused increased flood elevations and overbank flow to the east, damaging the driveway to the Degray house. The bridge is also the first significant constriction downstream of the Gates Pond, increasing the potential for debris catchment. Additionally, a berm on the east bank of the Gates Pond drainage at the confluence is restricting access to a flood chute and floodplain (Figures 7 and 8). Removing the berm and replacing the bridge with a larger structure could lower flood depths in the confluence area.

**Figure 7:** A berm (right) restricts access to a floodplain (left) and flood chute along the Gates Pond drainage near the confluence with M07.A

Based on the field surveys of the berm dimensions and assuming the removal of 150 linear feet of berm, we estimate that approximately 250-300CY of dredged channel material would be removed. We recommend shaping the north bank back to a stable 1V:3H slope to reduce the risk of bank erosion and to increase bankfull channel width by approximately 15-20%. In the modeled alternative, the increased floodplain storage along the east bank would decrease water elevations during large flood events by less than 0.5 feet. These reductions are relatively low; however, the model predicts that berm removal would allow 20% of the floodwater in the 500-year flood to access the floodplain and decrease channel velocities by approximately 25% (Figure 26). This project will require additional design to ensure that berm removal will not increase flood vulnerability to the downstream houses. The driveway will also require additional stabilization and drainage improvements. We estimate that this project will cost between \$15,000 and \$20,000.

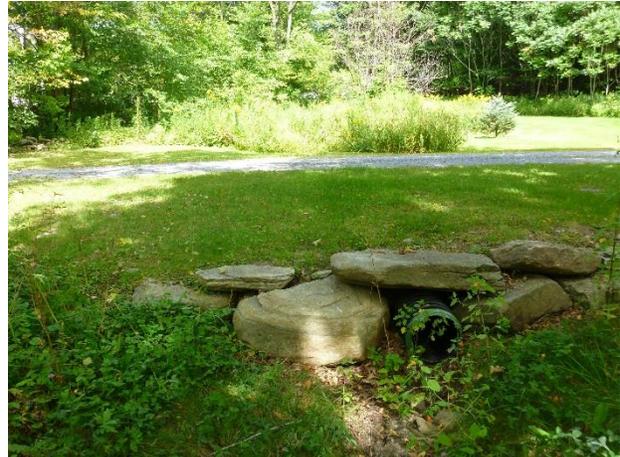
**Figure 8:** Reconnecting the floodplain may make a downstream driveway vulnerable to erosion in larger flows.

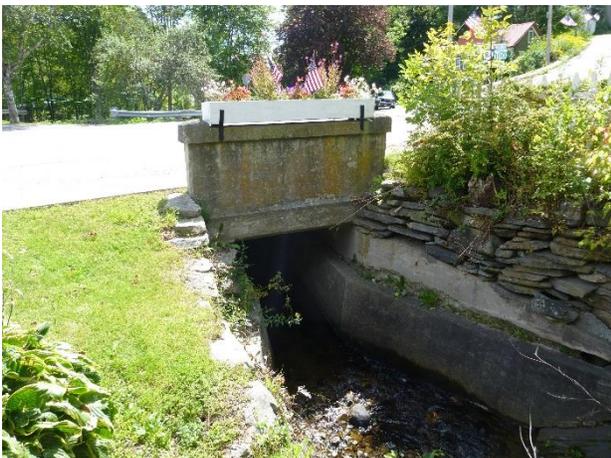
The 90-foot long crossing under the intersection of Route 100 and Route 112 in downtown Jacksonville is severely undersized, causing severe overbank flooding in T.S. Irene. The bridge and downstream channel have an approximate width of only 6ft, or 38% of bankfull width (Figures 9 and 10). Electrical conduits on the downstream end of the bridge are exposed and could catch debris. When the bridge is up for replacement, it should be replaced with a large structure. The downstream channel should also be enlarged to match the capacity of the bridge.

**Figure 9:** Inlet to the undersized crossing at the intersection of Route 100 and Route 112.

In order to increase hydraulic capacity of the East Branch North River channel to pass flows during larger floods, we recommend replacing the bridge at the intersection of Route 100 and Route 112 with a larger structure. Based on our hydraulic model the bridge is overtopped in the 25-year flood and in large floods the bridge affects flooding for several houses along Route 100. Additionally, the structure is a severe channel constriction at risk for snagging debris. Increasing the size of the structure to a bankfull bridge is predicted to allow the crossing to pass all floods without causing them to jump the channel at the road. Flooding for the houses directly adjacent to the channel upstream of the crossing is still predicted (Figure 24). In the scenario that combines this alternative with Alternative 2 (removing the municipal complex

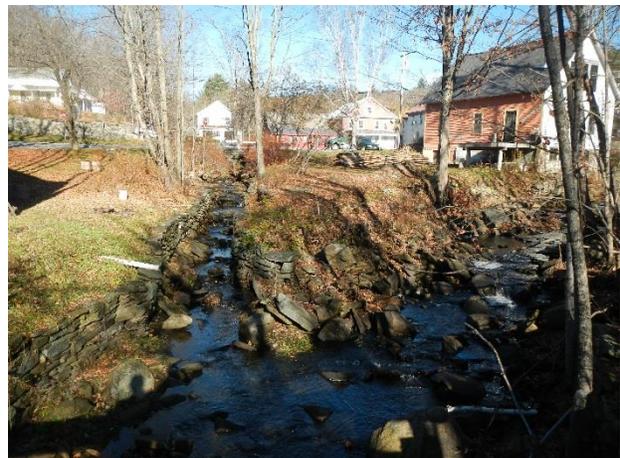
**Figure 10:** Undersized channel downstream of the crossing, at the intersection with the Gates Pond Branch.

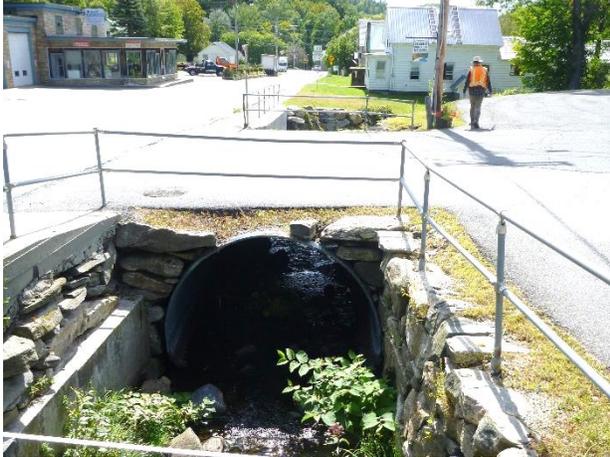
The 8.5ft wide squash CMP culvert under the southern entrance to the municipal center is in poor condition is a significant bankfull width constriction at 53% (Figures 11 and 12). The culvert capacity may back up floodwaters during high flow events, especially when sediment and debris accumulate or snag in the channel or at the structure inlet. However, the upstream and downstream bridges have significantly lower capacity. When the culvert comes up for replacement, replacing this culvert with a larger structure will mitigate flood risks. The entrances to the municipal center could be consolidated to a single crossing.

**Figure 11:** Undersized squashed culvert inlet at the Whitingham municipal complex.

To increase hydraulic capacity of the East Branch North River channel to pass flows during larger floods, we recommend replacing the culvert at the town offices with a larger structure in addition to removing the upstream bridge. Additionally, the estimated bankfull width for this section of the East Branch North River is 15.6 feet, but the current channel width is approximately 10 feet (Figure 20). Therefore, we propose widening the channel bottom by approximately 5 feet upstream and downstream of the new structure along the west bank at the municipal complex and fire station (approximately 240 linear feet along the channel). The existing culvert is at capacity in the 500-year flood, raising flood depths upstream and is at risk for snagging debris. Increasing the size of the culvert to a bankfull structure and increasing the channel capacity is predicted to allow the crossing to pass all floods without backing up floodwaters. In the Alternative 2 scenario, modeled flood depths are 3-5 feet lower in the 500-year flood than existing conditions (Figure 21).

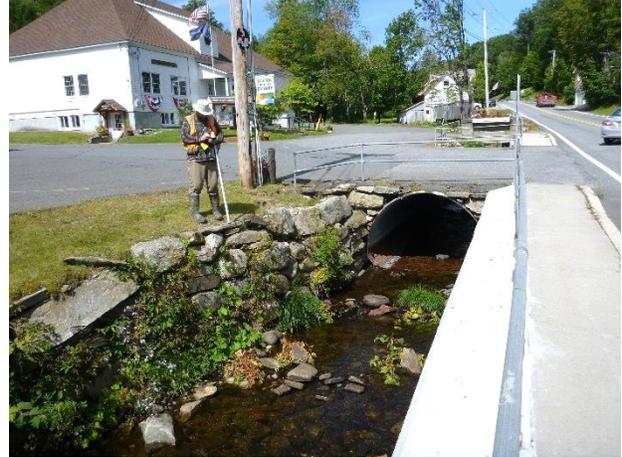
**Figure 12:** Undersized squashed culvert outlet at the Whitingham municipal complex.

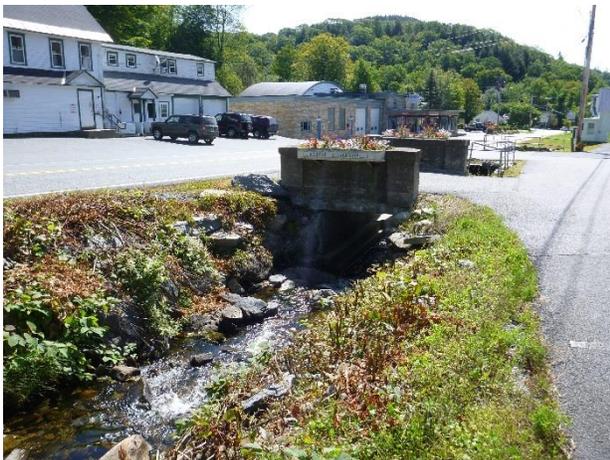
The concrete bridge at the northern entrance to the municipal center is an extreme bankfull constriction (34%) and was the location of major overbank flooding during T.S. Irene. The bridge hydraulic capacity is exceeded during large flood events, backing up floodwaters and increasing flood depths (Figures 13 and 14). The bridge could be replaced with a larger structure or removed to consolidate access to the municipal complex with the downstream culvert crossing. Alternatively, installation of a bypass channel behind the town hall was assessed as an alternative to relieve flooding on Route 100 in the Village.

**Figure 13:** Undersized bridge inlet at the Whitingham municipal complex.

To increase the capacity of the East Branch North River to pass large flows and debris, we recommend removing this crossing. The crossing is redundant as an entrance to the municipal offices, with a crossing immediately downstream. The downstream culvert has a large capacity, so in the modeled alternative in which only the bridge was removed floodwaters dropped by 2-2.5 feet during the 500-year flow and remained in the channel at the municipal complex (Figure 18). In the Alternative 1 scenario, the culvert is at capacity, suggesting floodwaters are still at risk of jumping out of the channel and onto Route 100 (Figure 19).

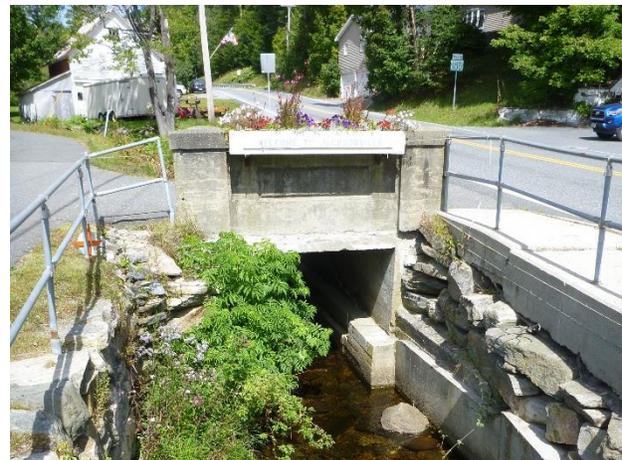
**Figure 14:** Undersized bridge outlet at the Whitingham municipal complex.

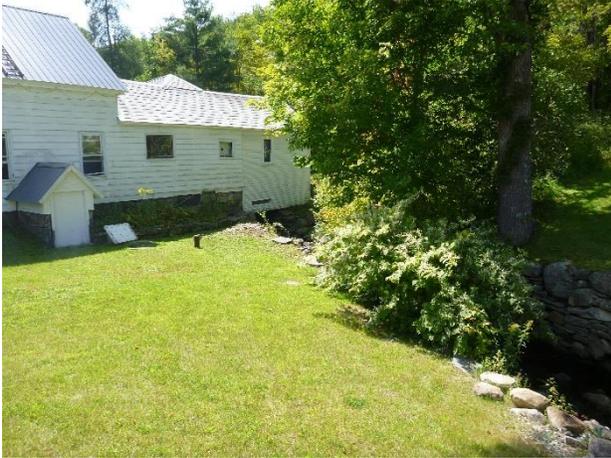
The house downstream of the Town offices and fire department is a bankfull constriction at its opening (45%). In large flood events, the opening of the house may increase local flood depths (Figures 15 and 16). The house is at risk of snagging debris that may cause structural damage and raise flood elevations, especially if upstream constrictions at the Town offices are removed. Alternatives considered included removing a portion of the house and creating a floodplain overflow area in the backyard.

**Figure 15:** Reach M07.A as it approaches a house is severely straightened and armored.

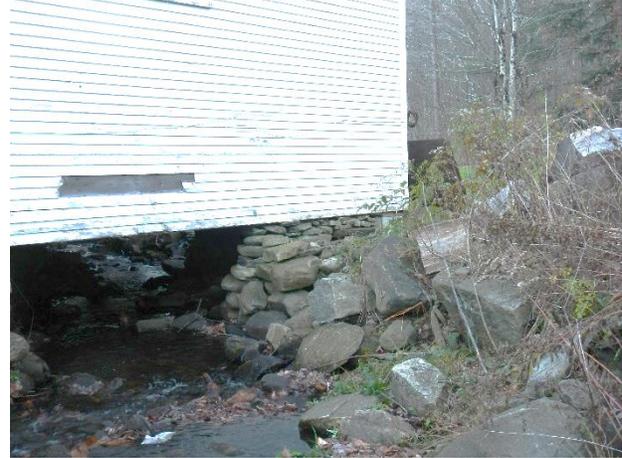
**Figure 16:** Inlet to the passage of reach M07.A under a house in Jacksonville.

Additional design work is recommended for any floodplain restoration effort. Based on unit costs for excavation and off-site trucking of the material from the floodplain of \$30/CY, we estimate that the excavation portion of this project will cost between \$15,000 and \$25,000.

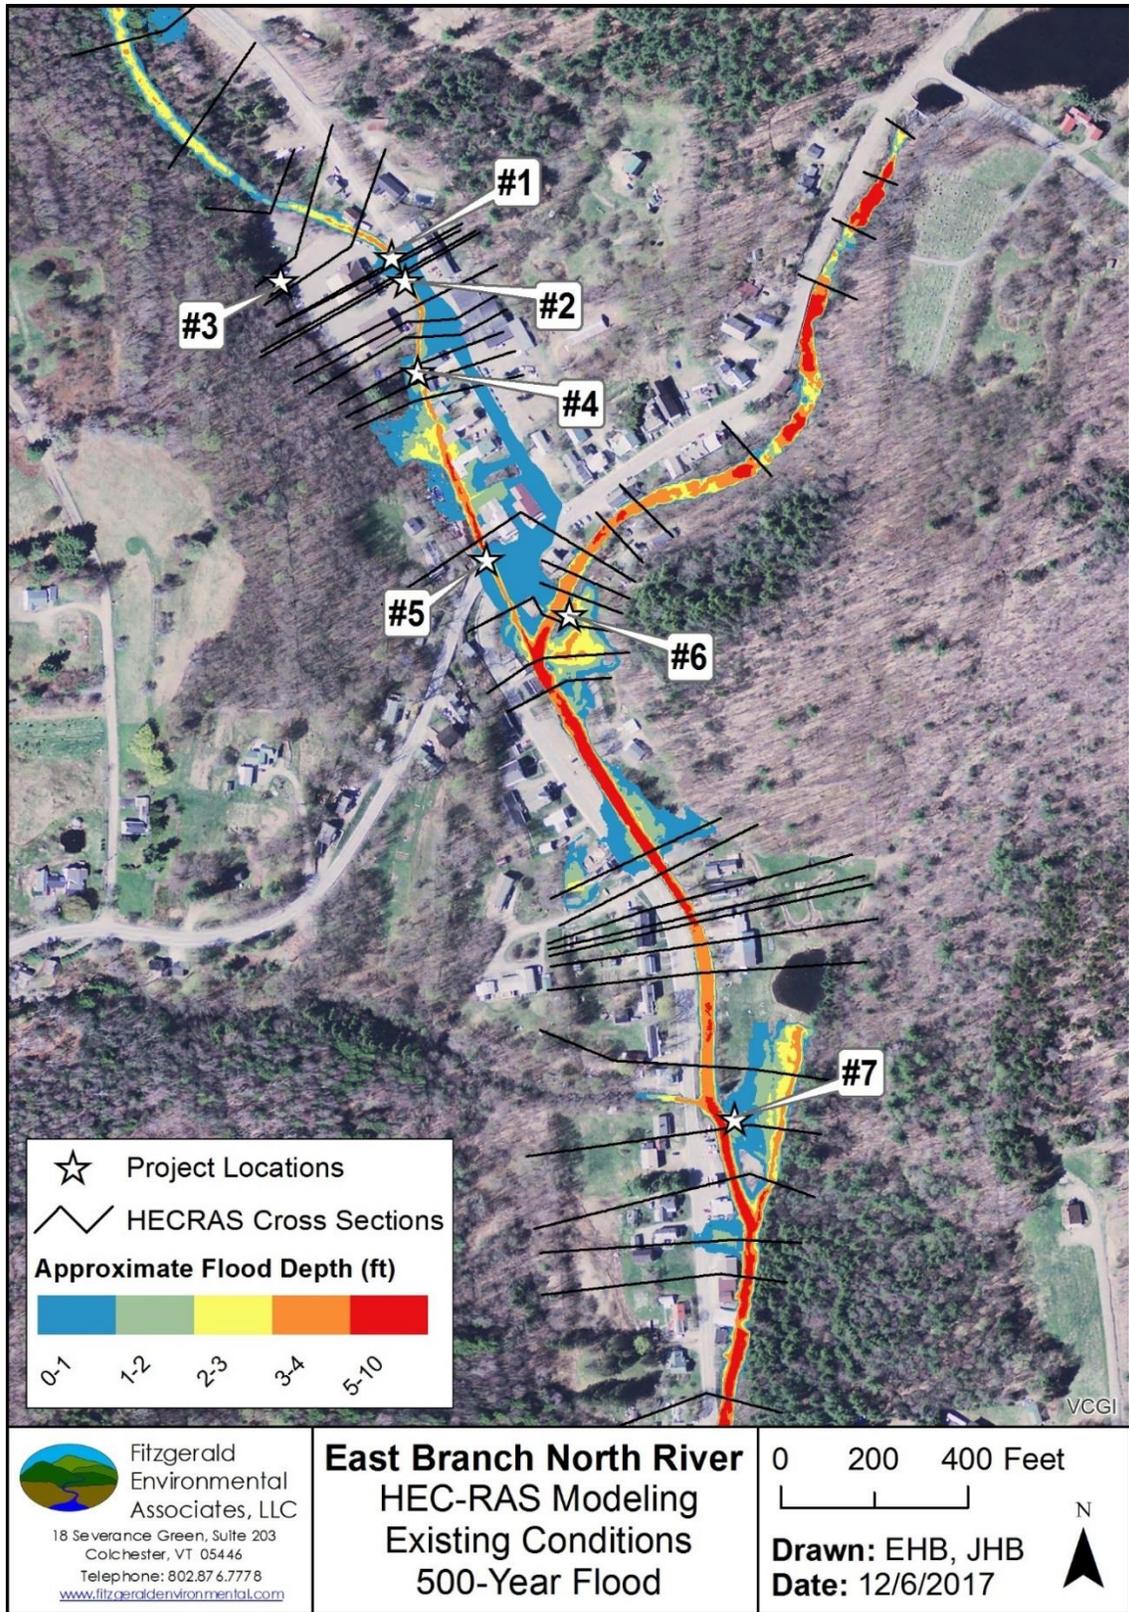
**Figure 17:** Alternatives modeled for the river corridor projects in Jacksonville. Approximate 500-year flood depths under existing conditions modeled with HEC-RAS.

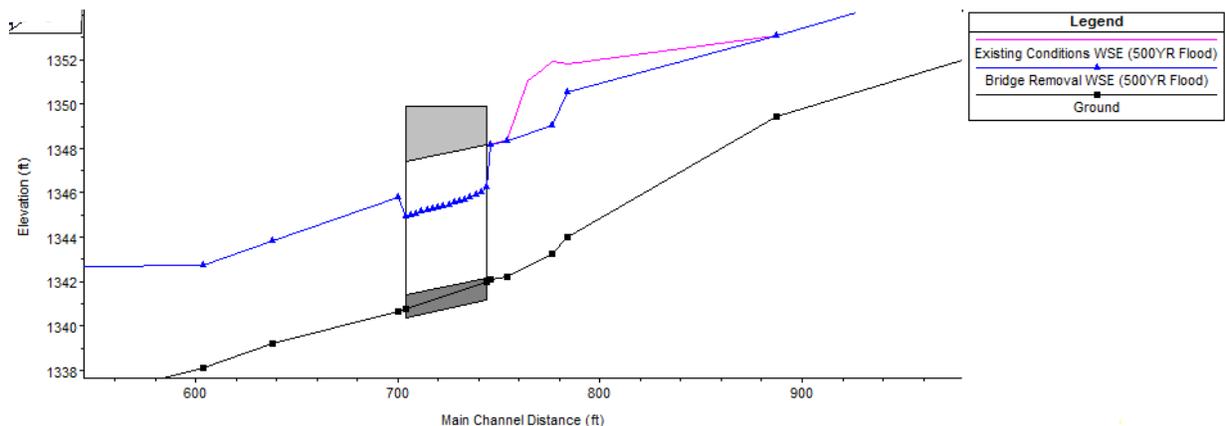
**Figure 18:** Profile of modeled water surface elevations at the Town Hall in Alternative 1 where the bridge is removed, and culvert is left as-is (blue) and under existing conditions (pink). The culvert is at capacity in the 500-year flood without the bridge in place.

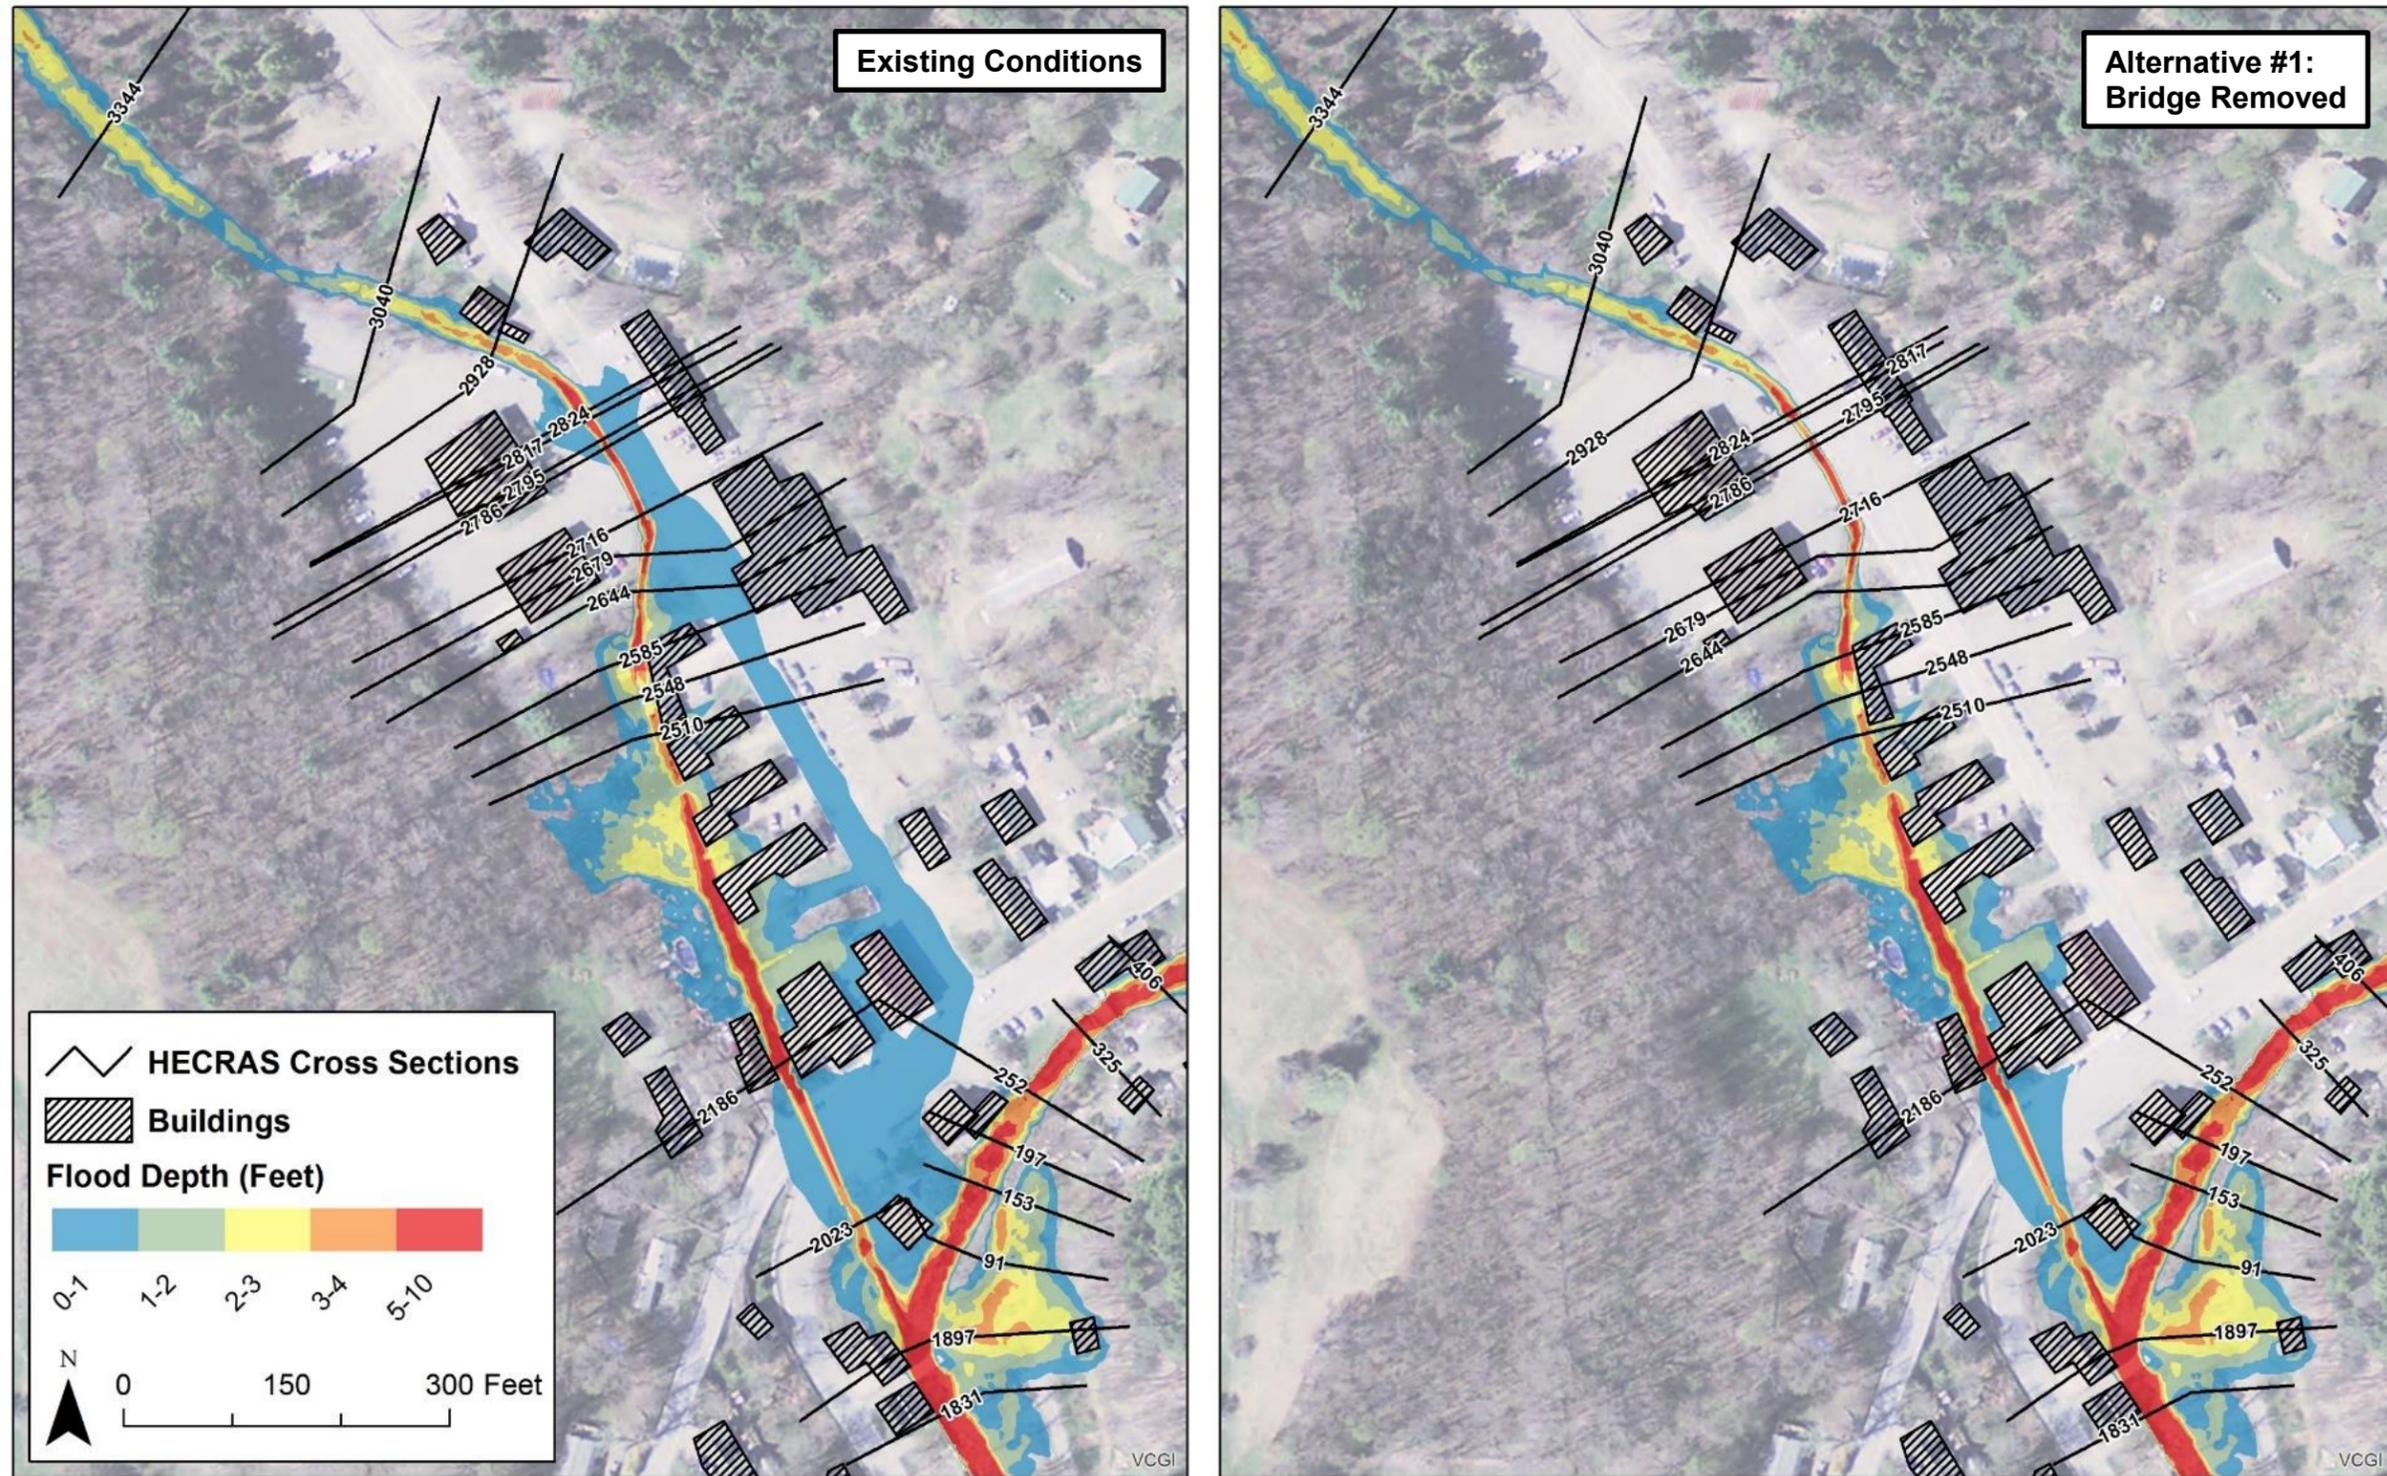
Figure 19: Approximate 500-year flood depths modeled with HEC-RAS for existing conditions (left) and the alternative in which the bridge at the municipal complex is removed (right).

The project will require demolition and removal of the existing structure and some bank excavation and reshaping. We anticipate approximately 40-50CY of material to be removed from the bridge and from the embankment along the parking lot. Approximately 30CY of heavy stone armor will be required to improve the stacked stone wall along the parking lot. Assuming rates of \$120/hour for an excavator and operator, \$30/CY for excavation and trucking, and \$50/CY for construction of a stacked stone wall, we estimate that this project will cost \$5,000 - \$10,000 if completed by the Town Highway Department. If the project is put out to bid private contractors, it will likely cost more.

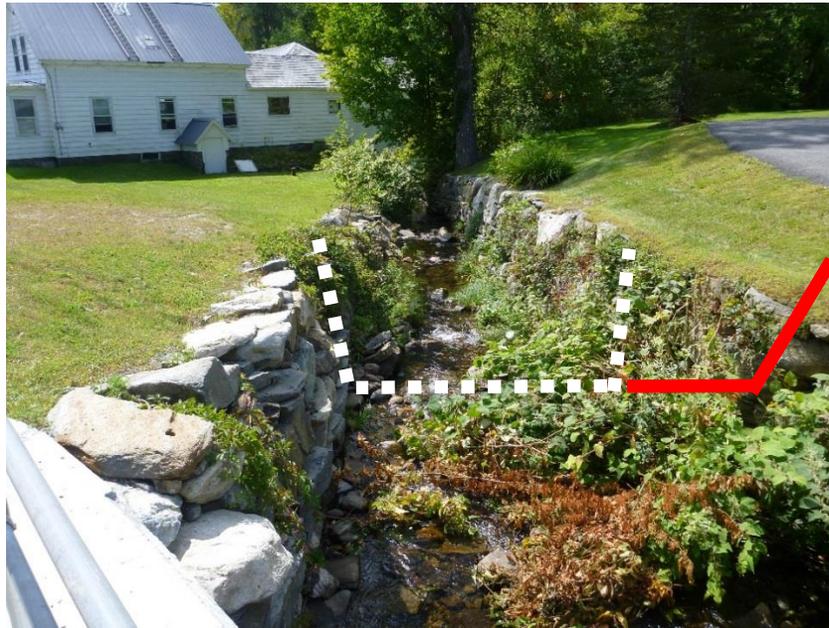
**Figure 20:** Schematic showing existing bank dimensions (white dash) and proposed channel bottom widening and bank shaping (red) on the right bank of the East Branch North River at the fire station.

The channel enlargement will require approximately 450CY of excavation and approximately 180CY of heavy stone armor. Assuming rates of \$30/CY for excavation and trucking and \$50/CY for placed stone armor, this portion of the project will cost \$20,000 - \$30,000. Replacing the culvert with a bankfull width structure will require additional analysis and design, and will likely cost over \$200,000 for a box culvert or over \$400,000 for a bridge.

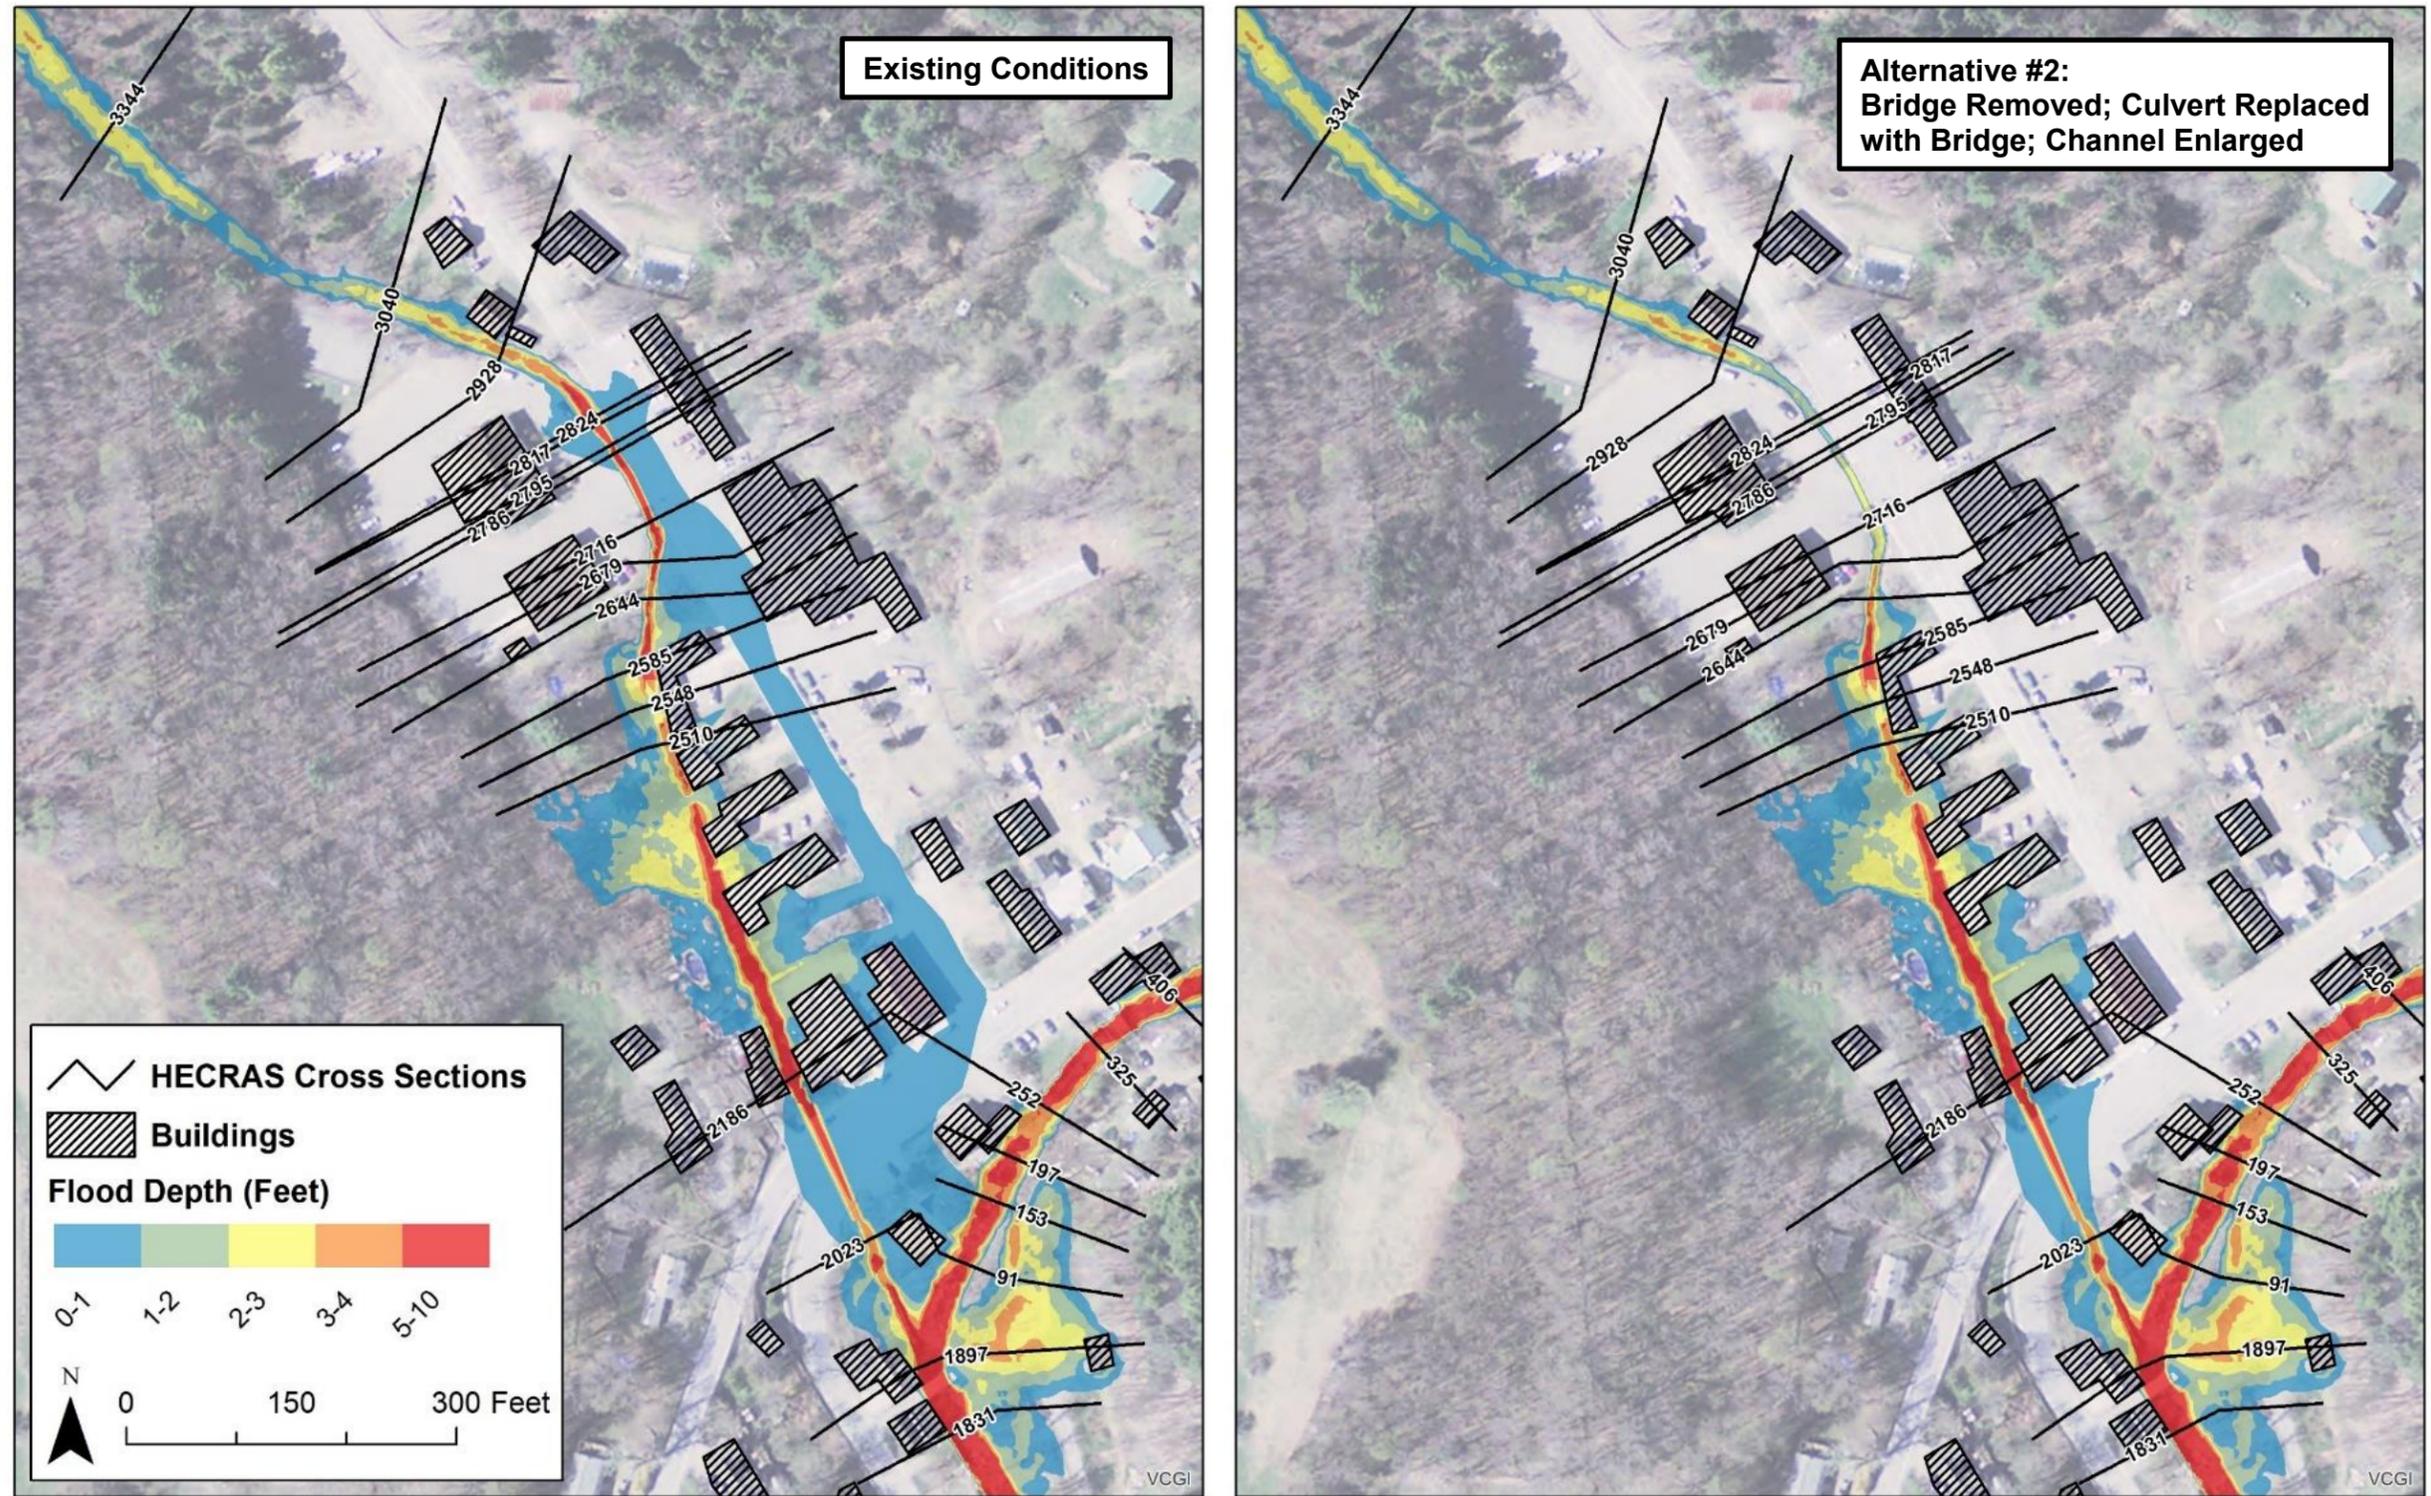
**Figure 21:** Approximate 500-year flood depths modeled with HEC-RAS for existing conditions (left) and the alternative in which the bridge at the municipal complex is removed, the culvert at the municipal complex is replaced with a bankfull structure, and the channel along the municipal complex and fire station is enlarged on the west bank (right).
