**APPENDIX F:**

**East Branch North River Project Development Summaries  
Halifax and Whitingham, Vermont**

## River Corridor Plan for the East Branch of the North River - Project Development

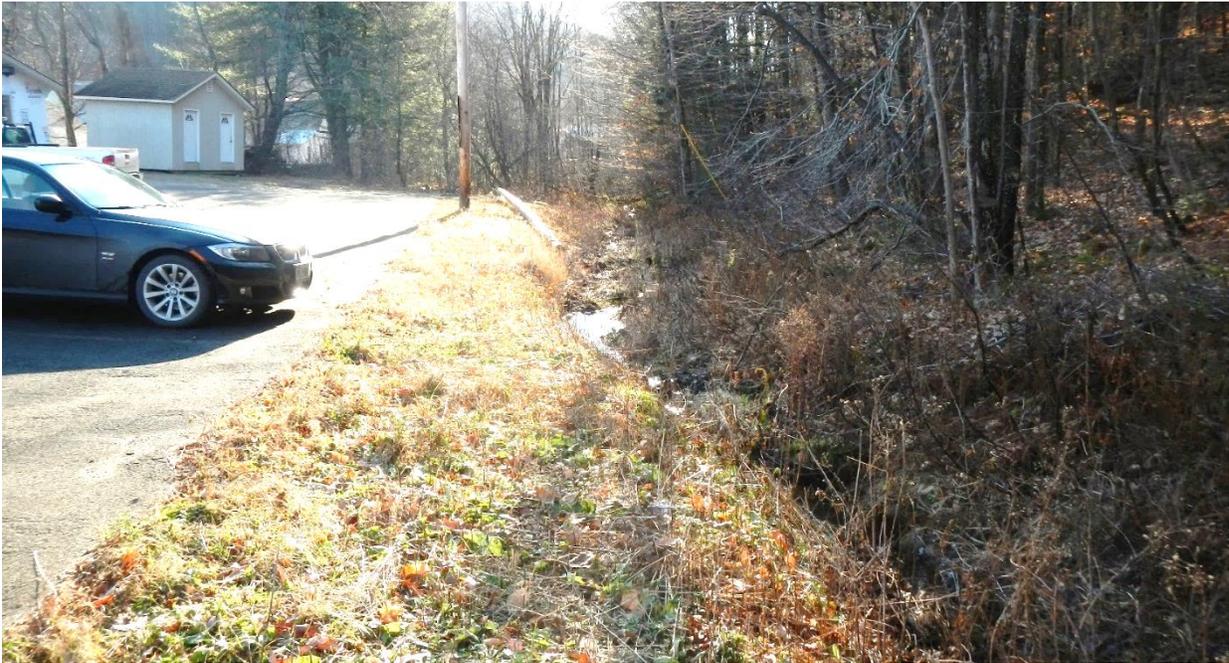
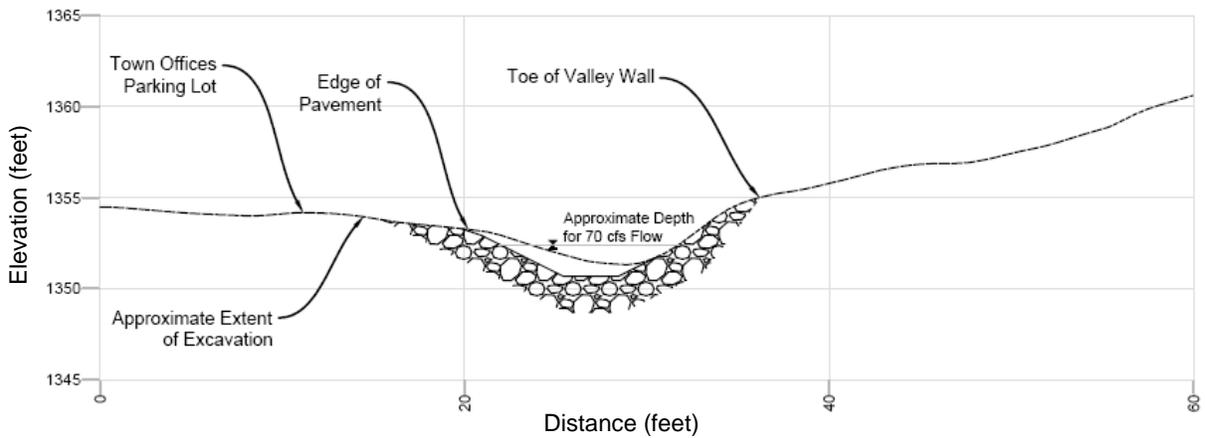
**Figure 22:** The existing channel conveying water behind the Town Offices, which is not currently connected to the East Branch North River at its upstream end (Top); and a conceptual design (Bottom) showing the existing ground surface (dashed line) and the proposed channel dimensions (solid line) with rock armor.

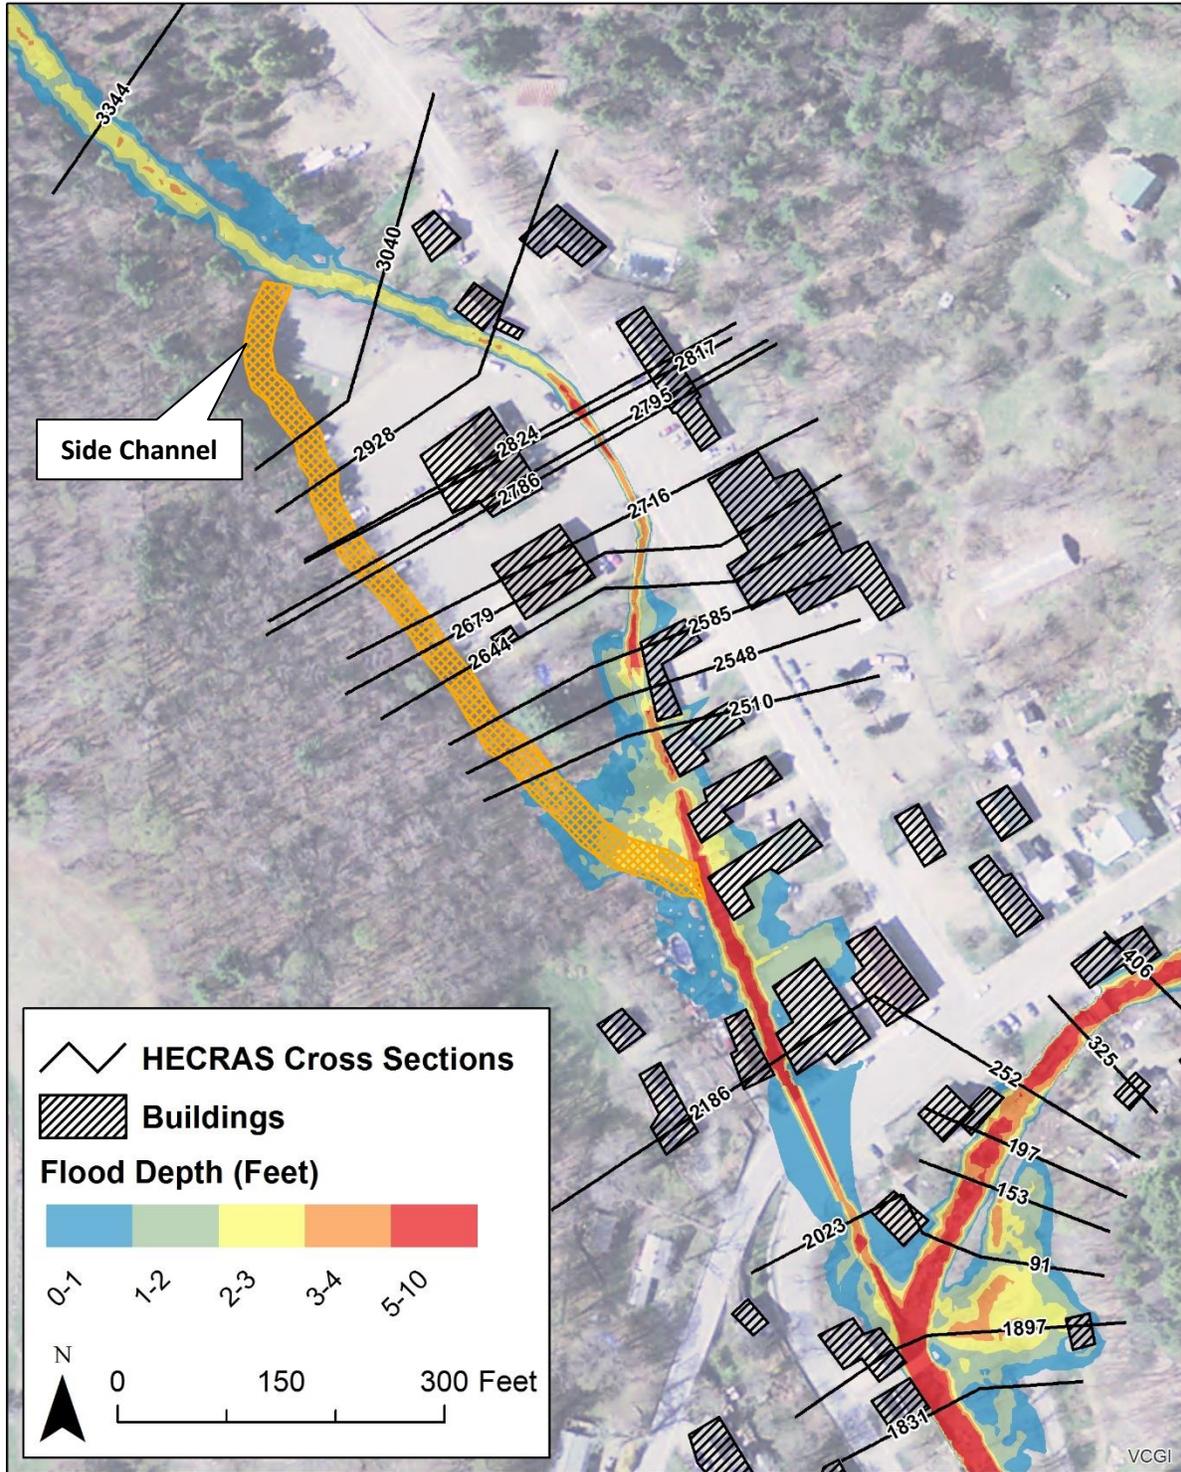
This project is not recommended due to the high risk involved in diverting flood flows into a setting and channel not meant to handle flood flows. During large floods the East Branch North River carries a significant debris and sediment load, as evidenced by the woody debris snagging and sediment deposition throughout the Village in flood events. The diversion of floodflows in a bypass channel would increase the risk of sediment and debris snagging at that location, and potentially cause the main flow to avulse or jump into the diversion channel. This would likely result in significant property damage downstream.

**Figure 23:** Approximate 500-year flood depths modeled with HEC-RAS for the alternative in which a side channel (70 cfs capacity) is excavated behind the municipal complex (right).

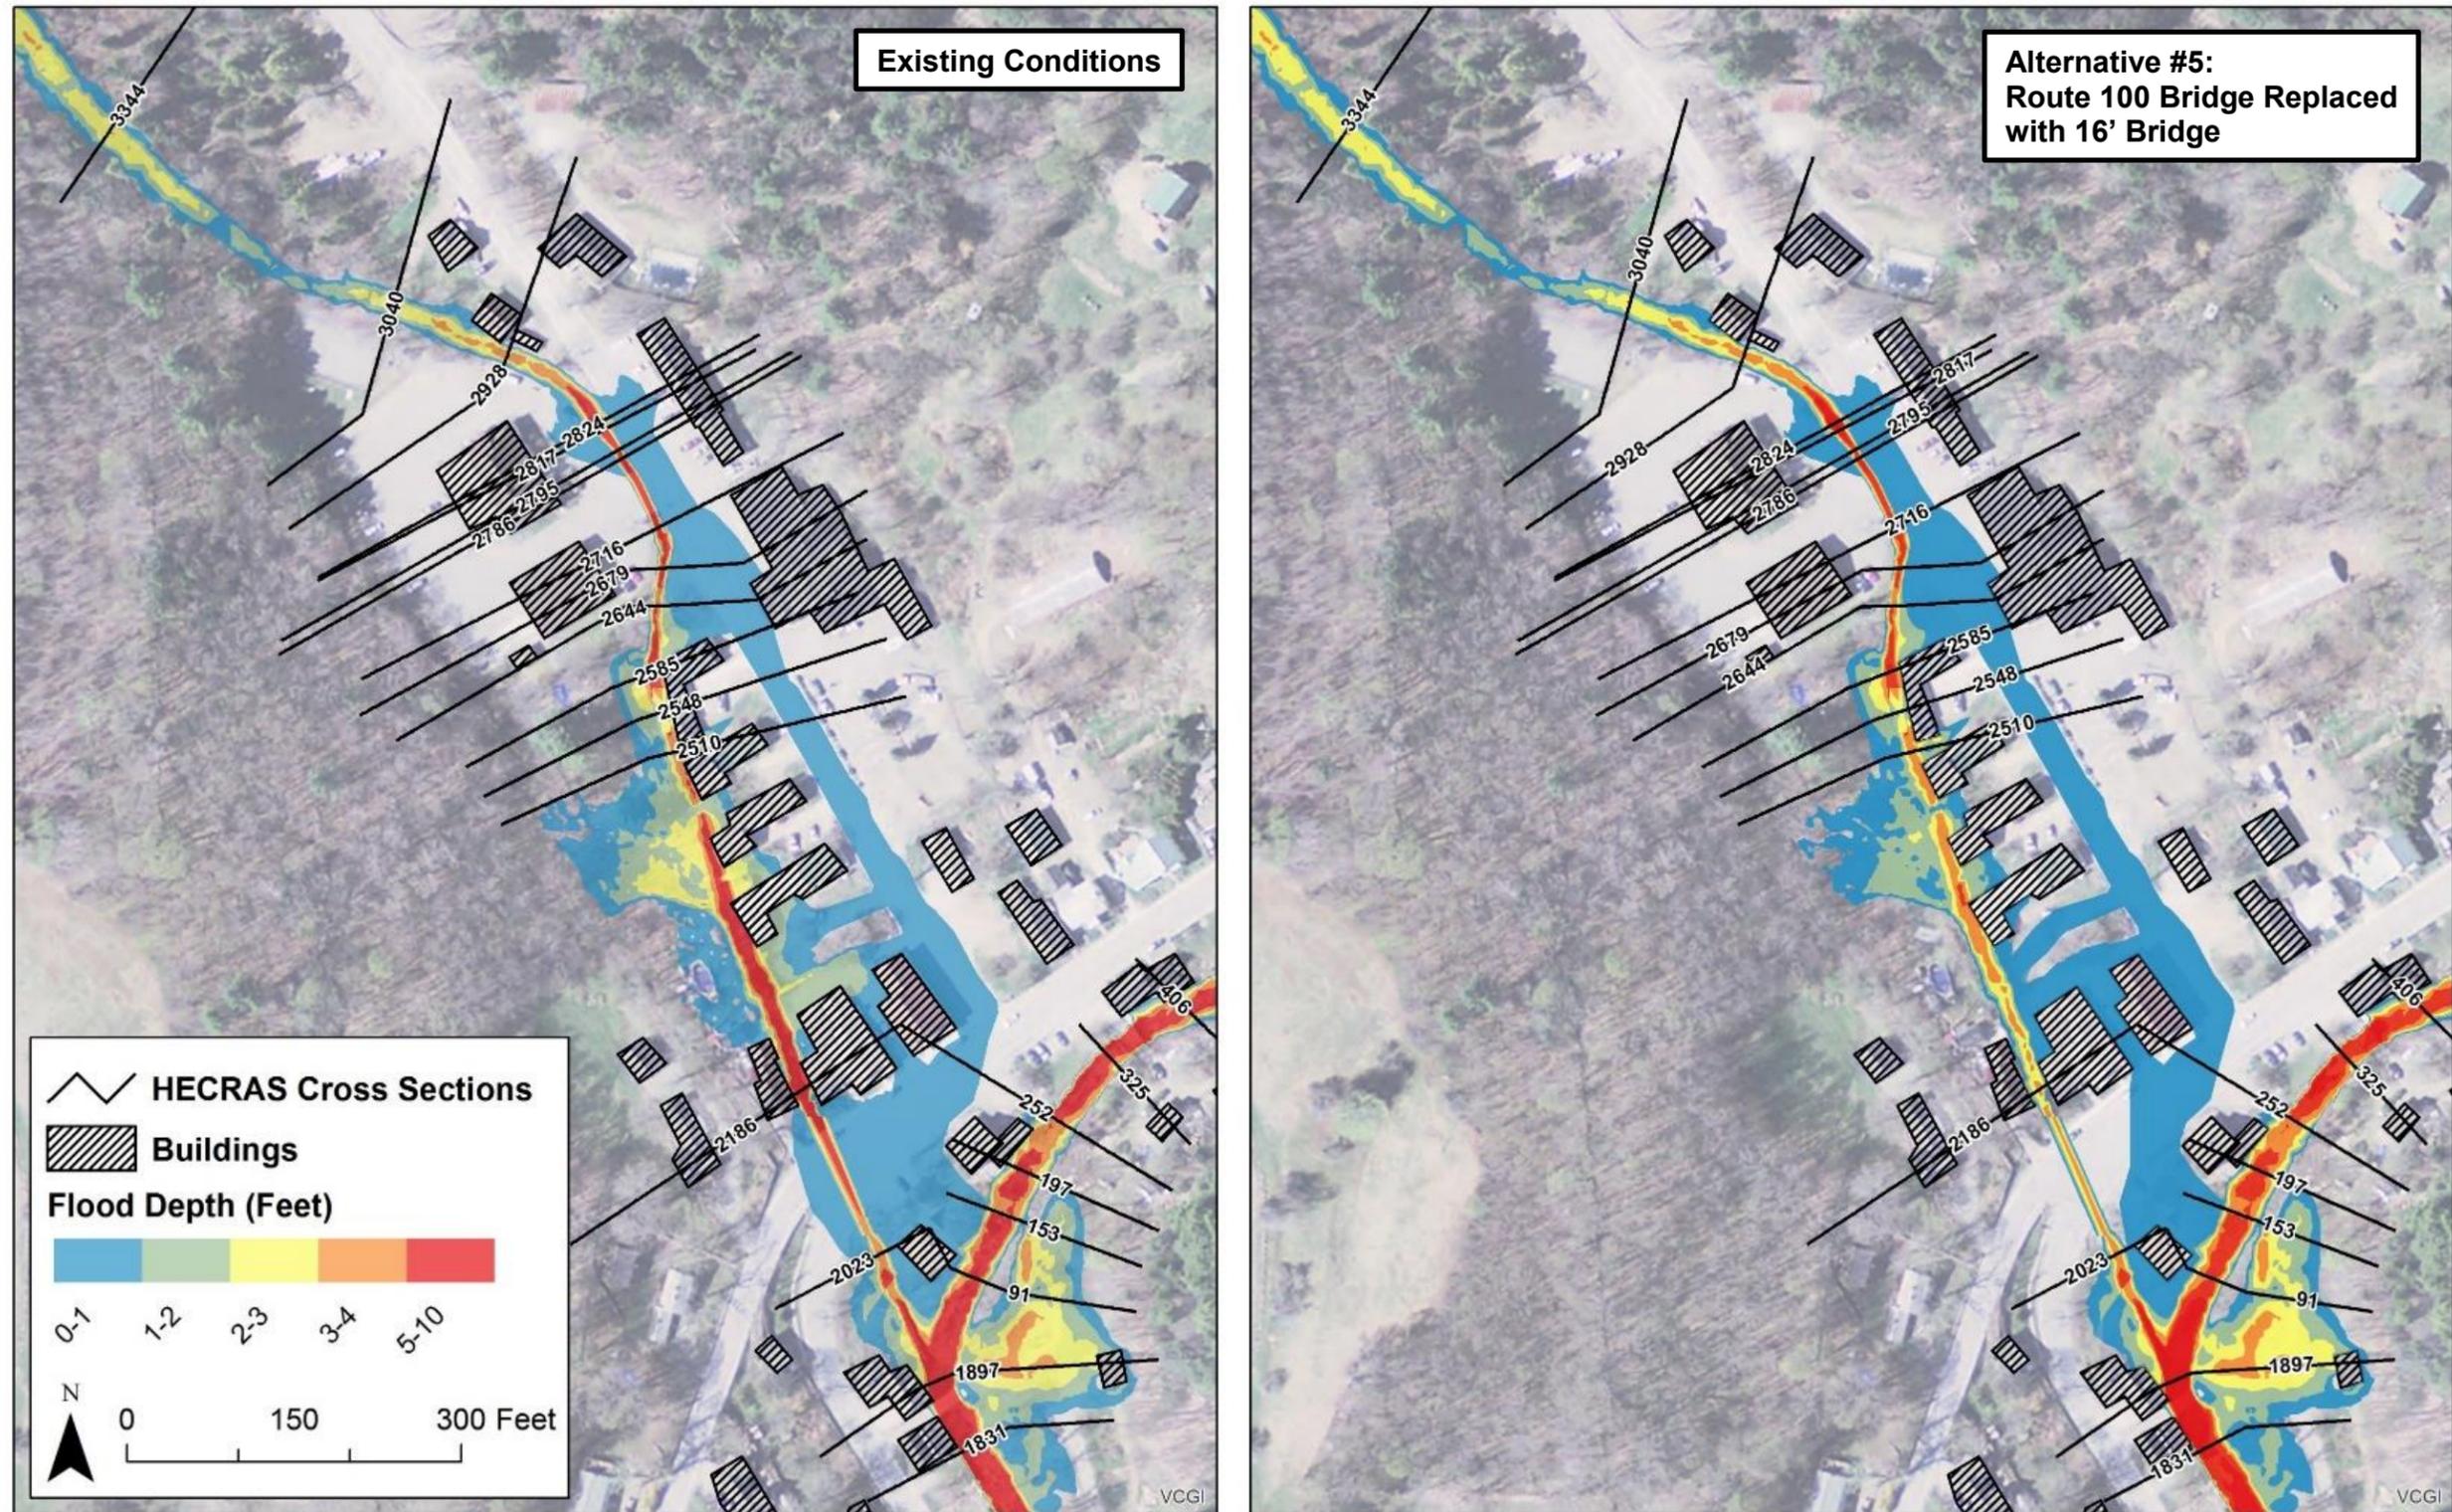
Figure 24: Approximate 500-year flood depths modeled with HEC-RAS for existing conditions (left) and the alternative in which the Route 100 bridge is replaced with a bankfull structure (right).

In order to increase hydraulic capacity of the East Branch North River channel to pass flows during larger floods, we recommend replacing the bridge at the intersection of Route 100 and Route 112 with a larger structure. Based on our hydraulic model the bridge is overtopped in the 25-year flood and in large floods the bridge affects flooding for several houses along Route 100. Additionally, the structure is a severe channel constriction at risk for snagging debris. Increasing the size of the structure to a bankfull bridge is predicted to allow the crossing to pass all floods without causing them to jump the channel at the road. Flooding for the houses directly adjacent to the channel upstream of the crossing is still predicted (Figure 24). In the scenario that combines this alternative with Alternative 2 (removing the municipal complex

bridge and replacing the municipal complex culvert with a bankfull structure), no flooding of Route 100 or Route 112 was predicted by the model (Figure 25). Replacement of this large structure would require extensive additional design and planning. We estimate that this project would likely cost upwards of \$500,000.

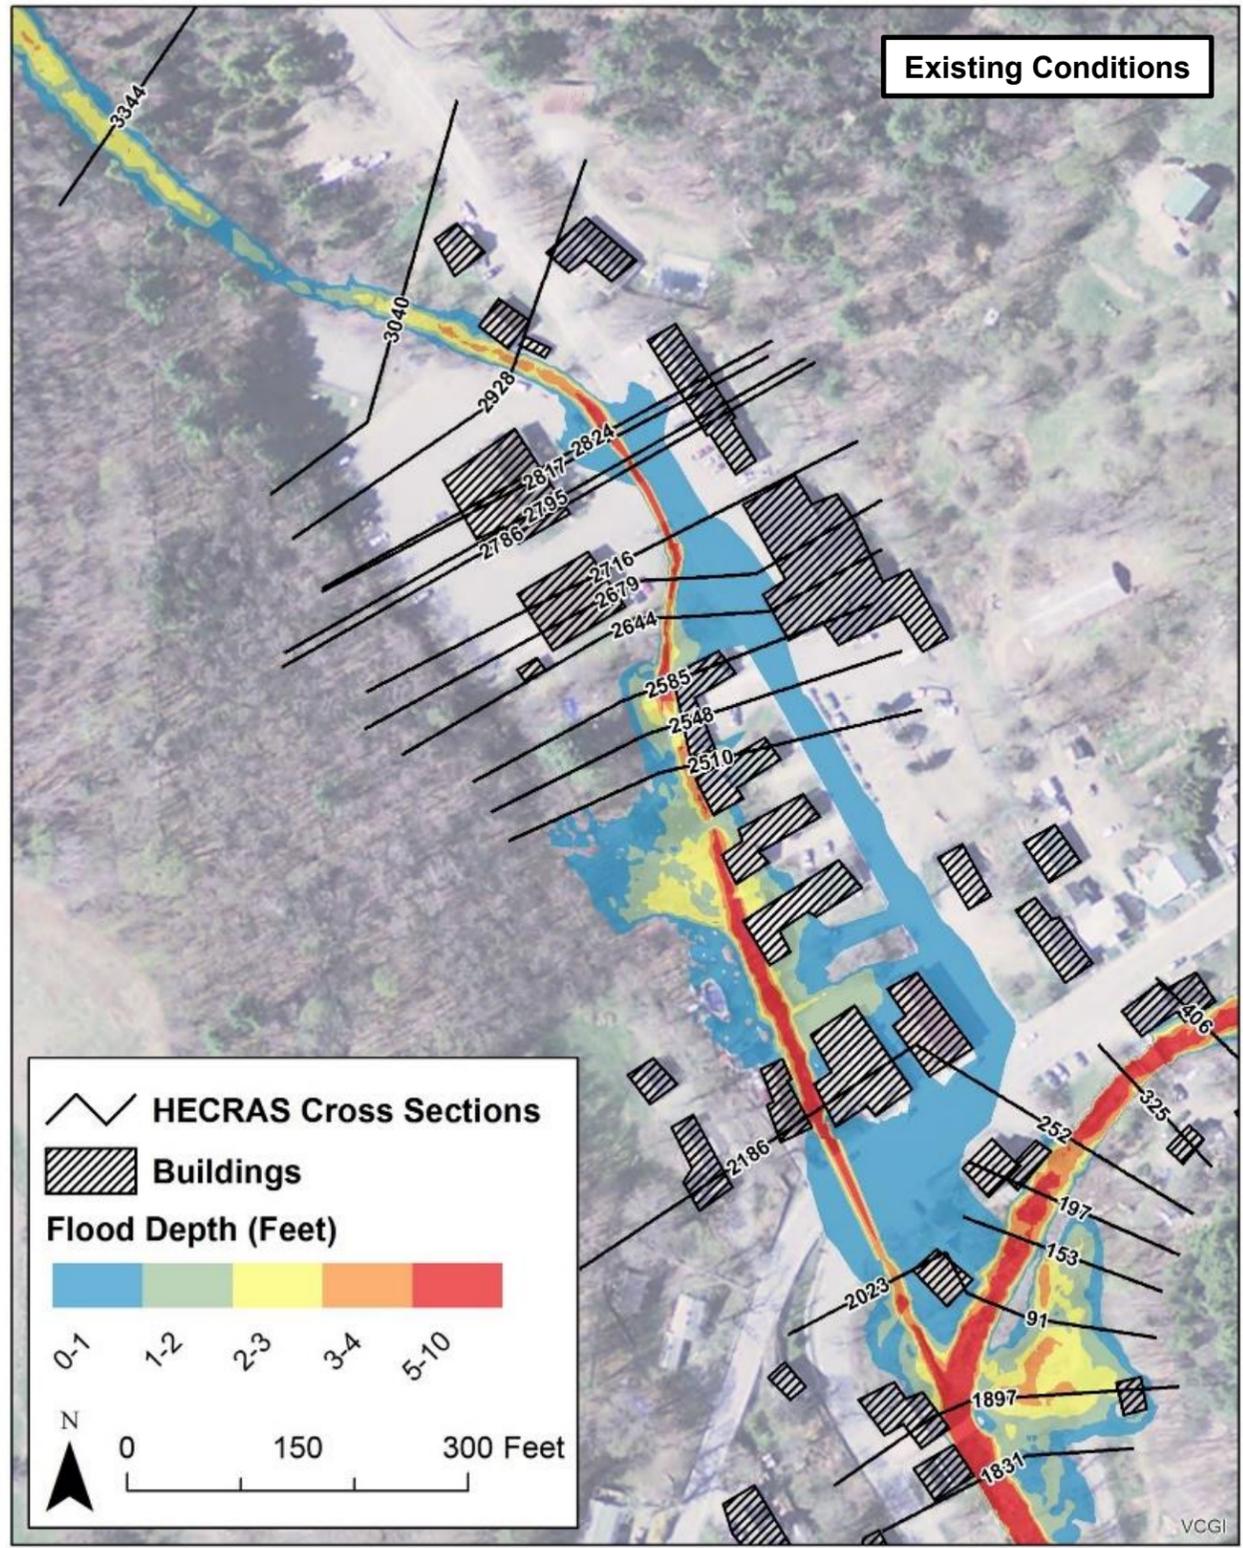
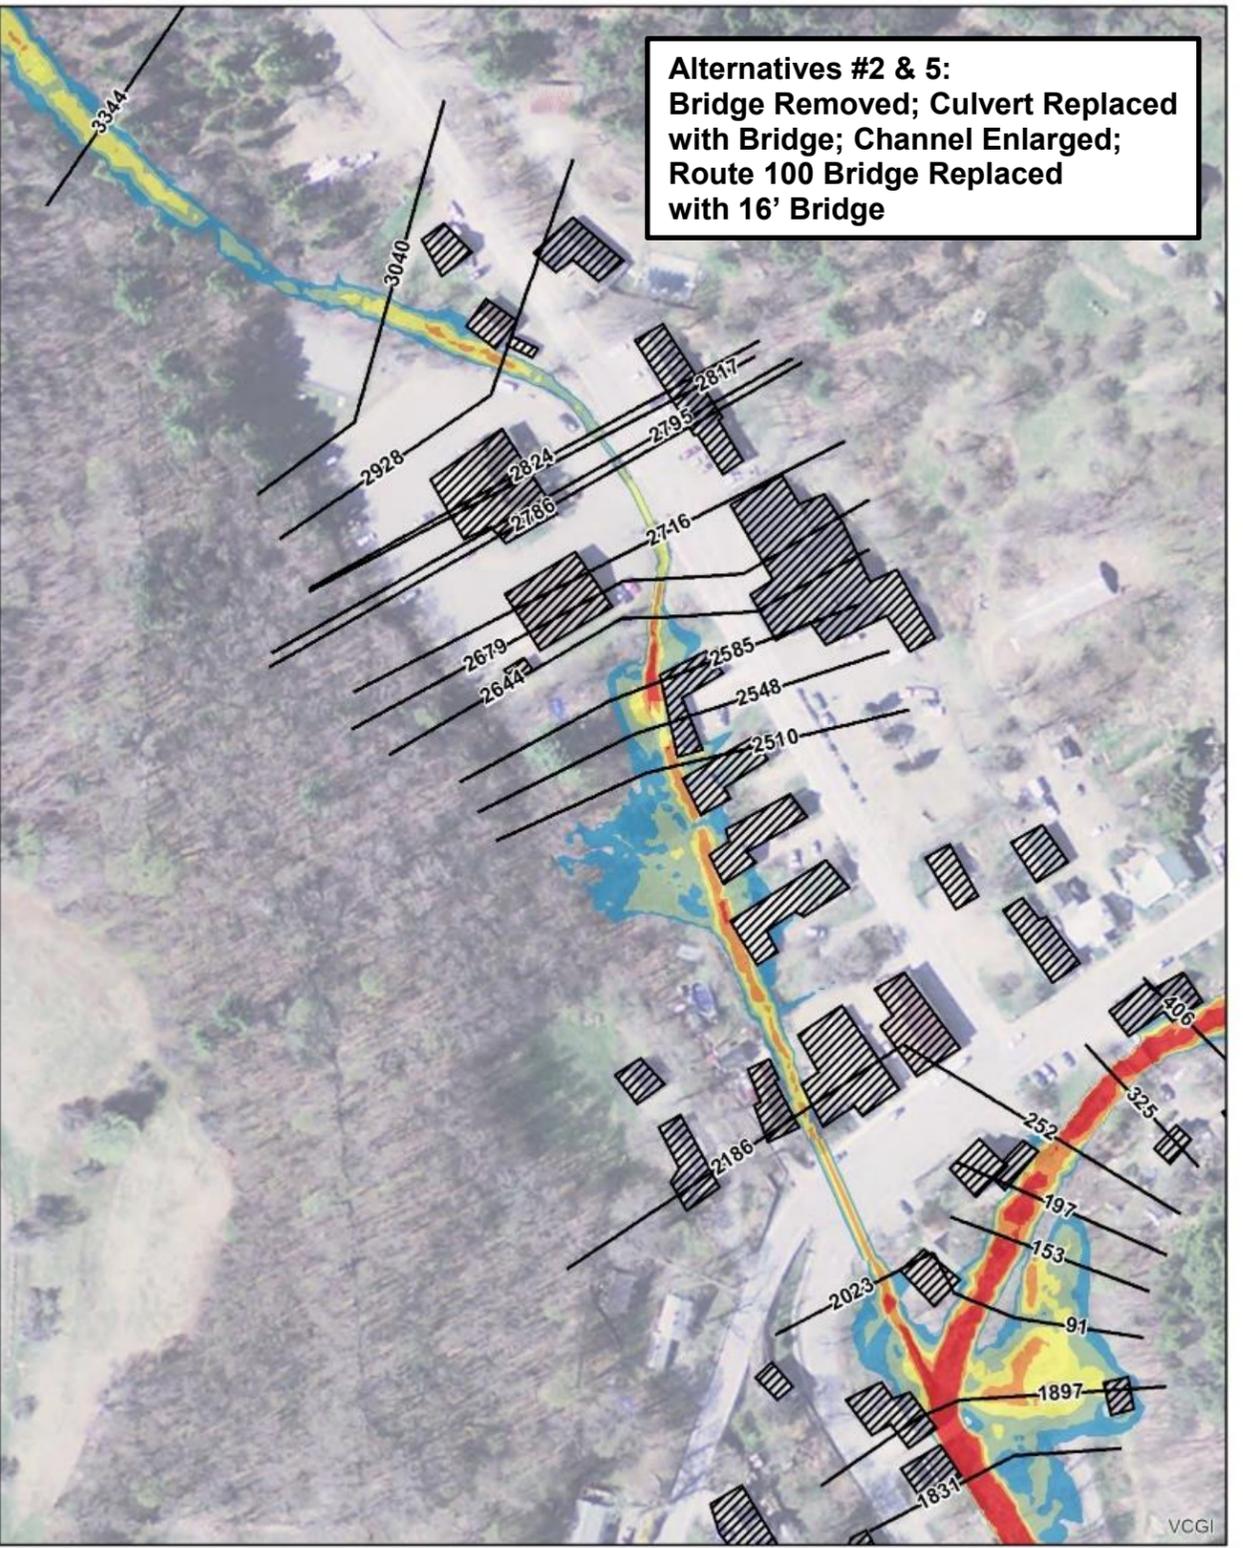
Figure 25: Approximate 500-year flood depths modeled with HEC-RAS for existing conditions (left) and the model which combines Alternatives 2 & 5 (right).

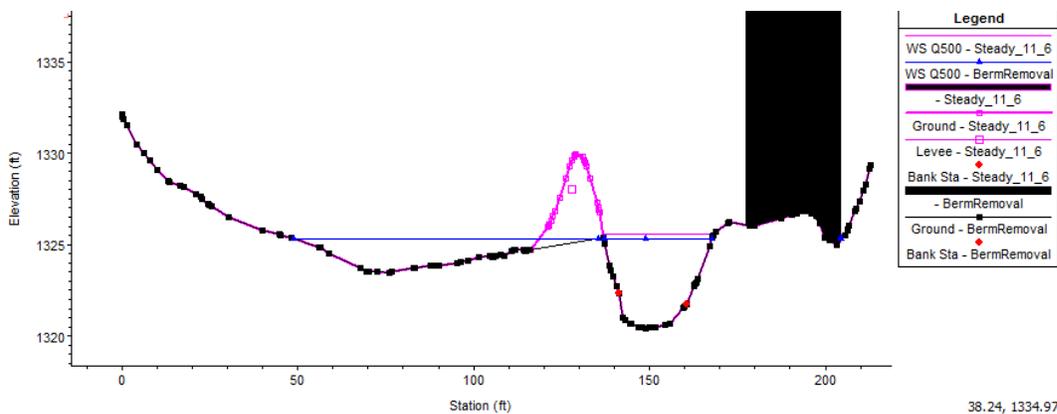
An approximately 200ft long historic berm is located along the east bank of the tributary to the East Branch of the North River draining Gates Pond. The berm blocks access to a flood chute and floodplain. Alternative 6 considered the effect of removing the berm on flood depths and velocities during the 500-year flood. Several large trees are growing on top of the berm and provide valuable stability to the bank and shading for the channel. We recommend removing portions of the berm to minimize disturbance to large trees while restoring sufficient access to the floodplain.

Figure 26: Model cross section showing increased floodplain area following berm (pink line) removal.

Based on the field surveys of the berm dimensions and assuming the removal of 150 linear feet of berm, we estimate that approximately 250-300CY of dredged channel material would be removed. We recommend shaping the north bank back to a stable 1V:3H slope to reduce the risk of bank erosion and to increase bankfull channel width by approximately 15-20%. In the modeled alternative, the increased floodplain storage along the east bank would decrease water elevations during large flood events by less than 0.5 feet. These reductions are relatively low; however, the model predicts that berm removal would allow 20% of the floodwater in the 500-year flood to access the floodplain and decrease channel velocities by approximately 25% (Figure 26). This project will require additional design to ensure that berm removal will not increase flood vulnerability to the downstream houses. The driveway will also require additional stabilization and drainage improvements. We estimate that this project will cost between \$15,000 and \$20,000.

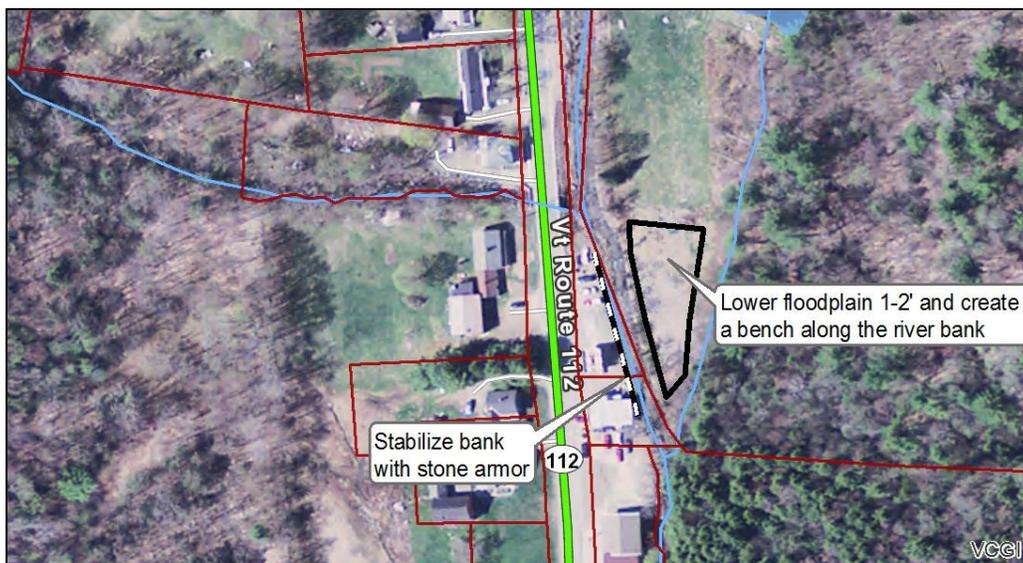
**Figure 27:** Extent of floodplain lowering for implementation of Alternative 7 and recommended stacked stone wall along the First Stop Convenience Store property.

A floodplain on the East Branch of the North River across from the First Stop Convenience Store was accessed in T.S. Irene and was slightly lower in elevation than the gas station, reducing damage to the property. Flood deposits stockpiled on the floodplain have raised the elevation and lessened the potential benefits during future floods. Reshaping the east bank to form a floodplain bench and lowering the elevation of the upper floodplain area could reduce the risk of flooding and erosion at the First Stop Convenience Store (Figure 27). The stability of the embankment along the west bank should be assessed and replaced with large stone armor if needed. The embankment could be reconfigured with a stacked stone wall to increase channel capacity. In the modeled alternative where the floodplain was lowered by 1-2 feet, flood depths were lowered by over 1-foot in the 500-year event and velocities were reduced by 20%. We estimated approximately 800 to 1,000CY of excavation and off-site trucking. Replacing the west embankment with a stacked stone wall would require approximately 100CY of placed stone armor. Based on unit costs of \$30/CY for excavation and trucking and \$50/CY for placed stone armor, we estimate that the total project costs will be between \$25,000 and \$35,000.
