Whitingham Flood Resiliency Scoping Study

Reach M02, Halifax

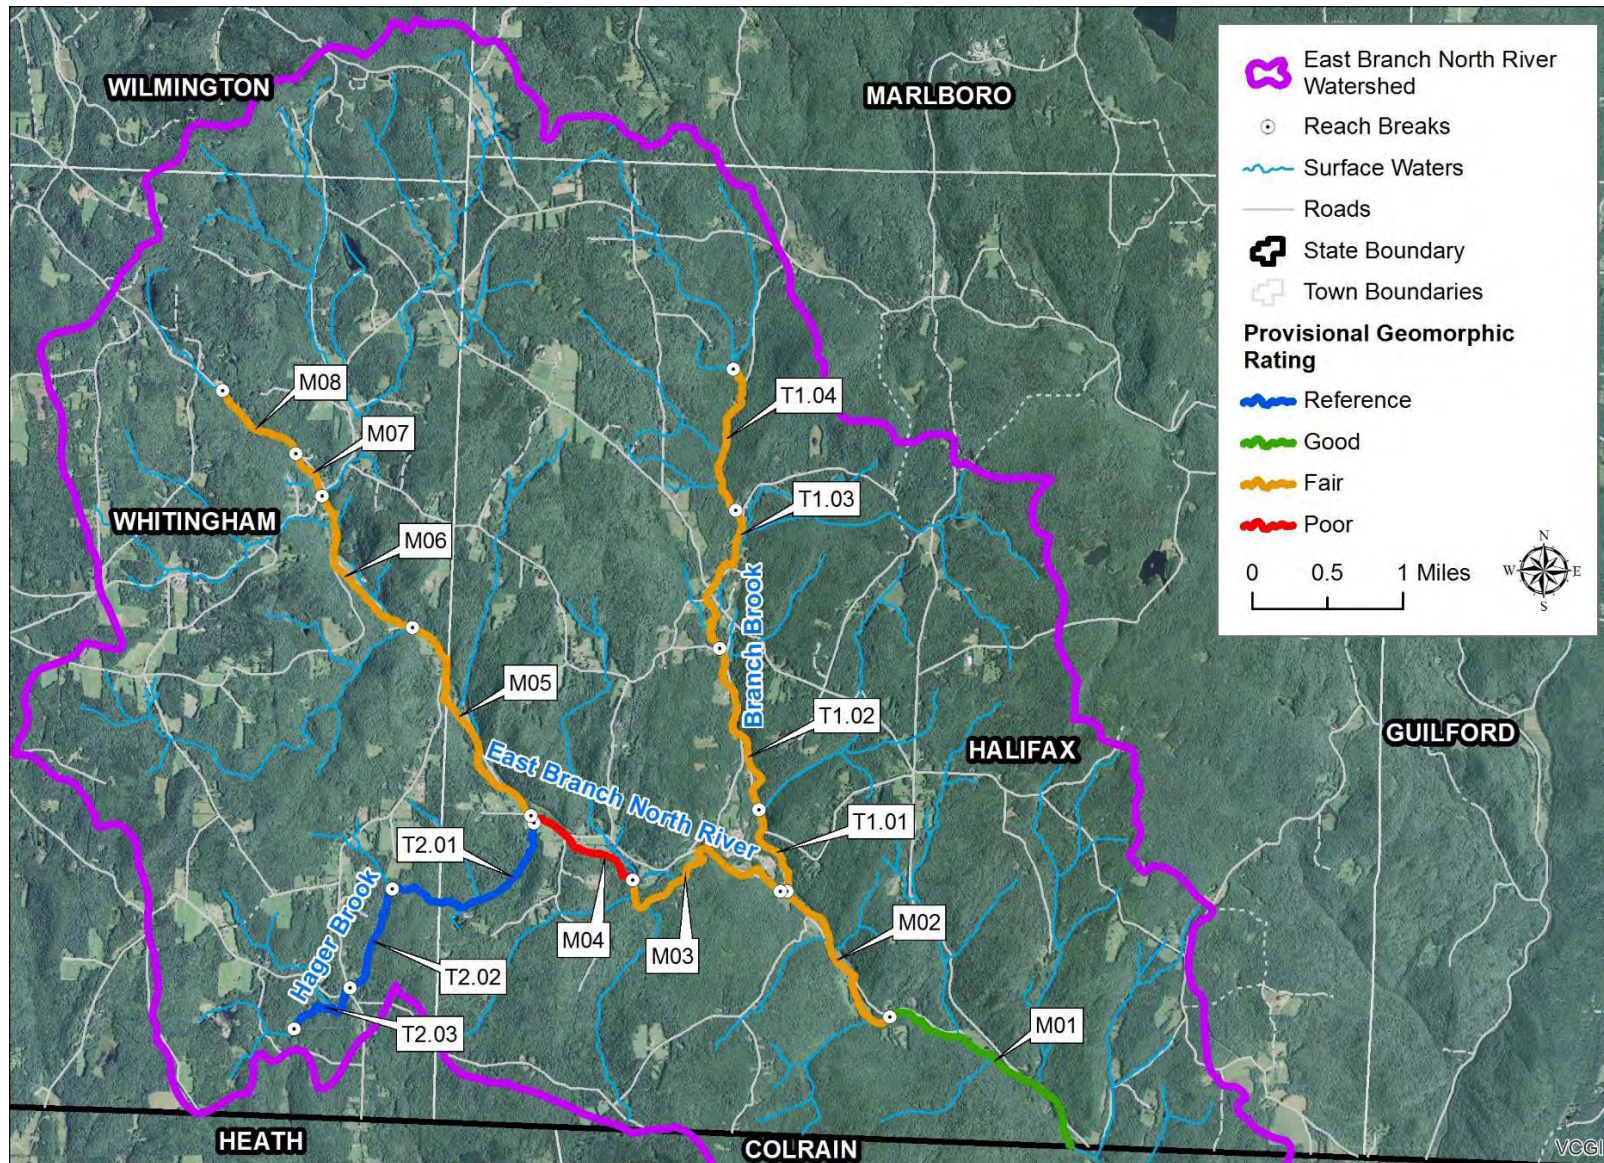
Figure 3.5: Provisional geomorphic ratings for the East Branch North River watershed.

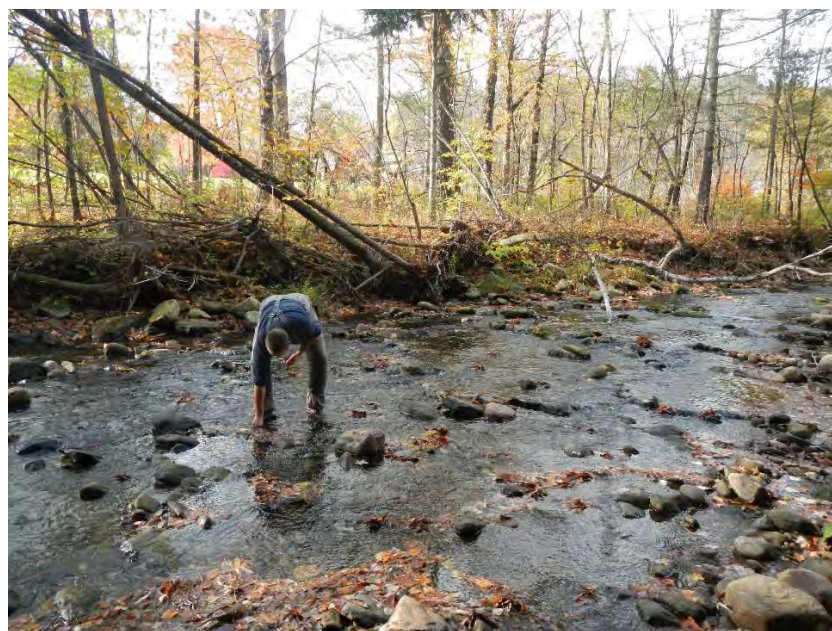
Figure 4.3: Pebble count data collection on M04B.

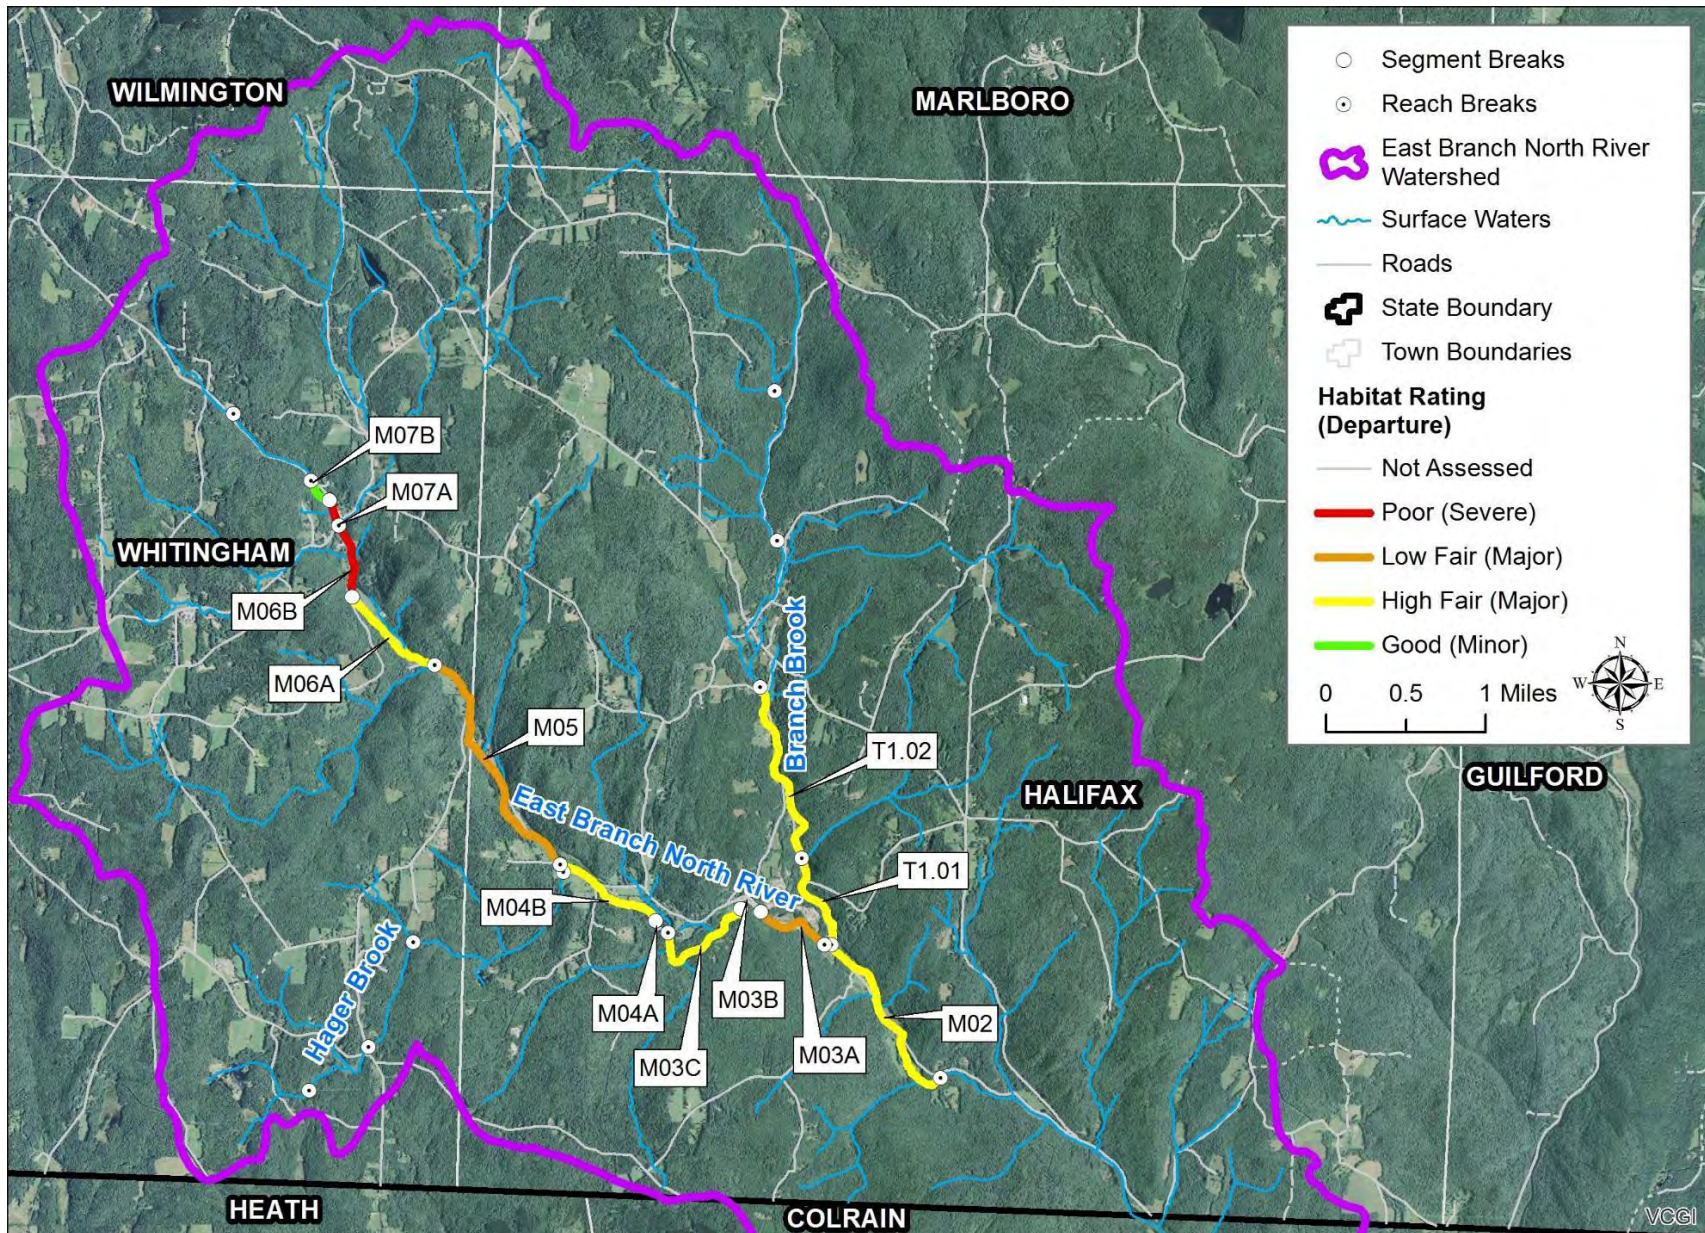
Stream	Reach/Segment	RHA Score	RHA Condition	RGA Score	RGA Condition
East Branch North River	M02	54%	High-Fair	40%	Low-Fair
	M03.A	48%	Low-Fair	44%	Low-Fair
	M03.B		*		Reference*
	M03.C	64%	High-Fair	60%	High-Fair
	M04.A		*		*
	M04.B	51%	High-Fair	44%	Low-Fair
	M05	48%	Low-Fair	41%	Low-Fair
	M06.A	56%	High-Fair	60%	High-Fair
	M06.B	34%	Poor	36%	Poor
	M07.A	34%	Poor	31%	Poor
	M07.B	65%	Good	71%	Good
Branch Brook	T1.01	56%	High-Fair	44%	Low-Fair
	T1.02	59%	High-Fair	52%	High-Fair

Figure 4.4: Rapid Habitat Assessment Ratings for the East Branch North River Watershed.

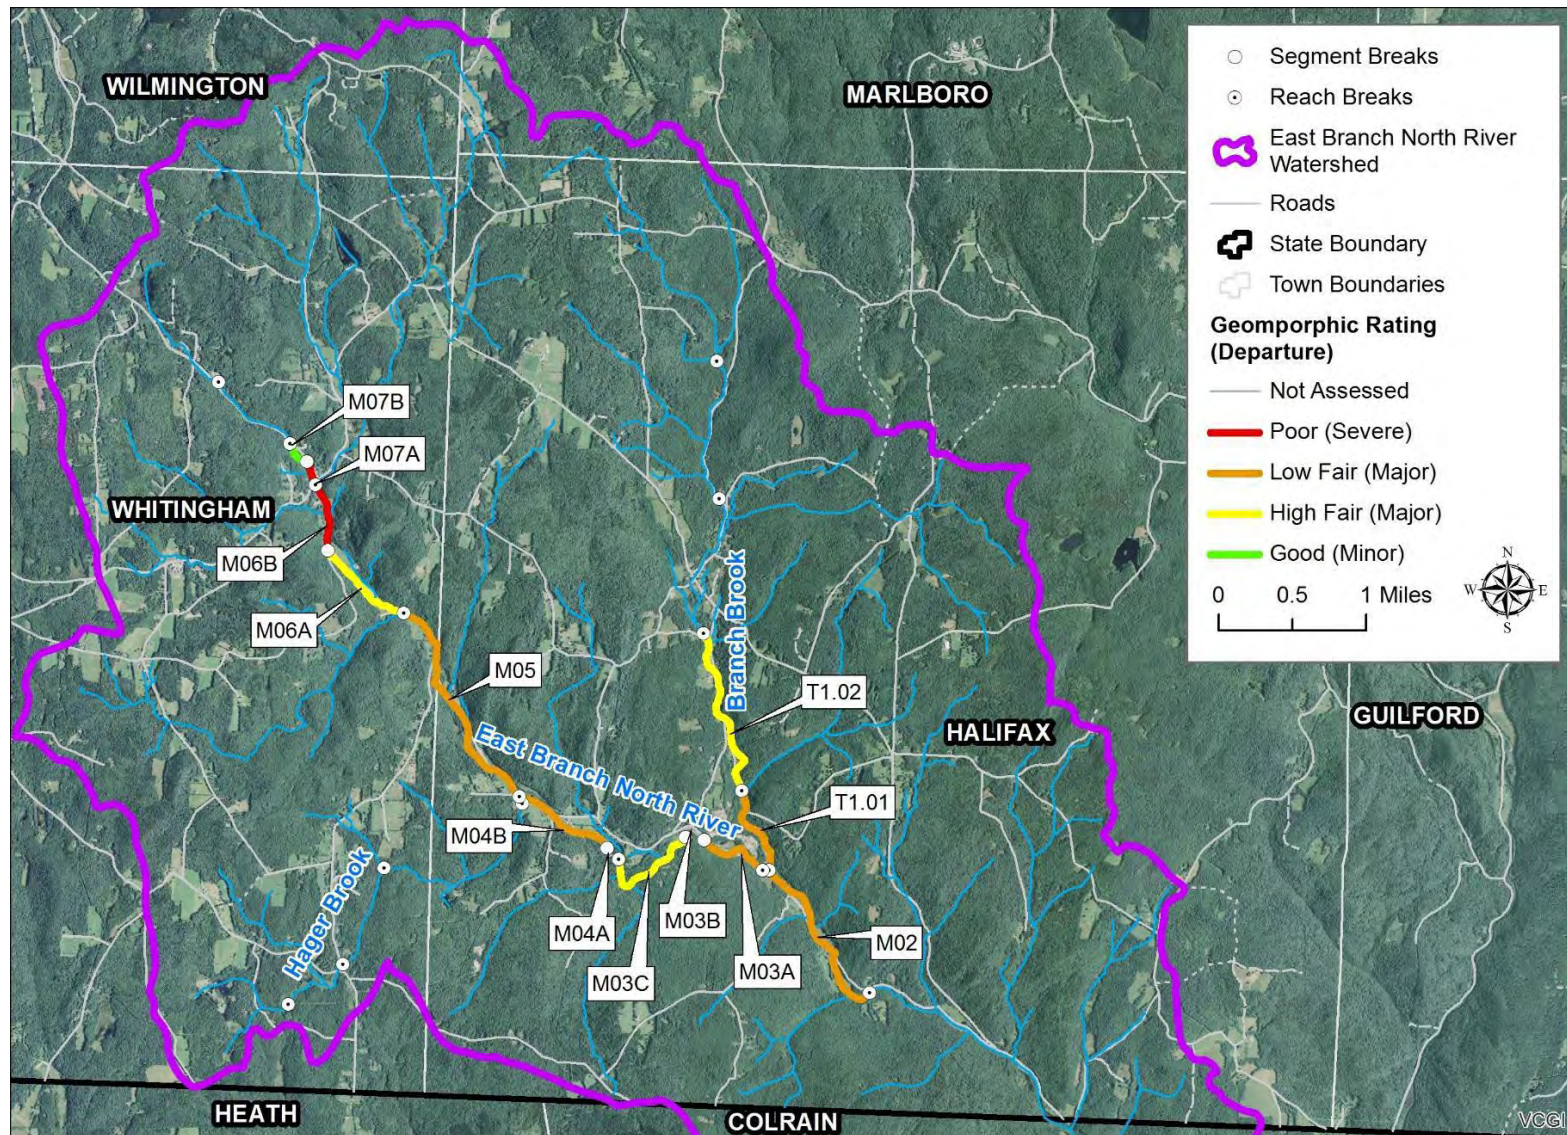
Figure 4.5: Rapid Geomorphic Assessment Ratings for the East Branch North River Watershed.

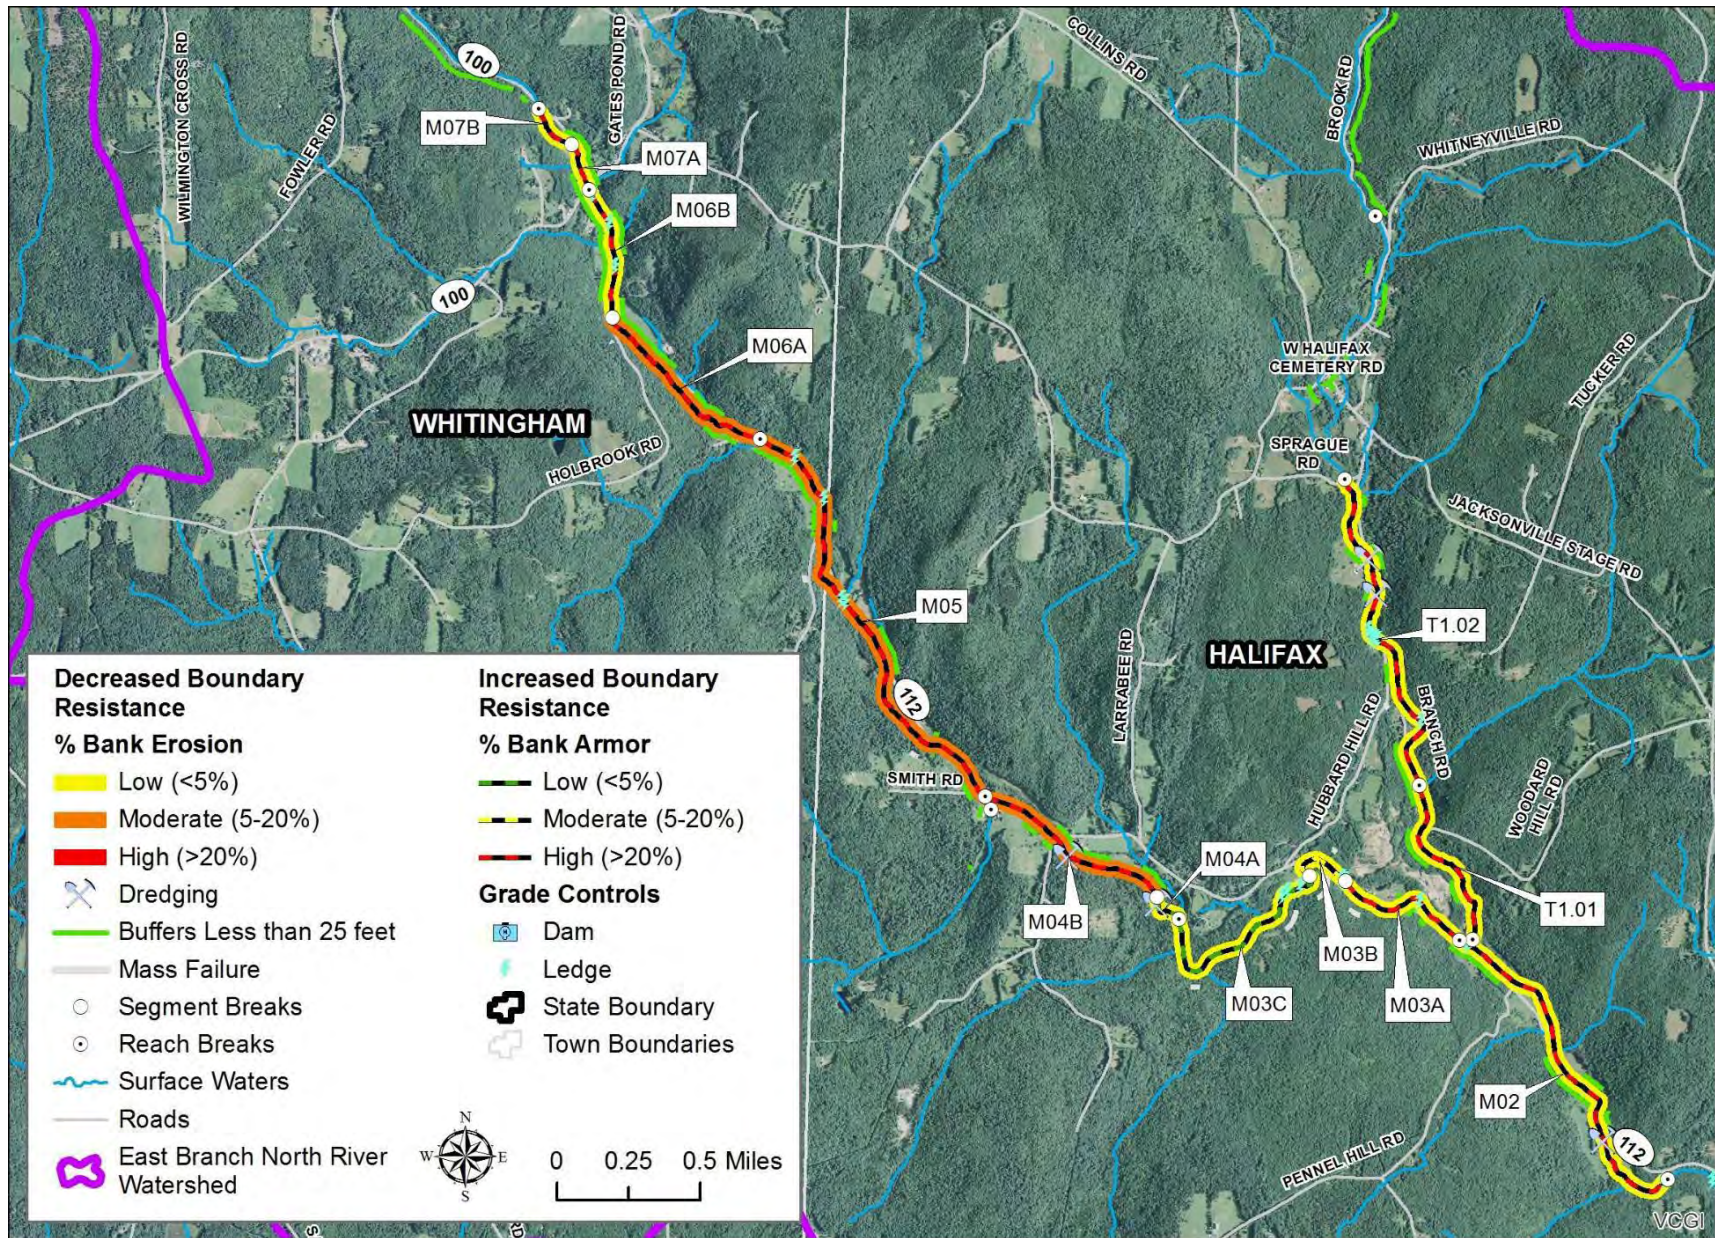
Alterations to the channel boundary conditions and riparian areas in the East Branch North River study area have been mapped using the variables extracted from the Phase 2 field dataset (Figure 4.16). Bank armoring (e.g., rip-rap) highlights areas of increased resistance to lateral migration, whereas bank erosion highlights reaches where significant lateral adjustments are found. Additional data showing the location of natural and man-made channel features (e.g., ledges and dam) depict areas that have a resistance to channel change.

Figure 4.16: Riparian and boundary condition modifiers for the East Branch North River watershed.

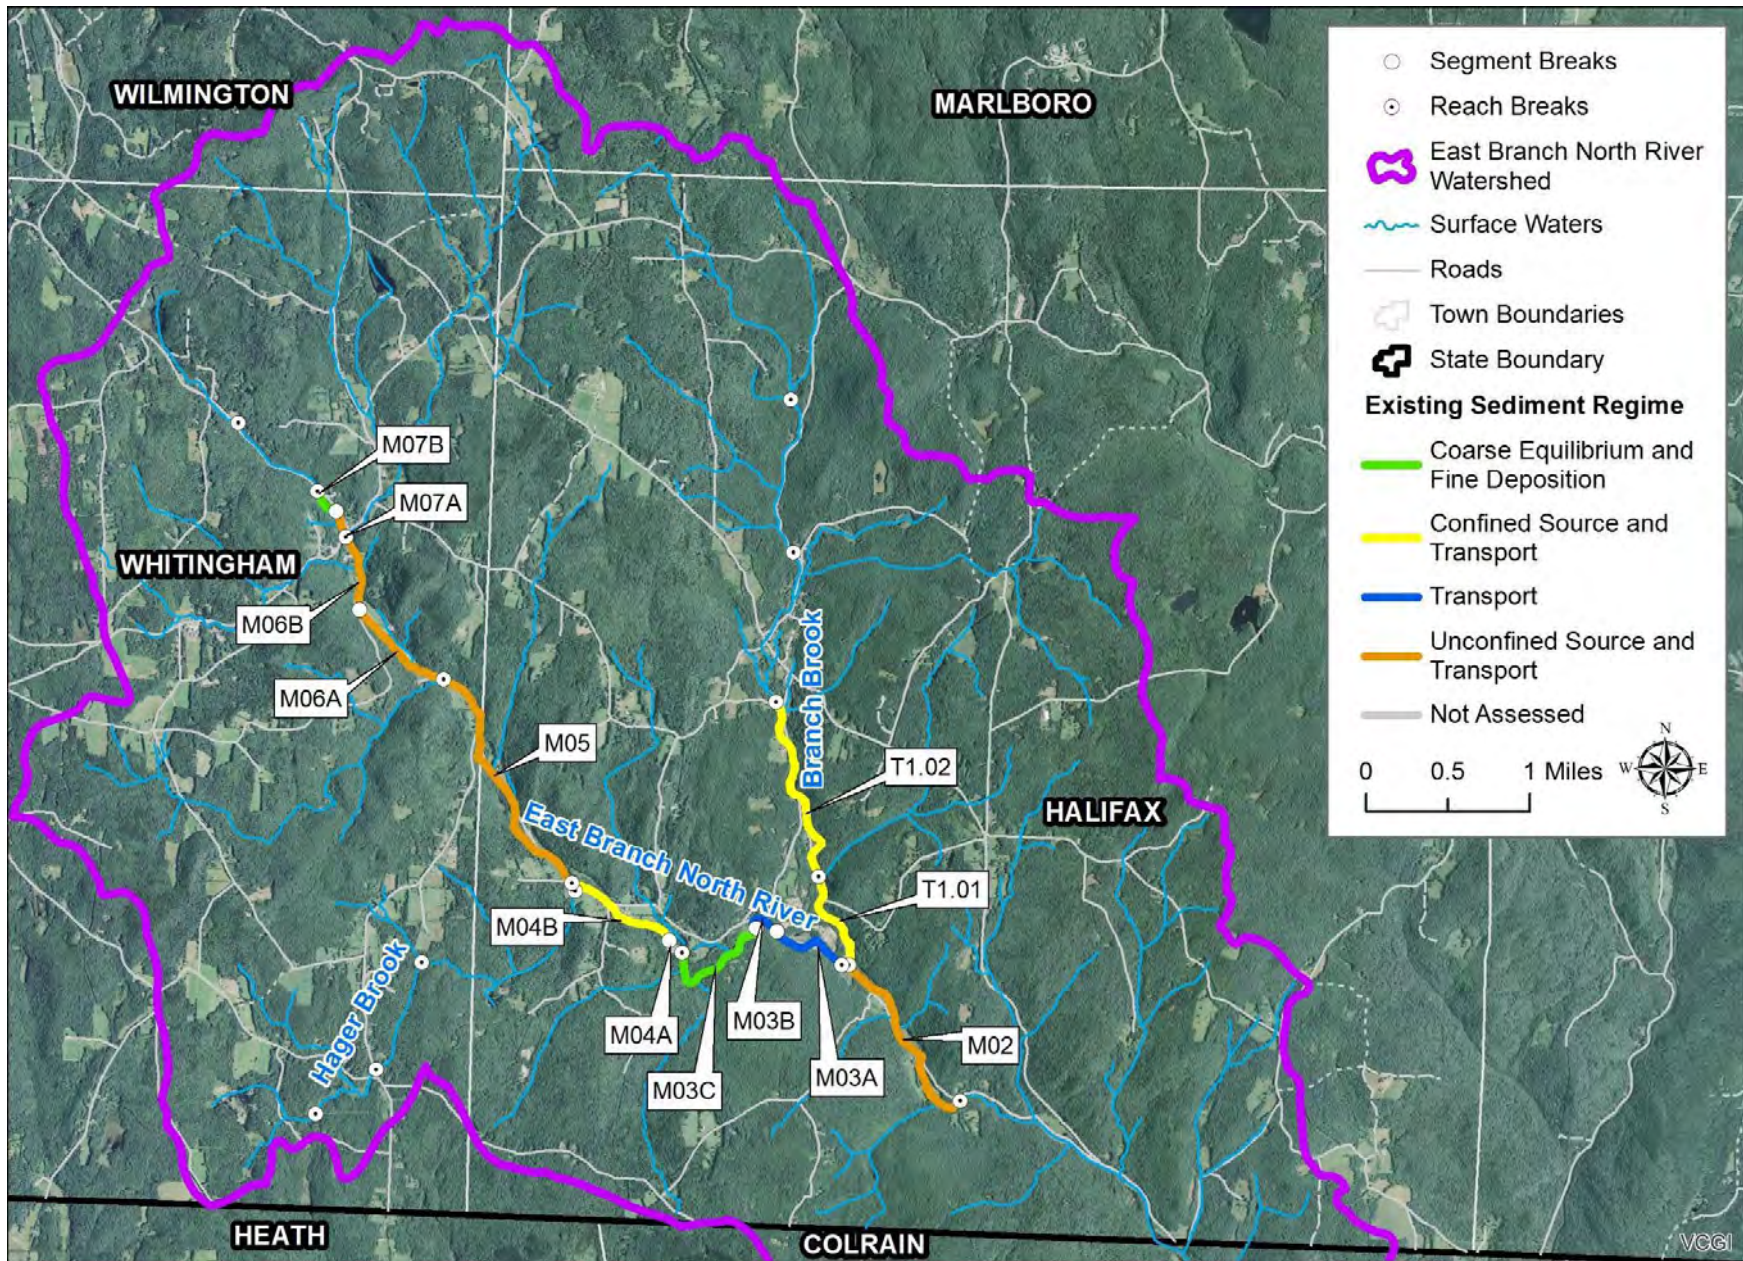
Phase 2 Segment ID	Reference Sediment Regime	Existing Sediment Regime	Cause of Departure
M02	Coarse Equilibrium and Fine Deposition	Unconfined Source and Transport	Historic straightening/encroachment
M03A	Coarse Equilibrium and Fine Deposition	Transport	Historic straightening/encroachment
M04B	Coarse Equilibrium and Fine Deposition	Confined Source and Transport	Historic straightening/encroachment
M05	Coarse Equilibrium and Fine Deposition	Unconfined Source and Transport	Historic straightening/encroachment
M06A	Coarse Equilibrium and Fine Deposition	Unconfined Source and Transport	Historic straightening/encroachment
M06B	Coarse Equilibrium and Fine Deposition	Unconfined Source and Transport	Historic straightening/encroachment
M07A	Coarse Equilibrium and Fine Deposition	Unconfined Source and Transport	Historic straightening/encroachment
T1.01	Coarse Equilibrium and Fine Deposition	Confined Source and Transport	Historic straightening/encroachment

Figure 4.25: Existing Sediment Regime for the East Branch North River watershed.

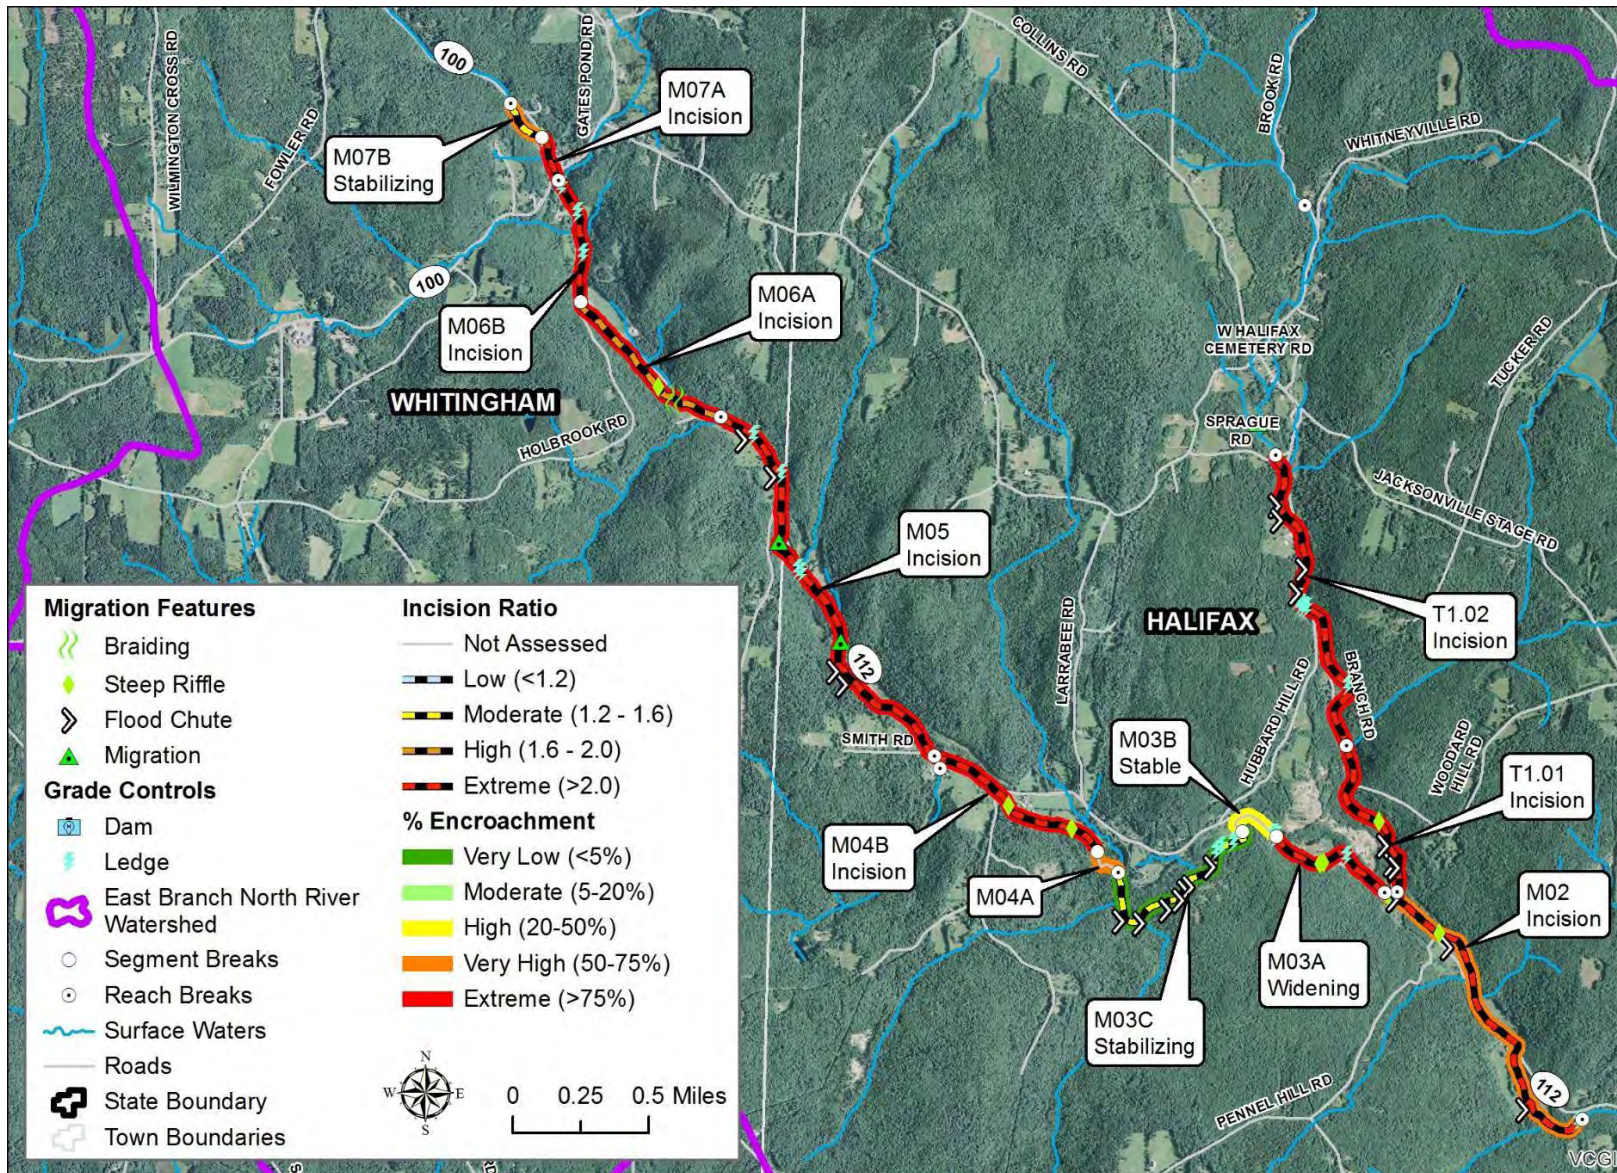
Figure 4.26: Channel Adjustment Process Map for the East Branch North River watershed.

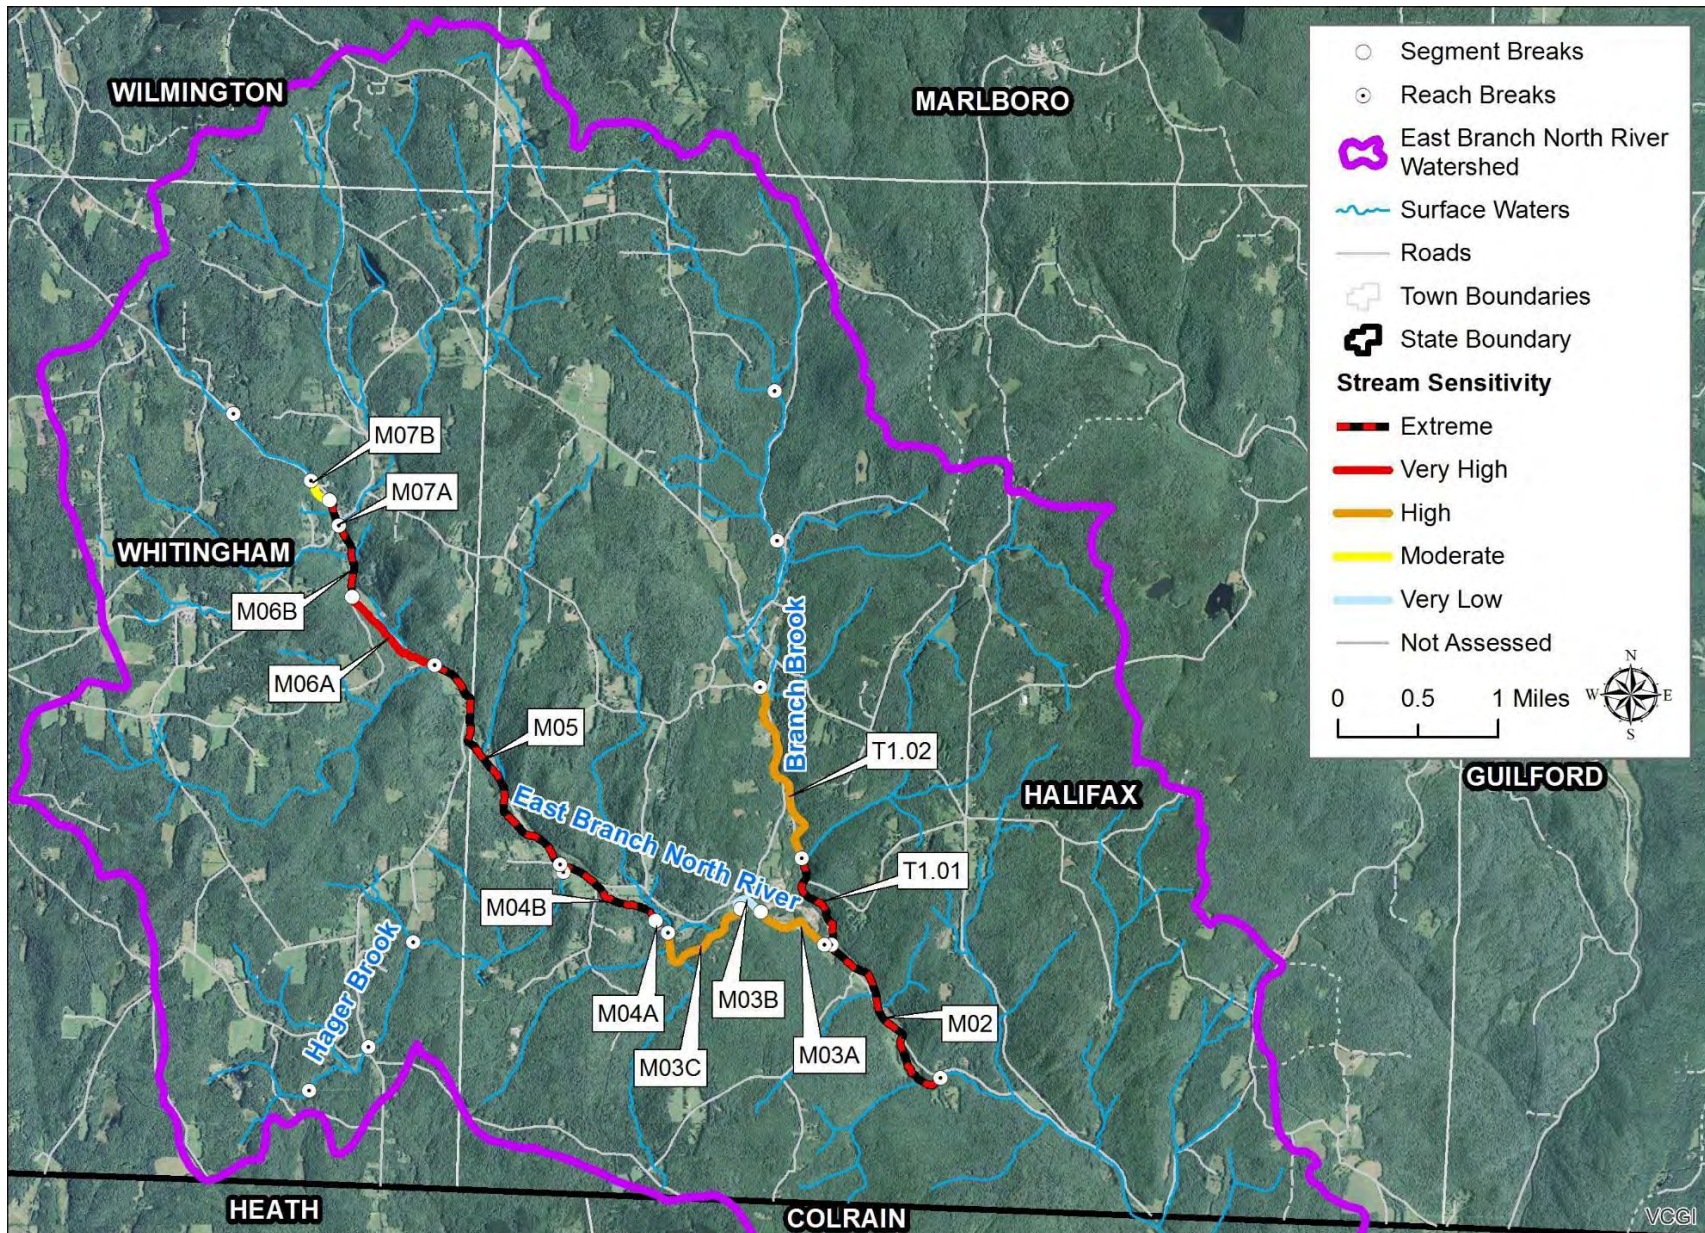
Phase 2 Segment ID	Stream Sensitivity	Description of Impacts
M02	Extreme	STD, Straightening, Encroachment, Incision
M04B	Extreme	STD, Straightening, Encroachment, Incision
M05	Extreme	STD, Straightening, Encroachment, Incision
M06B	Extreme	STD, Straightening, Armoring, Incision
M07A	Extreme	STD, Straightening, Armoring, Incision
T1.01	Extreme	STD, Encroachment, Incision

Figure 4.27: Stream Sensitivity Ratings for the East Branch North River study area.
