SUBMITTED TO
**WINDHAM COUNTY REGIONAL
COMMISSION**

SUBMITTED BY
MSK ENGINEERS

SCOPING STUDY

Jacksonville Municipal Center Access and Flood Resiliency

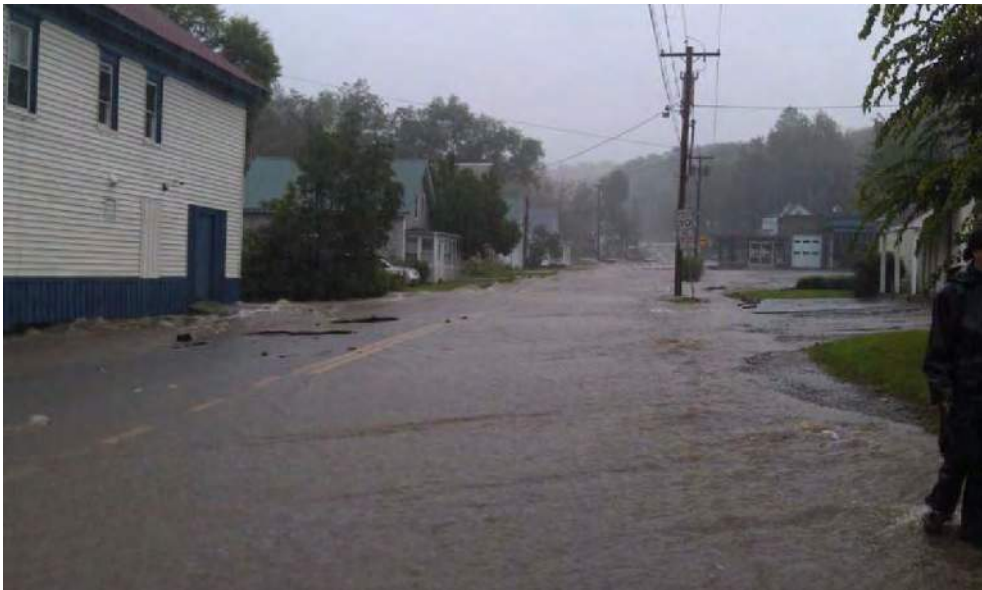
Figure 3: August 2011 flooding on VT 100 in Jacksonville during the Irene flood.

This alternative would be to leave the site as it is. This would not improve the downtown flood resiliency and leave the downtown at risk of flooding during storm events. Hydraulic modeling indicates that the undersized crossings at the municipal center, in particular the severely undersized bridge, cause floodwaters to overtop the road by 1-2 feet during an extreme flood event (i.e., 100-year flood). When the effect of sediment and debris buildup during a flood is considered at the bridge inlet, which has been commonplace in past floods, moderate floods such as the 25-year or 50-year floods are predicted to overtop the road and flow down VT 100. The no build alternative leaves the town's infrastructure and several other private residences and businesses along VT 100 at risk of repeat flood damage.

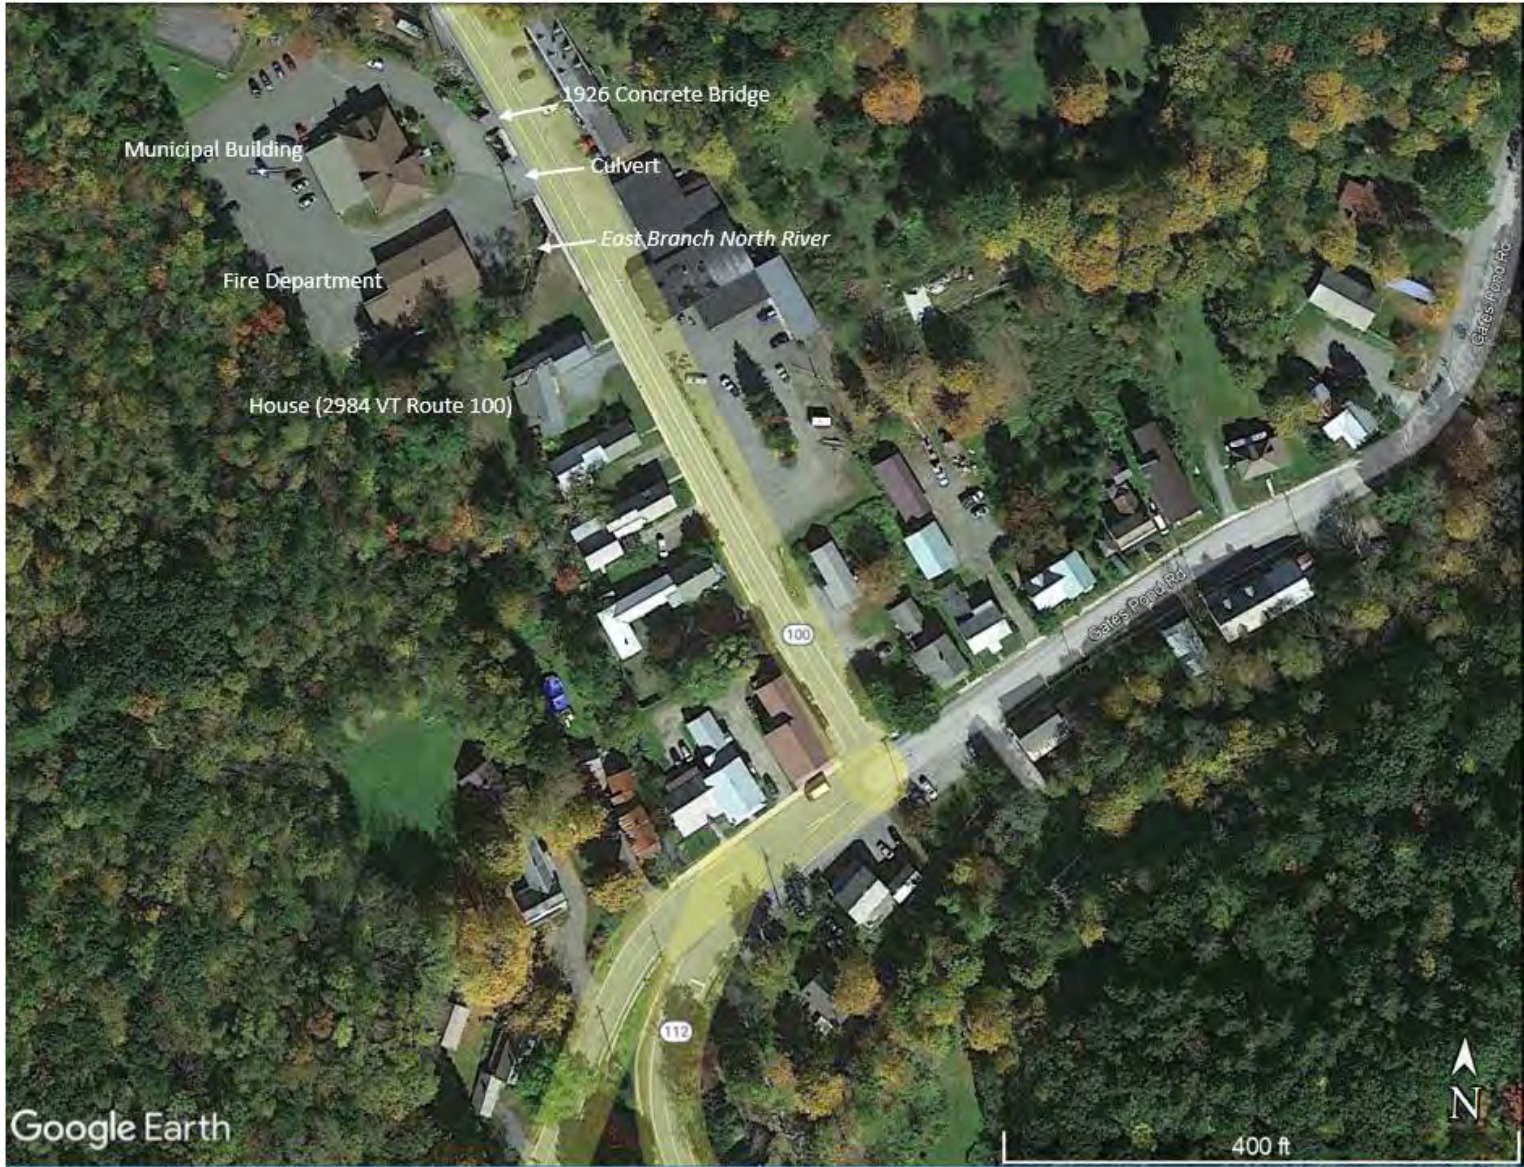
Figure 2. Map showing components of the Whitingham STP MM20(3) Flood Resiliency Project, Whitingham, Vermont.

Constructed in 1926, the structure that crosses the East Branch of North River in front of the Municipal Center, appears to be a box culvert type concrete bridge (Figures 26 – 31; see Figure 2). The bridge crosses the river in an east-west direction. It has solid rails with centered, recessed panels on both sides, topped by a capstone, that run between two pillars with capstones. All capstones have raised centers. The height of the rail, including the capstone, is 3 ft 1 in, while the total height of the pillars, including capstones, is 3 ft 3 in, with the pillars rising 2 in above the rail. Rails are 7 ft long and the pillars measure 2 ft 1 in, for a total length of 11 ft 2 in; total length with the capstones is 11 ft 5 in. Pillars are rectangular, with their north-south length measuring 1 ft 5 in. Railings, not including the capstones, are 9 in thick. The northeast pillar has a panel with “1926” engraved on its south side. Concrete used has a rough aggregate; it was not determined if the concrete is plain or reinforced. Board form marks are evident on the substructure and the pillars. The western pillars have 1 ½ in diameter holes through them, one under the capstone and one near the base; the purpose of the holes is unknown. There are recent concrete repairs / reinforcement to the substructure. Roadway width between the pillars measures 15 ft 6 in and the traveling surface consists of asphalt over concrete. Flower boxes with “Welcome to Jacksonville” painted on their stream sides, are bolted to each rail.

A structure under the southern entrance to the Municipal Center consists of an 8.5 ft wide squash Corrugated Metal Pipe (CMP) type culvert (Fitzgerald Environmental Associates 2017, Table 5.4) (Figures 32 and 33; see Figure 2). The CMP carries the East Branch of North River under the roadway, south of the concrete bridge. It is surrounded by rock and fill, and the road surface above it is paved.

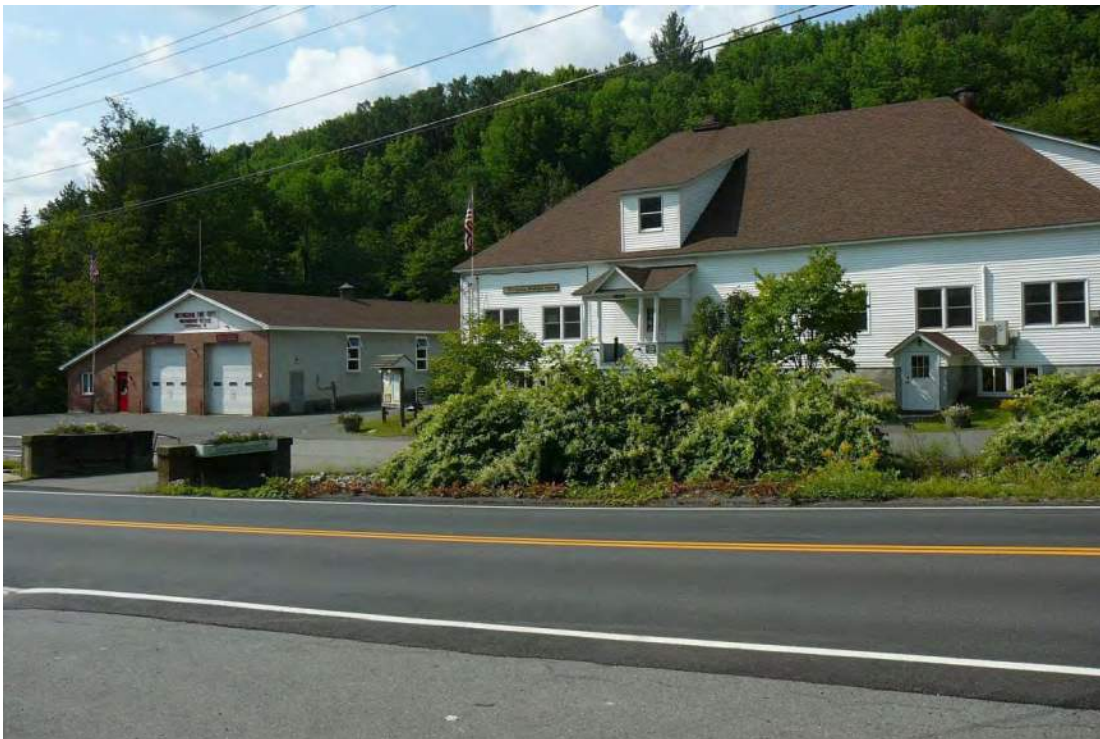
Figure 4. View southwest of the project area along VT Route 100; fire department building at left, municipal building at right, 1926 bridge at left foreground.

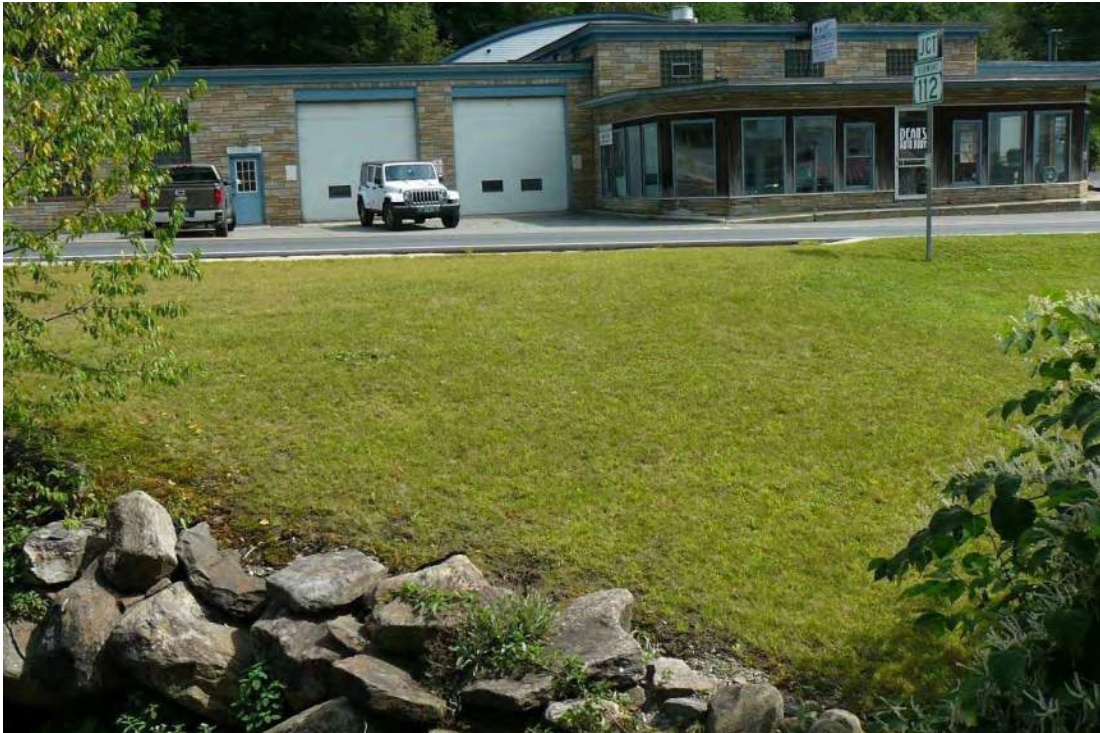
Figure 6. View east of the project area across VT Route 100 from in front of the fire department; stone-lined bank of East Branch North River in foreground.

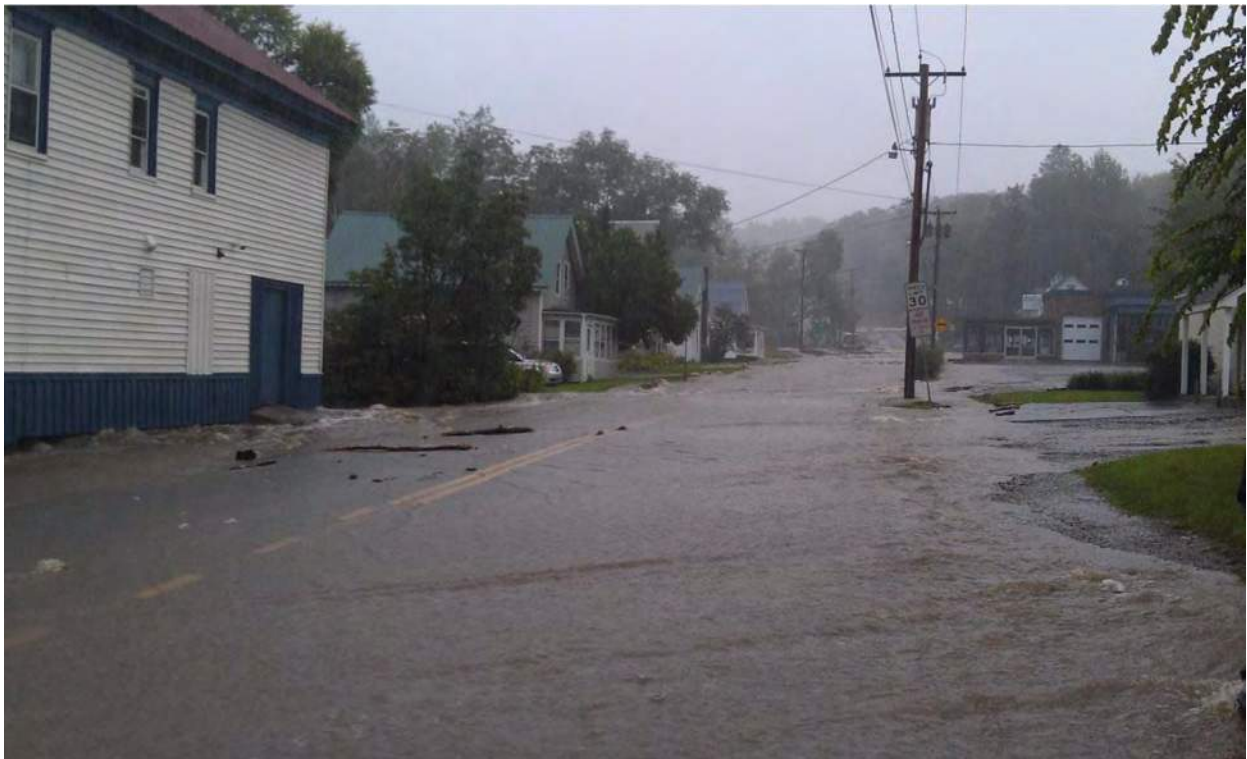
Figure 7. View northwest up Vermont Route 100 from the intersection of VT 112, during Tropical Storm Irene in 2011, with the project area in the background (Fitzgerald Environmental Associates, photo courtesy of G. Havreduk, n.d.:2).

Furthermore, near Jacksonville it was reported that the, "brooks have torn across the roads at numerous places causing washouts of varying degrees. In some instances, the worst washouts have been filled in with logs, junk & etc." (*North Adams Transcript* September 24, 1938). After the flood, it was reported that, "the town is widening and deepening the course of the river" in places (*Brattleboro Reformer* December 15, 1938). More recent severe flooding has also occurred, including during Tropical Storm Irene (Figure 7).

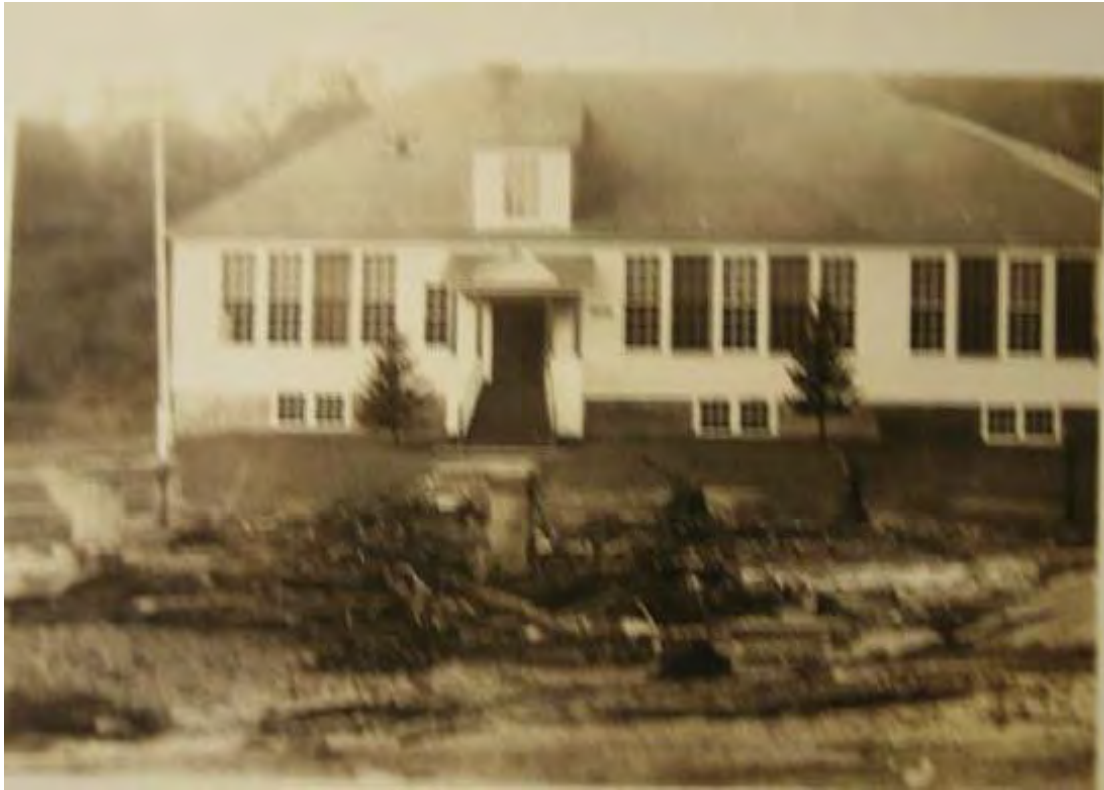
Figure 13. View southwest showing the flood damage in 1938 in front of the High School, now the Municipal Building, in Jacksonville (Bennington Museum, Bennington, Vermont. Gift of Marge Doyle, Cat No.#2004.301.7). Note that the “Welcome to Jacksonville Bridge,” built in 1926, survived the flood, but the ground around it was scoured.

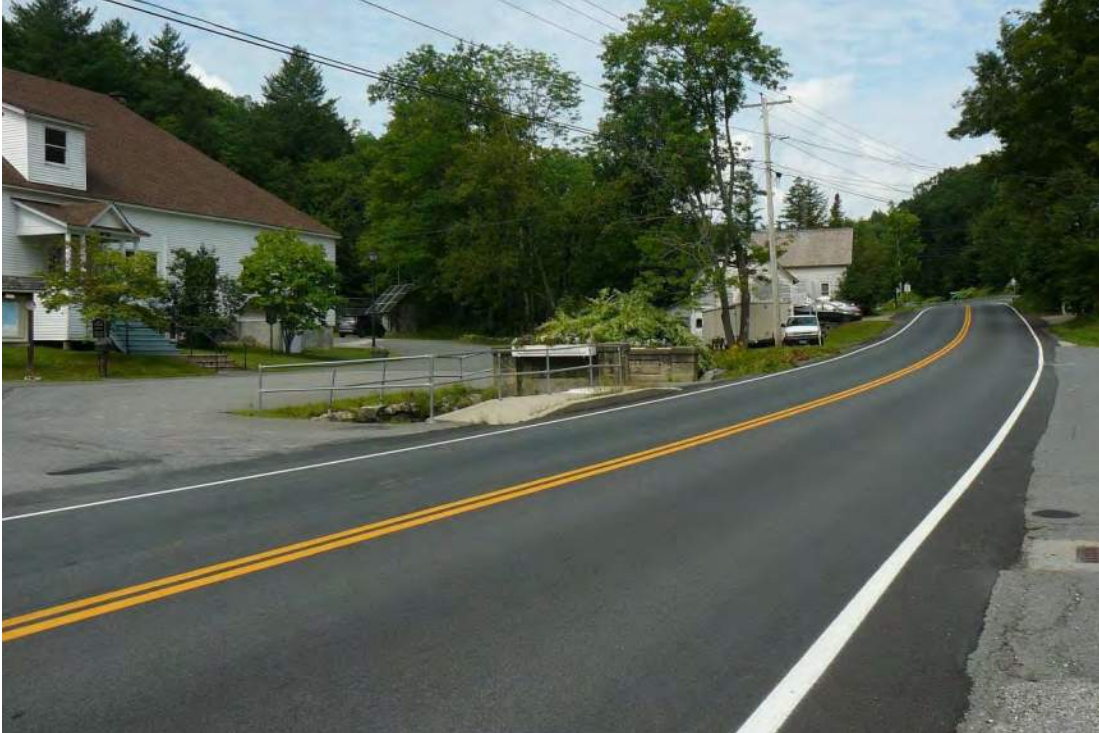
Figure 18. View northwest of the project area showing structures and paving in front of the Municipal Center.

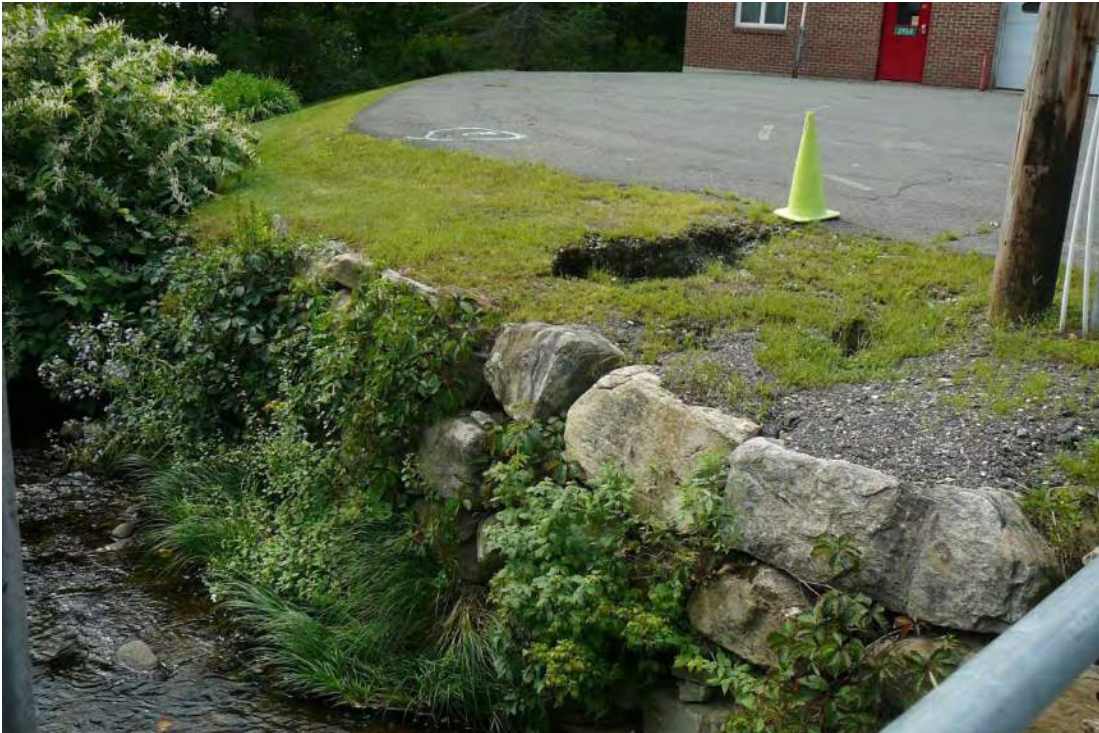
Figure 19. View southwest of the project area showing fill, utility pole and paving in front of the Fire House.

Hand cores taken in the grassed areas in front of the firehouse and north of the house at 2984 VT Route 100, where widening of the stream channel is proposed, indicate extensive fill and disturbed contexts from flood damage, stream management, buildings (including a structure once located on the lot north of the house), utility and parking lot/driveway construction. The portion of the project area where bridge and culvert replacement are proposed are also extensively disturbed by the construction of the current structures, sidewalk, roads and driveways, and the lining/relining of the river banks with rock and concrete walls. The house lot appears to be built up with fill or moved sediment. The APE was therefore not identified as sensitive for significant pre-Contact Native American sites.

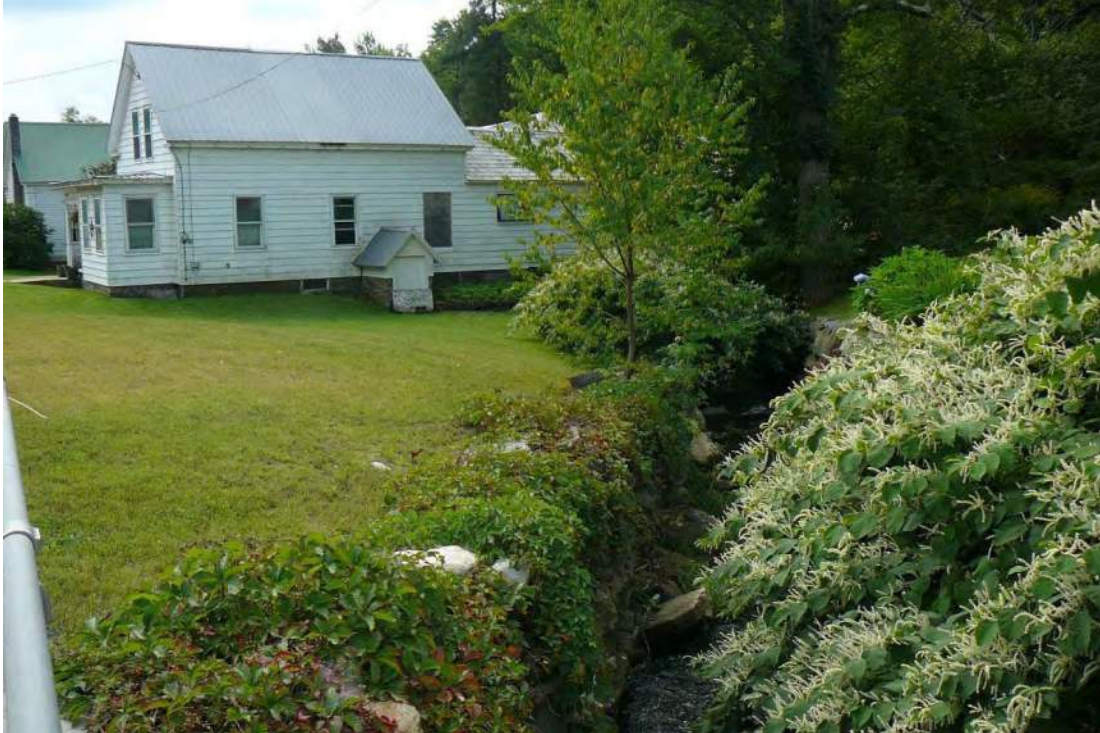
Figure 20. View southwest of the project area showing area of fill to the north of house at 2984 VT Route 100.

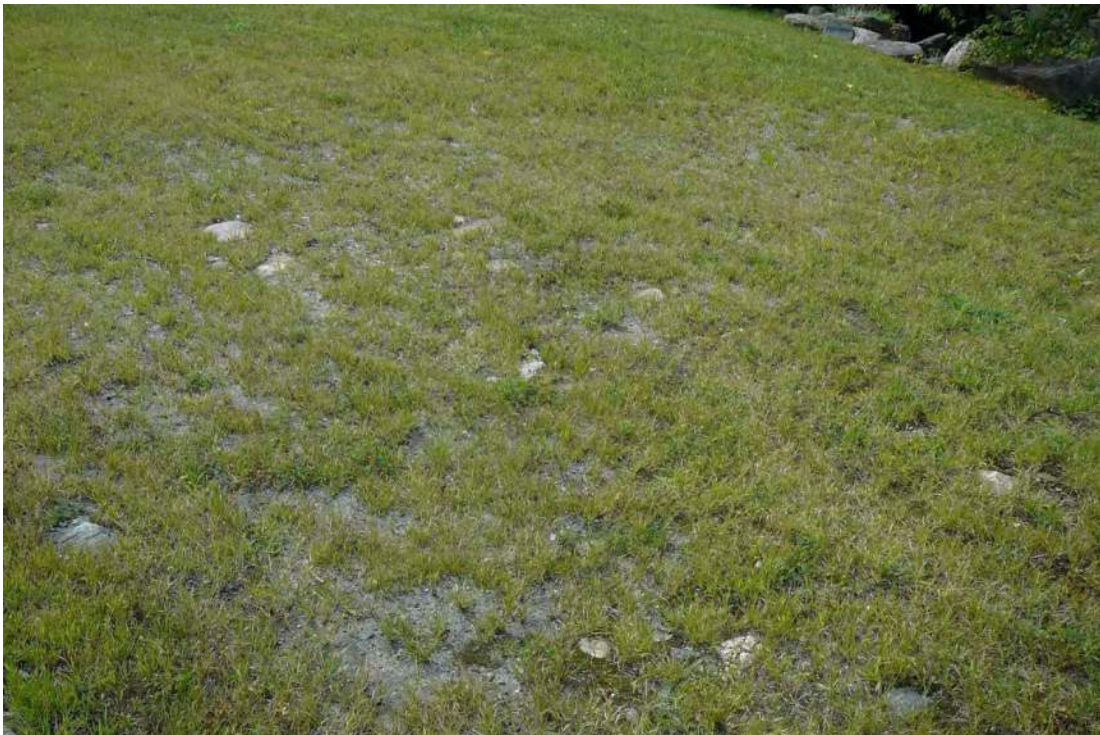
Figure 21. Close-up view southwest of fill to the north of house at 2984 VT Route 100.

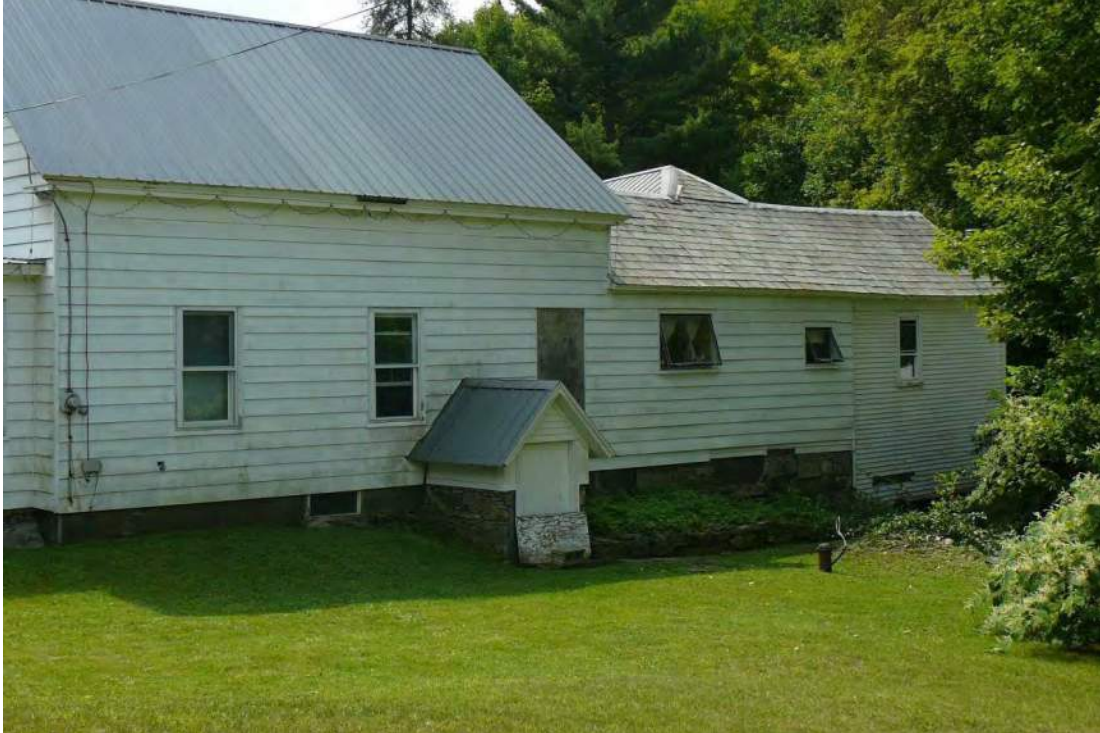
Figure 22. View southwest of the project area showing well location to the north of house at 2984 VT Route 100.

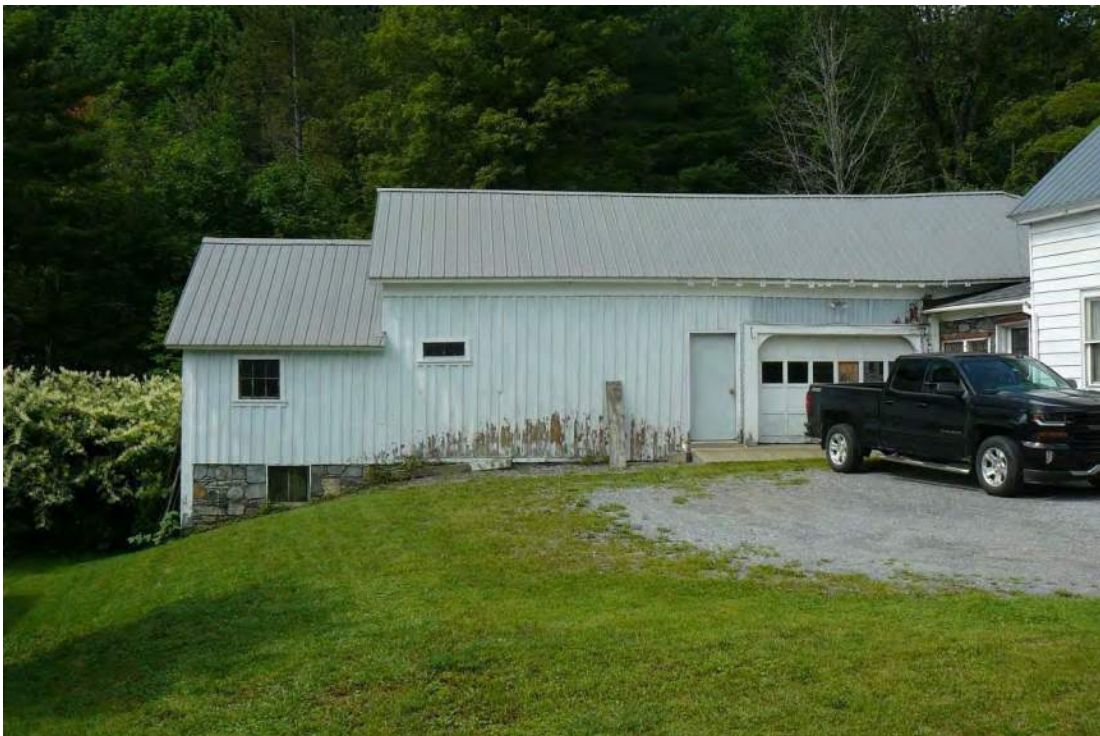
Figure 23. View west of the project area showing area of probable fill/land disturbance to the east of house at 2984 VT Route 100.

A field inspection of the project area was conducted by Catherine A. Quinn, Historic Preservation Specialist at the UVM CAP, on August 27, 2021. The general project area is primarily built upon with VT Route 100, a concrete sidewalk, the Municipal Center and surrounding paved parking areas, the concrete bridge, the metal culvert, and the house and its attached structures (Figures 18 – 23). Riverbanks within the project area are lined/reinforced with concrete and stone (Figures 24 and 25).

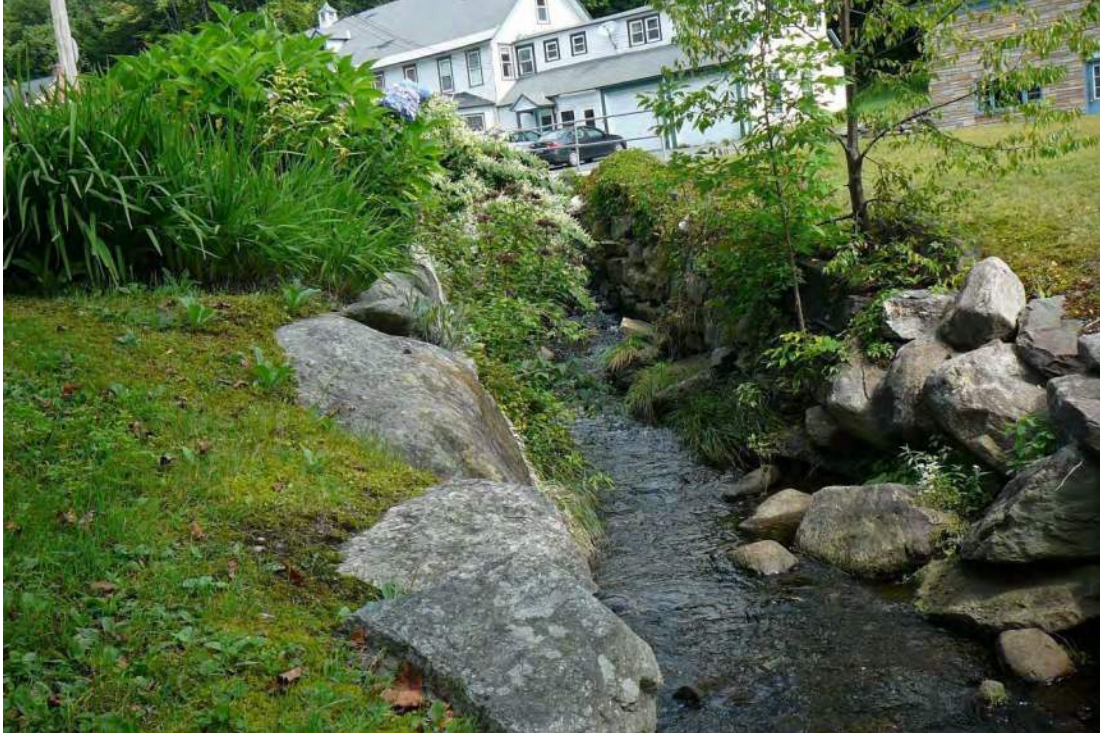
Figure 24. View northeast of riverbanks within the project area; fire station is to left and house at 2984 VT Route 100 is to right.

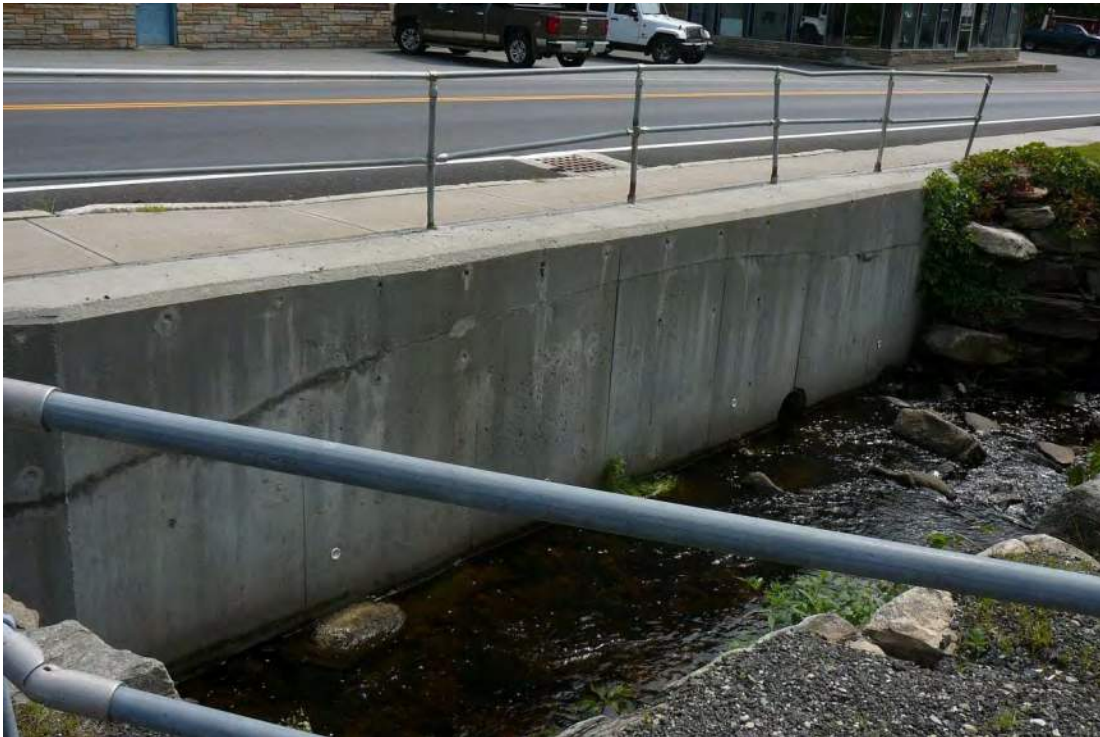
Figure 25. View southeast of concrete riverbank wall along VT Route 100 within the project area, between the concrete bridge and culver.

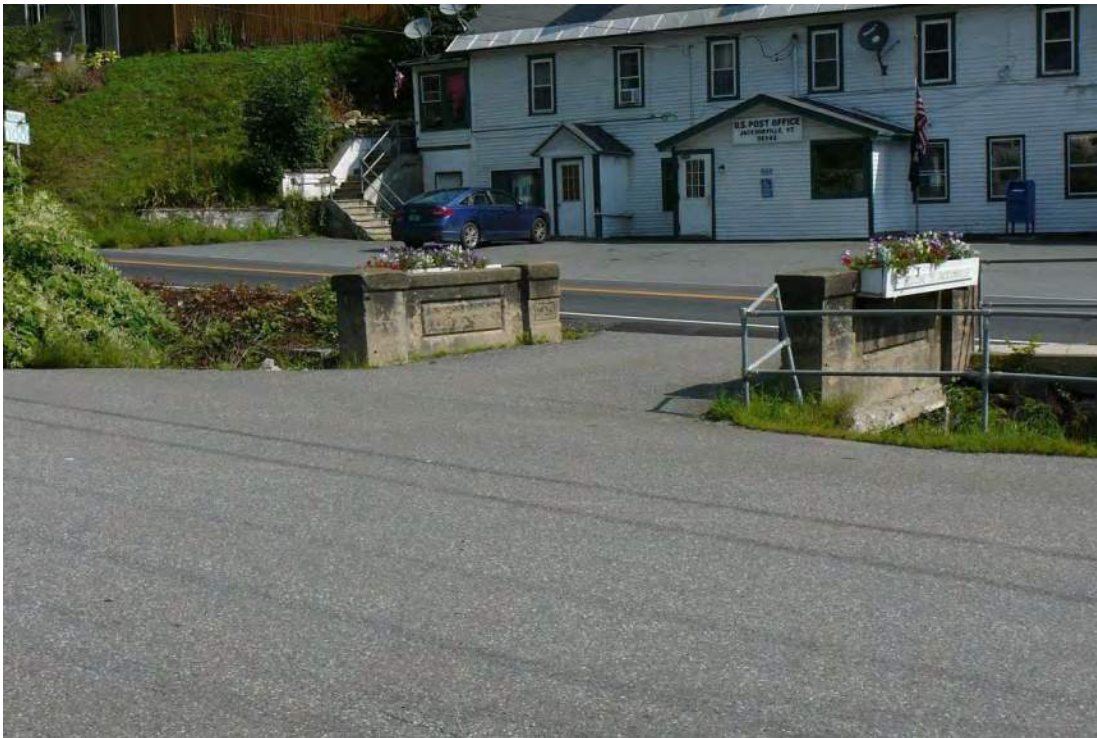
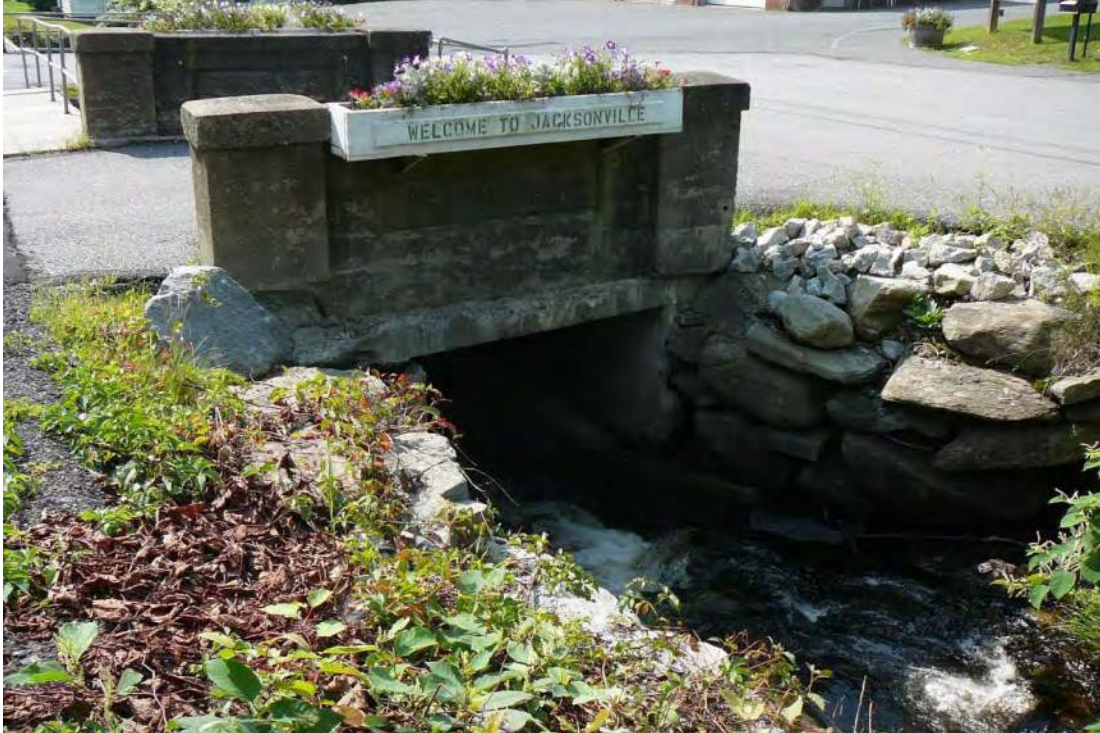
Figure 26. View northeast of concrete bridge.

Figure 27. View northeast of concrete bridge.

This HRR recommends that the 1926 concrete box culvert bridge located over the East Branch of the North River in front of the Municipal Center meets the eligibility requirements and significance outlined for concrete bridges in the *National Register of Historic Places Multiple Property Documentation Form: Metal Truss, Masonry, and Concrete Bridges in Vermont*, (MPDF) (USDI NPS 1990). The bridge is a functioning structure built before 1940, with its original core and design features intact, and it retains integrity of location and setting. It is historically significant under National Register Criterion A for its contribution to the broad patterns of transportation history, and architecturally significant under Criterion C for embodying the types, forms, and methods of engineering and constructions as associated with bridge building in

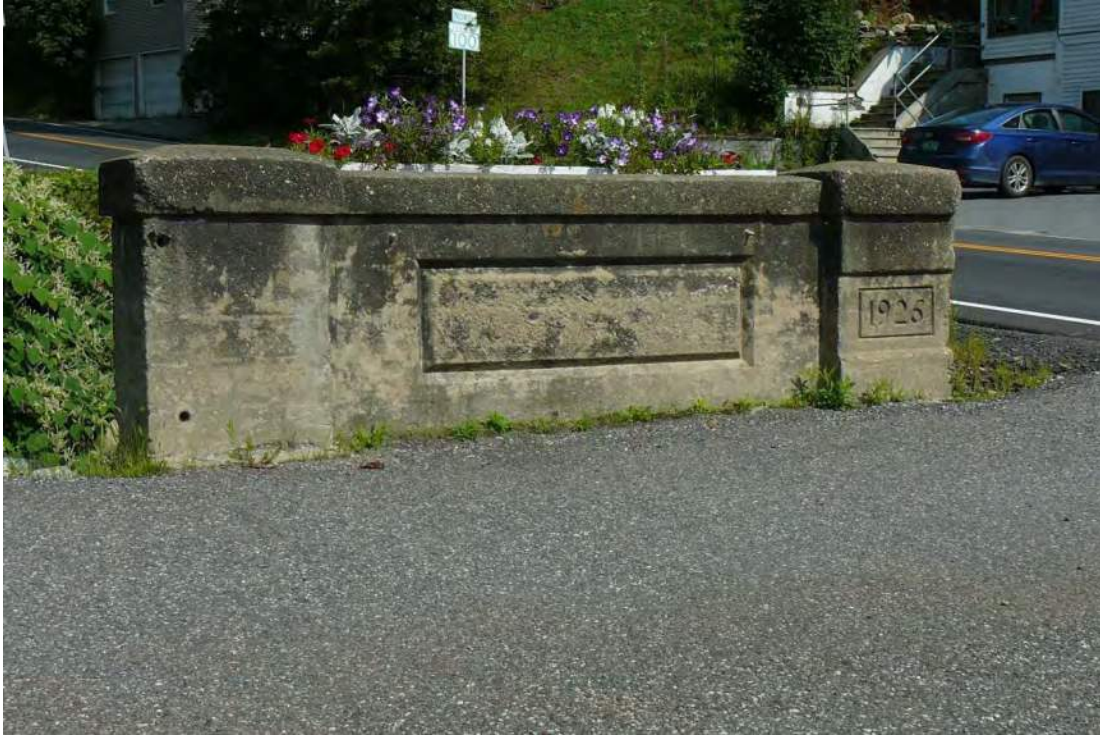
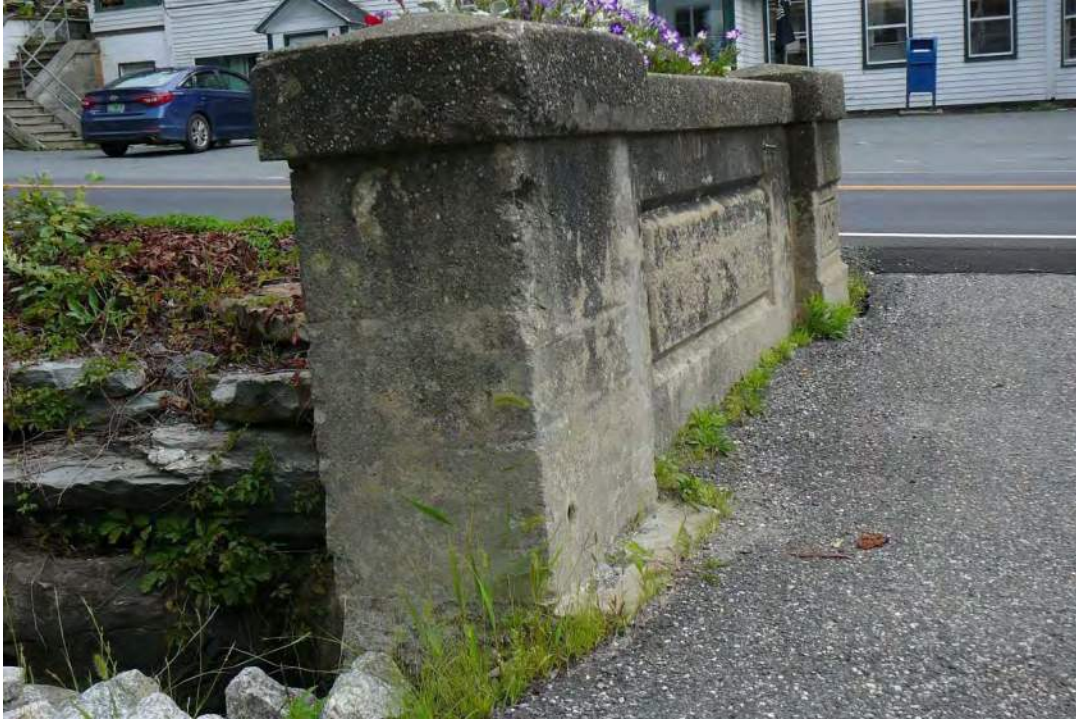
Figure 28. View northeast of upstream rail of concrete bridge.

Figure 29. View northeast of upstream rail of concrete bridge.

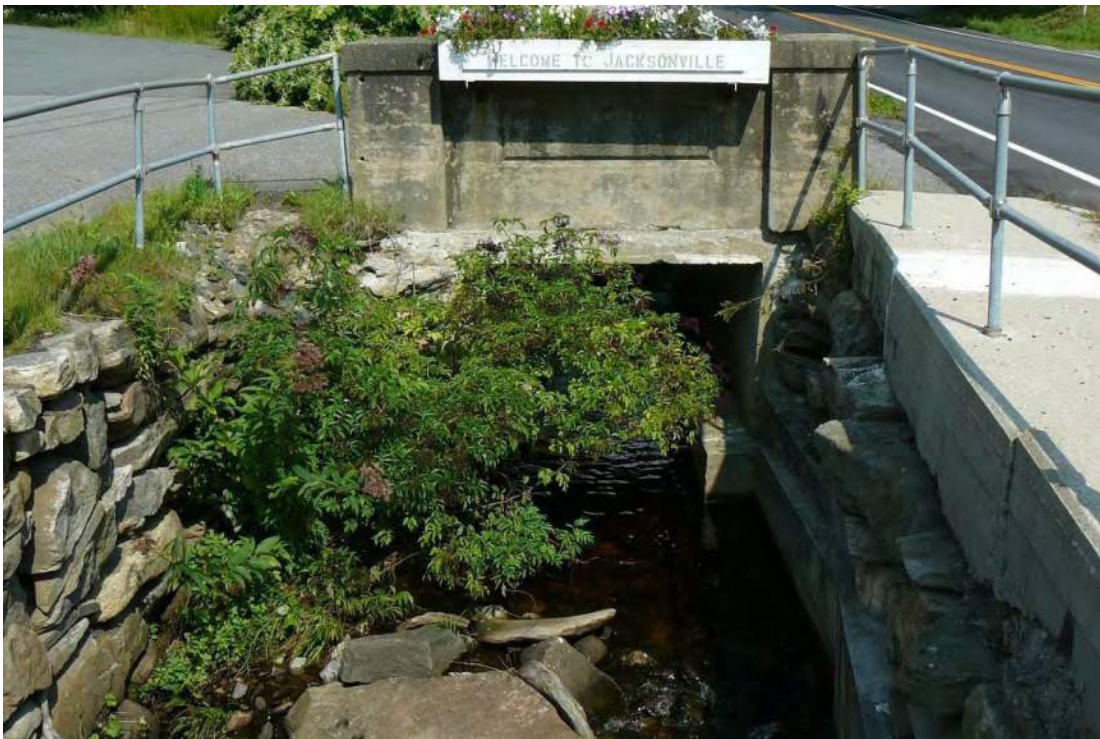
Figure 30. View northwest of downstream rail of concrete bridge.

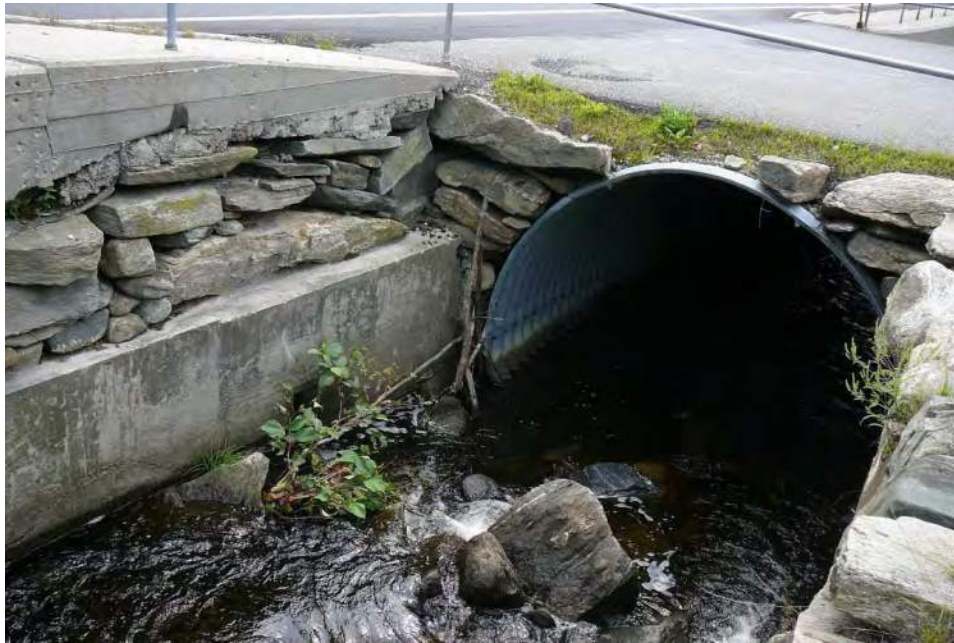
Figure 32. View southeast of inlet/upstream end of culvert.

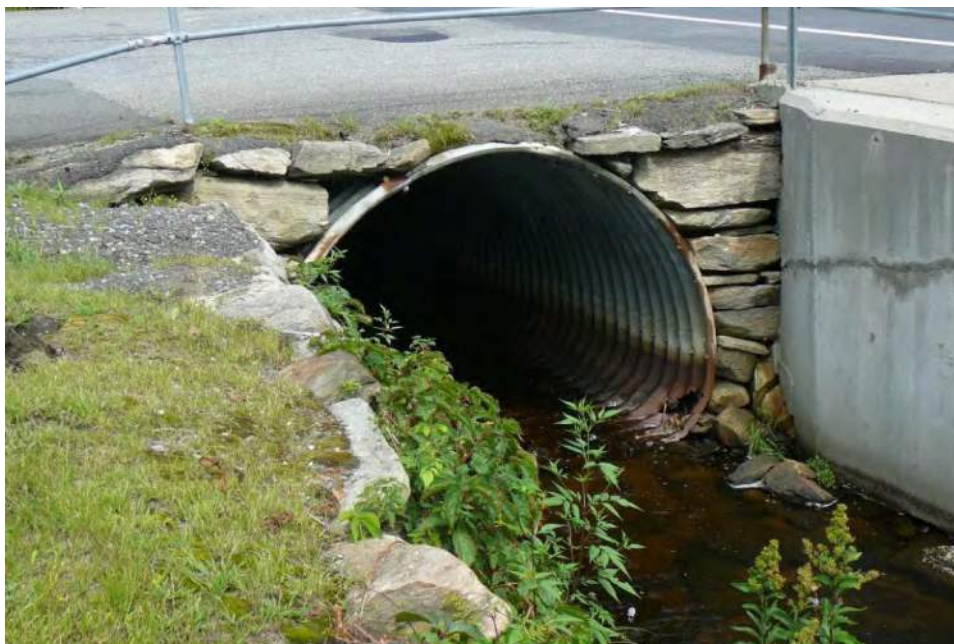
Figure 33. View northeast of outlet/downstream end of culvert.

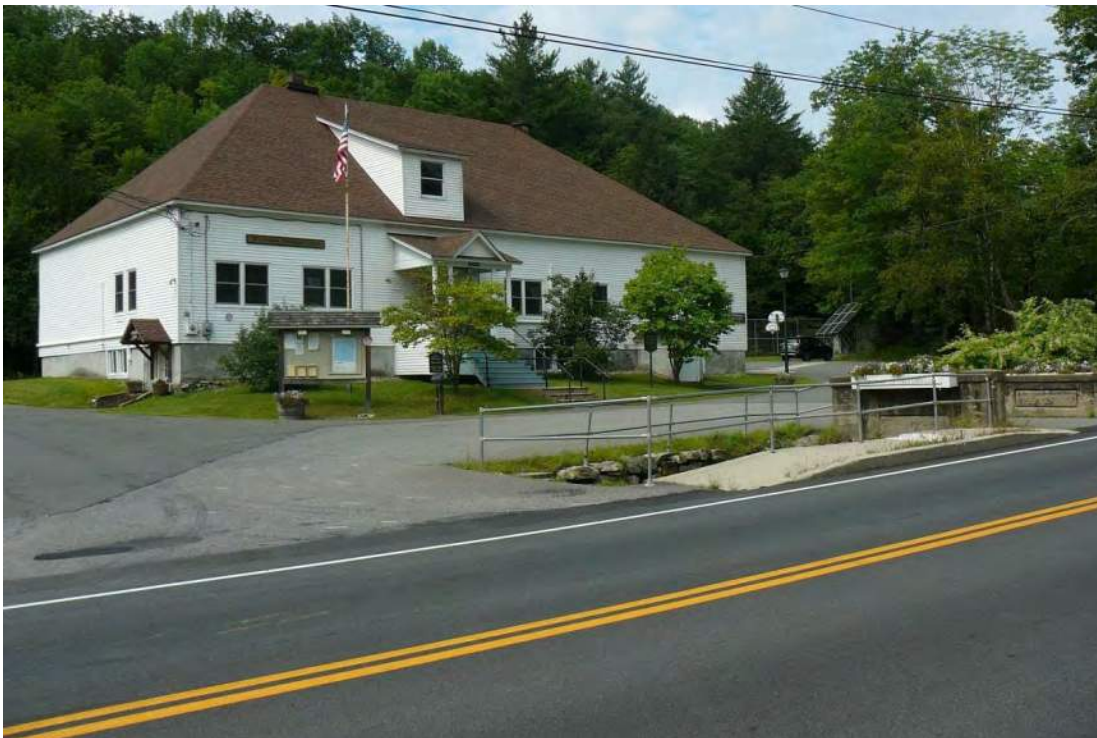
Figure 34. View northwest of the Municipal Center.

Constructed in 1927 as a high school and renovated to town offices in 1960 – 1961, the Municipal Center at 2948 VT Route 100 is a single story, rectangular building with steeply sloped hipped roof, concrete foundation, and rear wing addition (Figure 34). The primary entrance is on the east side of the building and a small porch with four columns covers the entry door. Concrete and wooden steps lead up to the porch. There are various other entrances around the building. Shed dormers are in place on the east, west and north roof slopes. It is clad in vinyl or aluminum siding and has asphalt shingle roofing. Windows on the building have been significantly altered since its use as a school (see Figure 13).

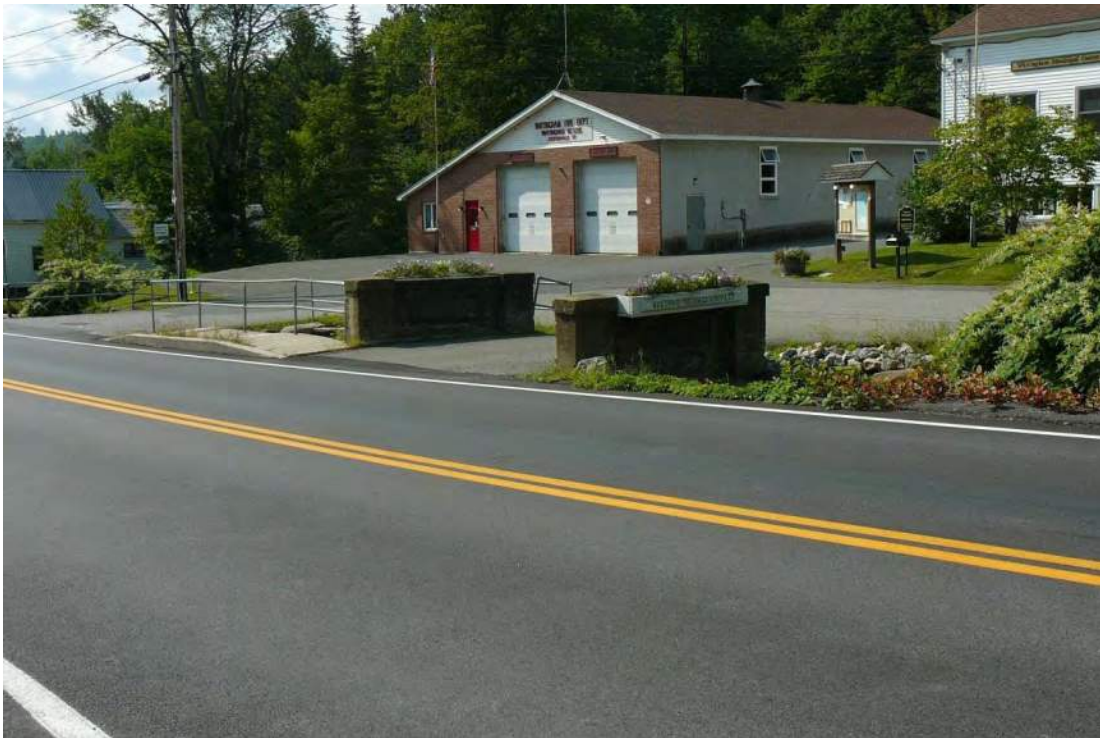
Figure 35. View southwest of the firehouse.

Constructed c. 1974, the firehouse at 2964 VT Route 100 is a rectangular, concrete building with an irregular sloped gable roof with asphalt shingles (Figure 35). The gable end faces VT Route 100. It has brick facing on its front (east) side, two overhead doors for firetrucks, and an entrance door. Windows are in place on the south and north sides of the building.

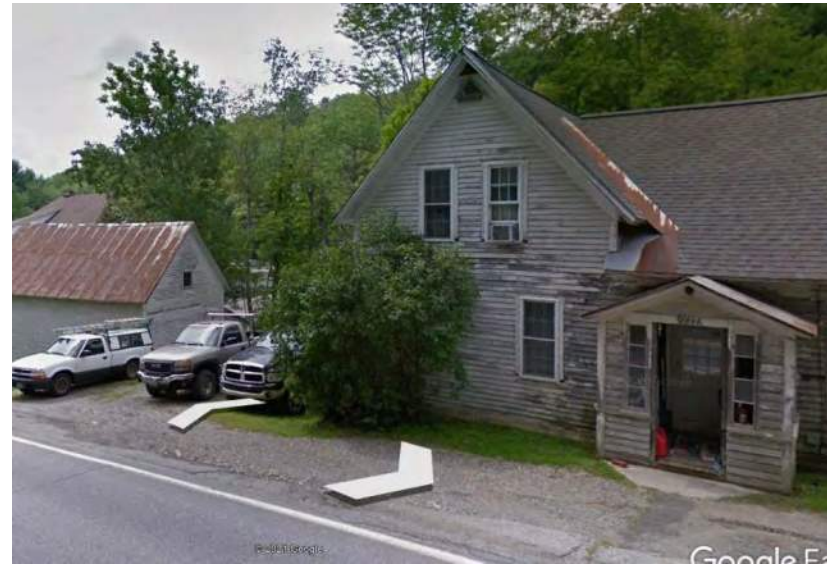
VT Route 100, view southwest

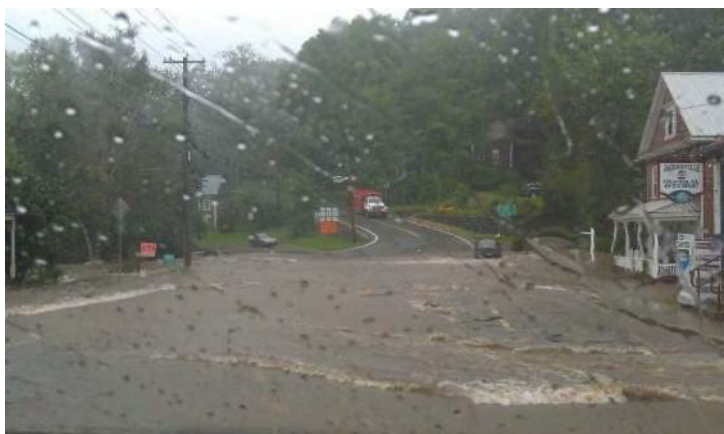
Figure 1.5: Floodwaters spilled out of the channel of the East Branch North River and flowed down VT 100 through Jacksonville, VT during Tropical Storm Irene in 2011 (Photo courtesy of G. Havreluk).

Tropical Storm Irene was a significant flood event in southern Vermont (Figure 1.5). The nearby USGS stream gaging stations recorded flows estimated at the 100-year flood on the Deerfield River and at the 200-year flood on the North River and Green River. Additional major floods (greater than the 25-year event) were recorded in 2006 in Shattuckville; 1915, 1928, 1938, 1948, 1987 in Charlemont; and 2005 in Colrain. Tropical Storm Irene produced the largest peak flows on record at the Shattuckville and Colrain monitoring stations. The September 21st, 1938 flood on the Deerfield River
