SUBMITTED TO
**WINDHAM COUNTY REGIONAL
COMMISSION**

SUBMITTED BY
MSK ENGINEERS

SCOPING STUDY

Jacksonville Municipal Center Access and Flood Resiliency

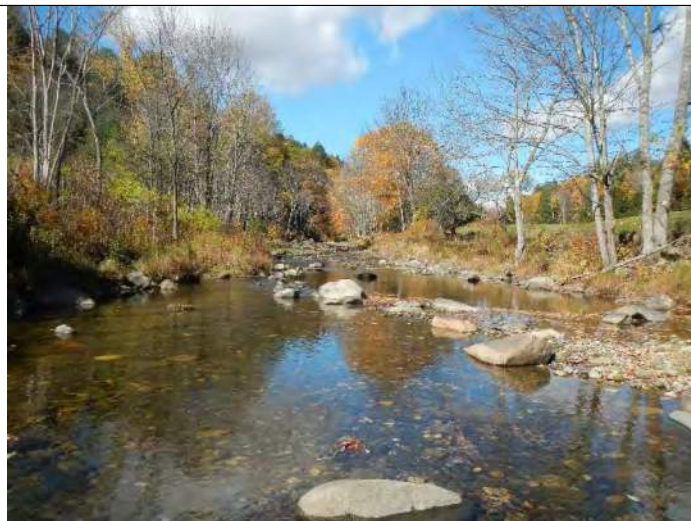
Reach Highlights: Historically this reach was incised due to straightening and encroachment along VT 112. A large alluvial fan is located in the upper portion of the reach, downstream of the confluence with Branch Brook. We assessed this reach as Stage II due to channel incision, but widening in some areas suggests it may be transitioning into a stage III reach. The stream departed from a C to a F-type channel due to incision and entrenchment.

Historically incised and straightened F-type channel.

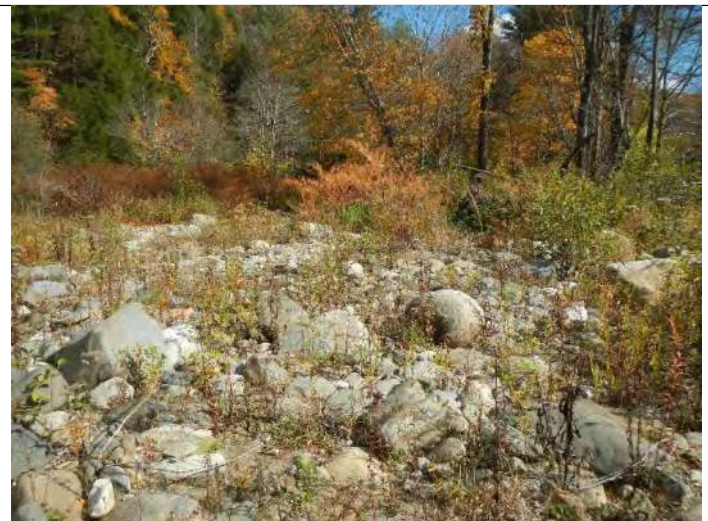
Alluvial fan deposits in the upper portion of the reach.

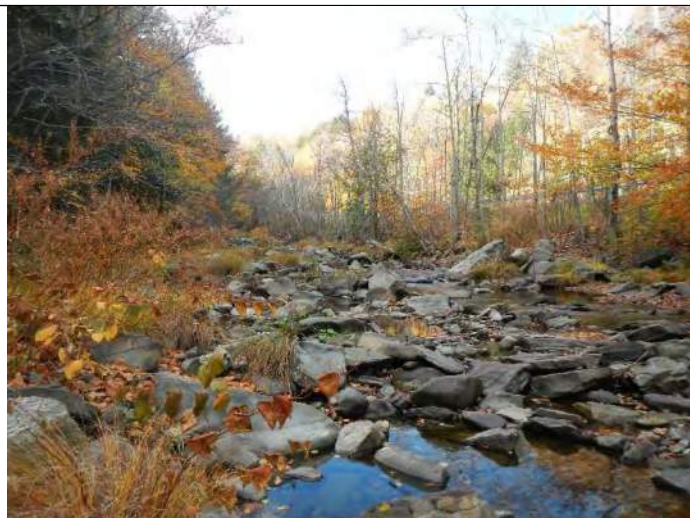
Reach Highlights: Historically this segment was incised due to historic straightening and encroachment along Rt 112. Moderate bank scour and bankfull widths typically greater than the predicted curve width indicate that the reach may be widening. Further incision is also unlikely due to grade control and large substrate. We assessed the reach as early Stage III with limited potential for further widening or planform adjustment due to the road encroachment.

Historically straightened and incised F-type channel.

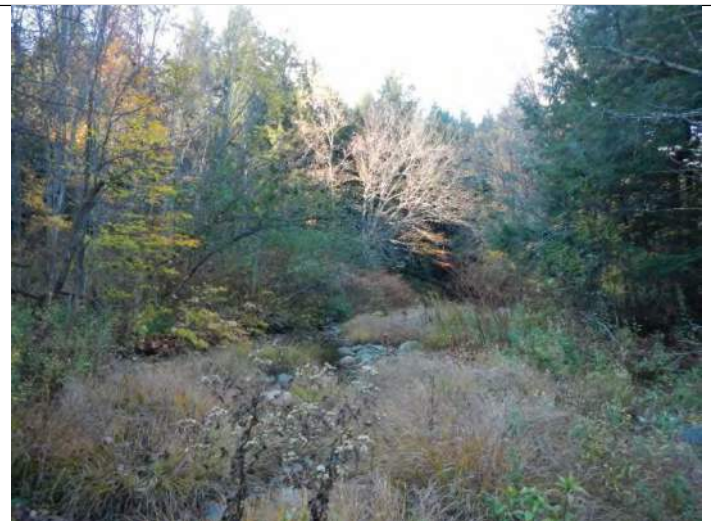
Large flood chute.

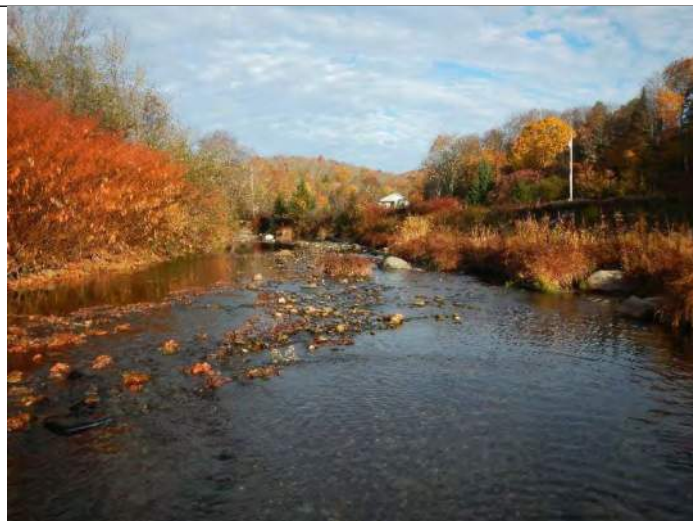
Reach Highlights: Historically this segment was incised due to straightening, armoring and encroachment along VT 112, which caused a stream type departure from a C to a F-type channel. We observed evidence of ongoing aggradation and recent widening. We assessed the segment as recently transitioning to Stage III, however widening and planform adjustment potential is limited due to road encroachment.

Segment upstream of beaver activity, with evidence of historic incision.

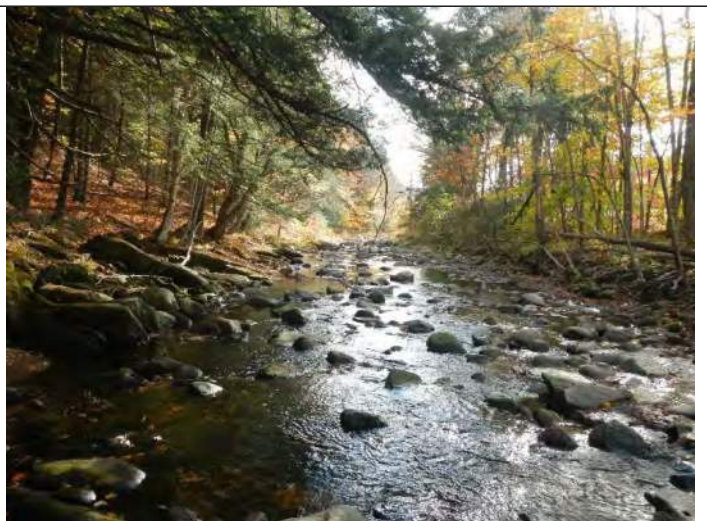
F-type channel near the top of the segment, historically incised due to straightening and encroachment.

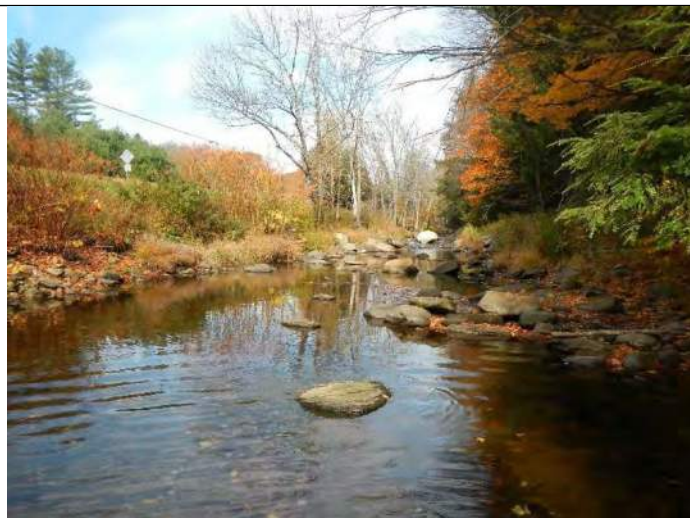
Reach Highlights: Historically this reach was incised due to straightening, armoring, and encroachment along Rt 112. We assessed this reach as Stage II because incision and entrenchment that caused a stream type departure from a C to a F-type channel. The presence of several large flood chutes and splits in the channel suggest the channel maintains some ability to adjust planform within its valley.

F-type channel due to historic straightening and armoring.

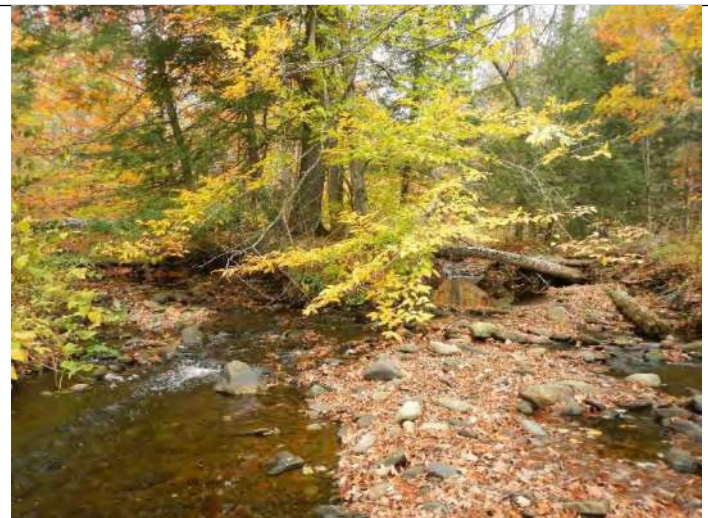
Channels converge downstream of a bifurcation.

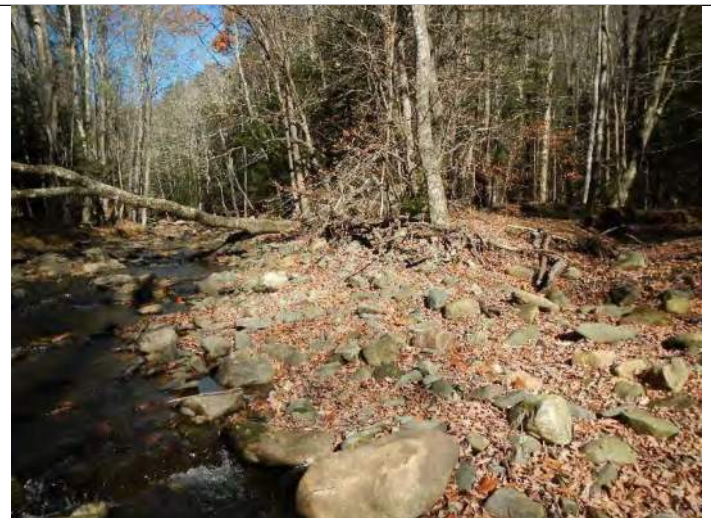
Large flood chute rejoining the channel near the confluence of Branch Brook and the North River.

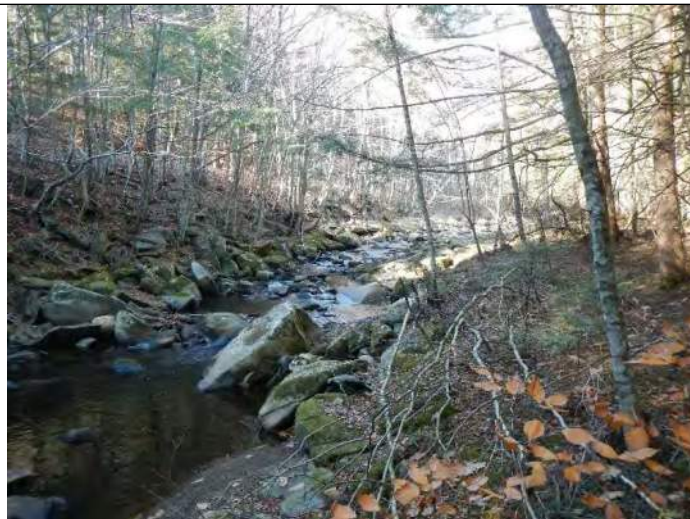
Reach Highlights: Historically this reach was incised due to straightening and development, as well as armoring and encroachment along Branch Road. Based on extensive scour we suspect that the channel incised during T.S. Irene. Further incision is very limited due to the presence of numerous grade controls and very large substrate throughout the reach. We observed some evidence of widening however this will be limited due to extensive road armoring and natural armoring along the banks. We assessed the reach as Stage II but it is likely slowly progressing to Stage III.

F-type channel due to straightening and encroachment.

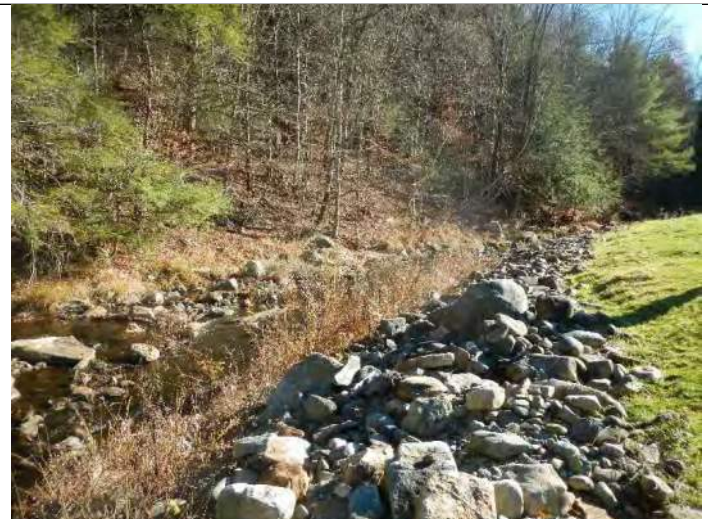
Bank straightening and armoring along cow pasture.

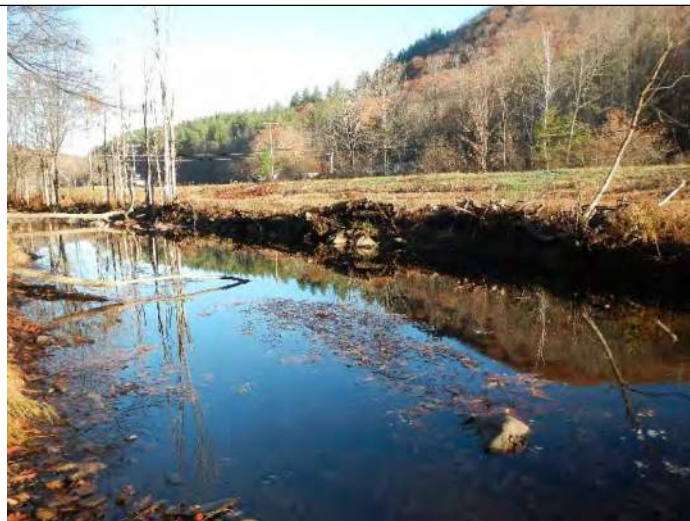
F-type channel due to historic straightening and encroachment.

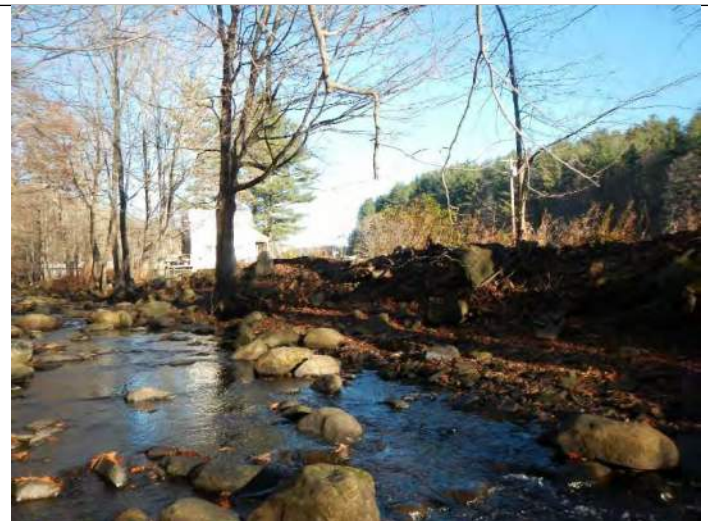
Historically straightened channel with an old berm on the left bank.

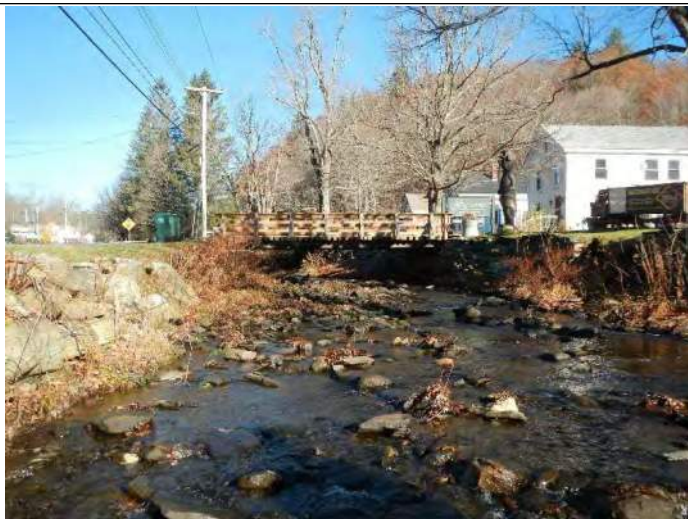
F-type channel due to straightening and armoring.

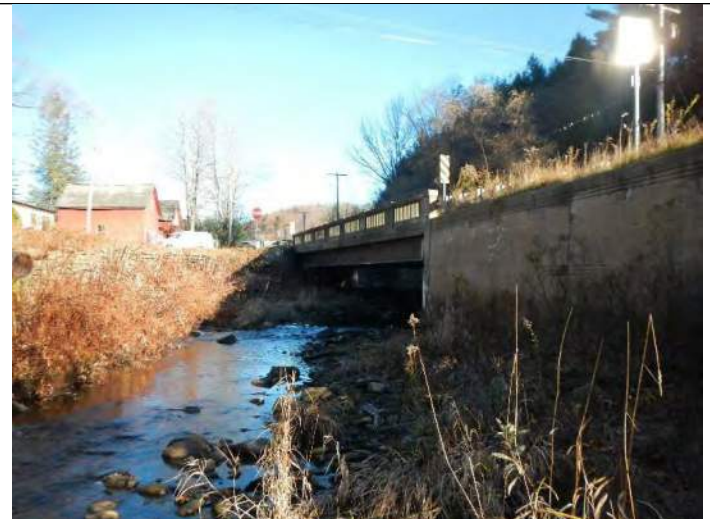
Incised channel at the intersection of VT 112 and Holbrook Road.

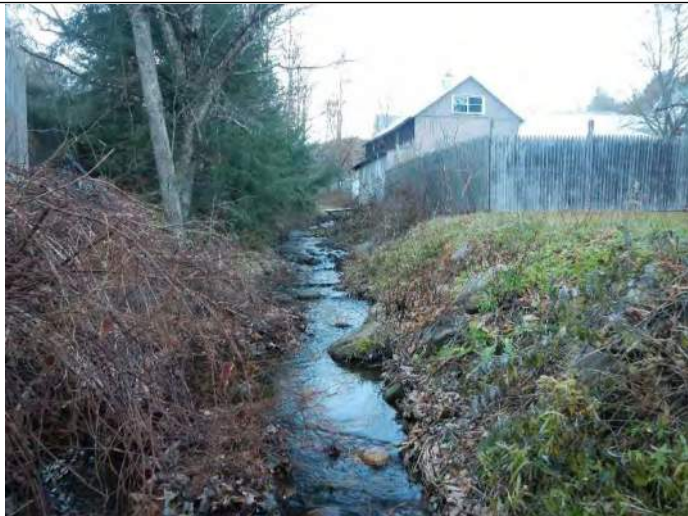
F-type channel due to historic straightening, encroachment, and armoring.

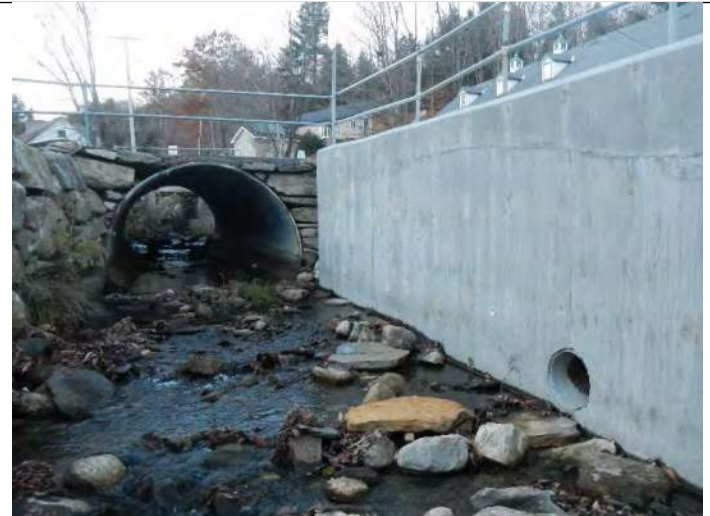
Bank armoring and constrictions at the Whitingham Municipal Complex.

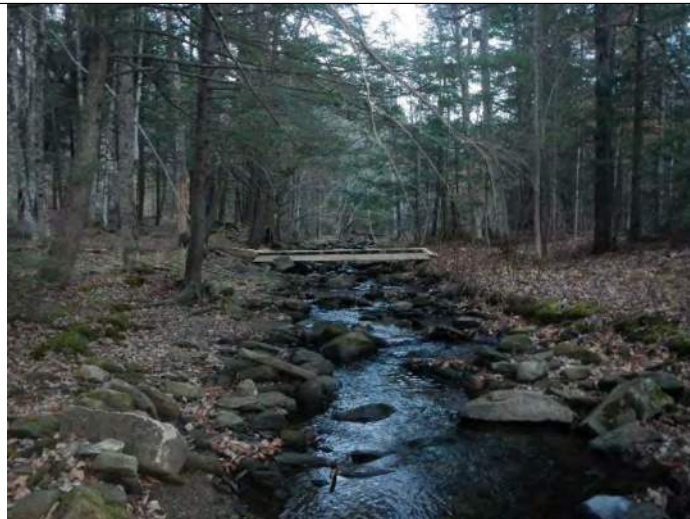
C-type channel in very broad valley.

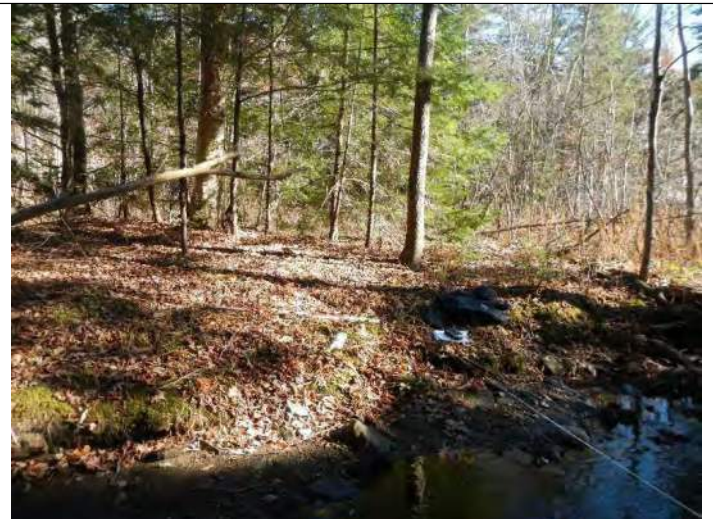
Floodplain access along channel.

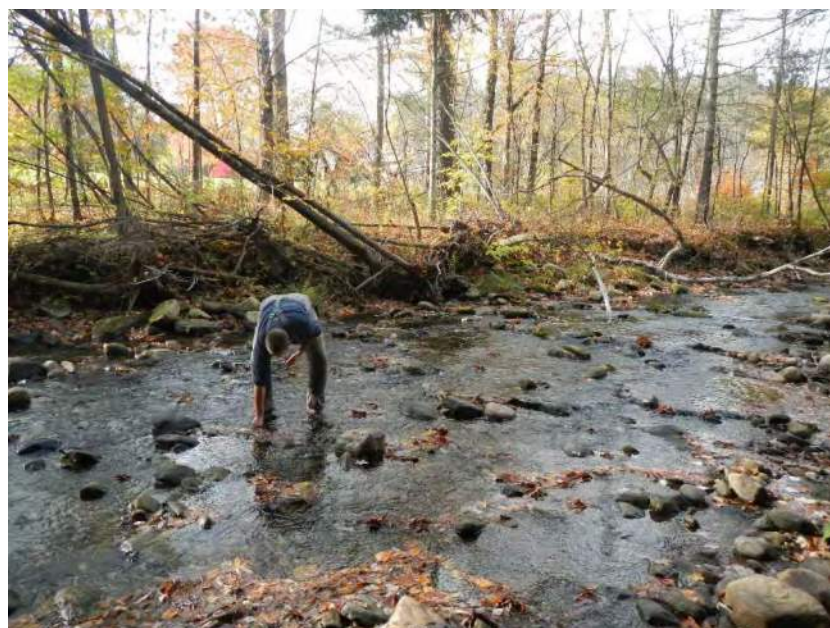
Figure 4.3: Pebble count data collection on M04B.

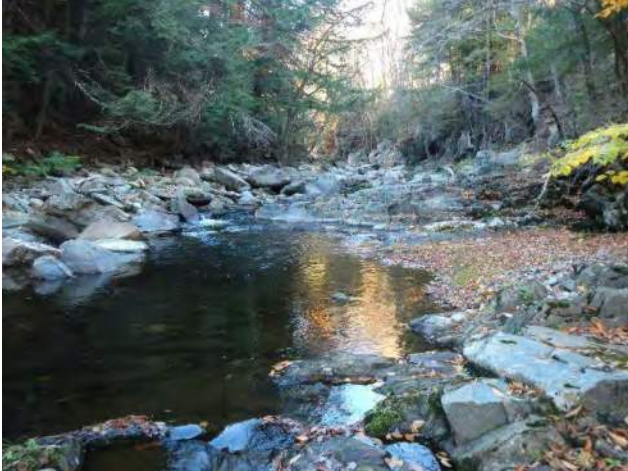
Figure 4.6: Grade controls in segment M03.B.

- Areas with numerous natural grade control on segments: M03B, M03C, M05, T1.02 (Figures 4.6 and 4.7).
- Beaver dams are located on segments M02, M04.A, M06.A (Figure 4.8) and a small cobble impoundment is located on segment M03.C (Figure 4.9).
- Extreme bank armoring on segments M06B and M07A (Figures 4.10 and 4.11). Extensive bank armoring on segments M02, M03.A, M04B, M05, M06.A, M07.B, T1.01, T1.02.

- Areas with numerous natural grade control on segments: M03.B, M03.C, M05, T1.02 (Figures 4.6 and 4.7).
- Beaver dams are located on segments M02, M04.A, M06.A (Figure 4.8) and a small cobble impoundment is located on segment M03.C (Figure 4.9).

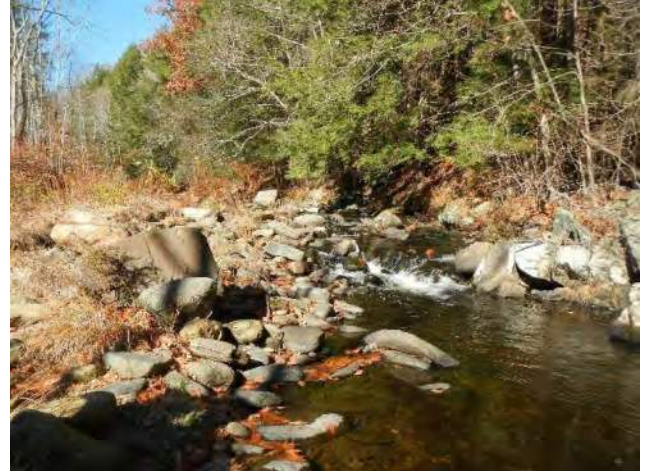
Figure 4.7: Grade controls in reach M05.

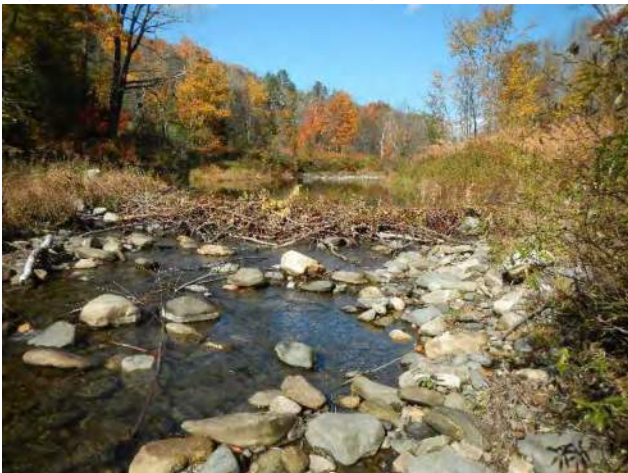
Figure 4.8: Beaver dam in reach M02.

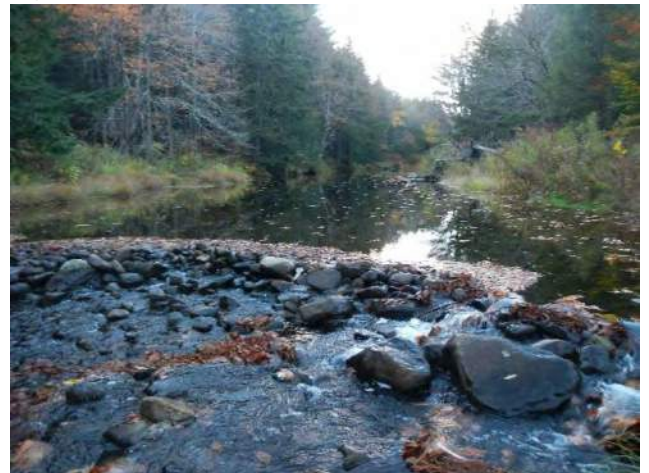
Figure 4.9: Small boulder & cobble impoundment to enhance a swimming hole in segment M03.C.

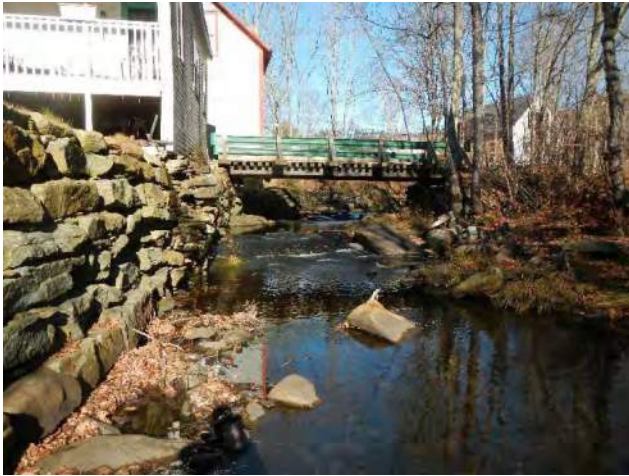
Figure 4.10: Extreme bank armoring on reach M06.B.

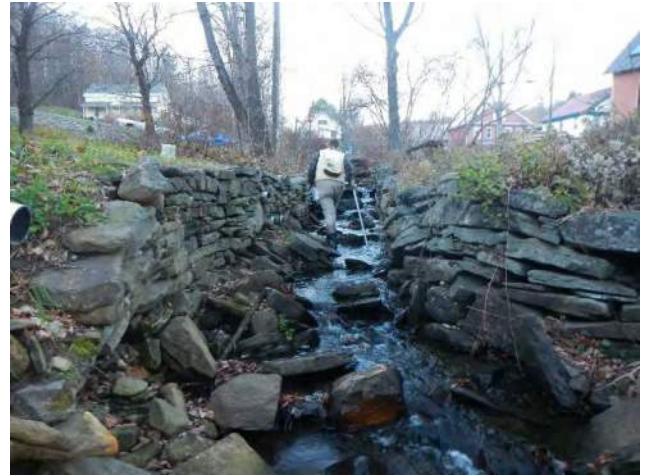
Figure 4.11: Extreme bank armoring on segment M07.A.

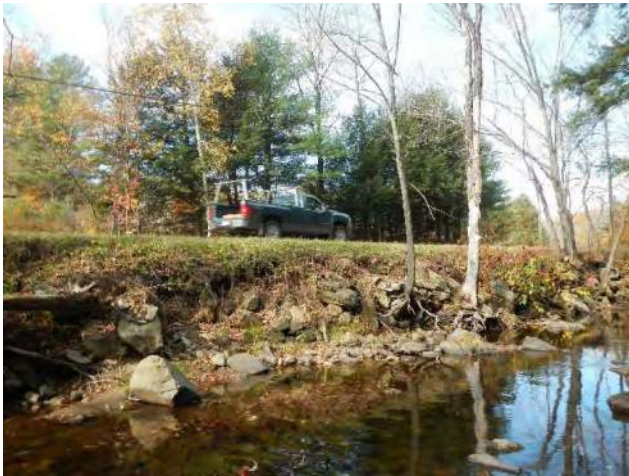
Figure 4.12: Bank erosion and failing armoring along VT 112 on reach M05.

- Moderate bank erosion in segments: M04.B, M05, M06.A (Figures 4.12 and 4.13).
- Multiple mass failures in segments: M03.C and M05 (Figures 4.14 and 4.15).

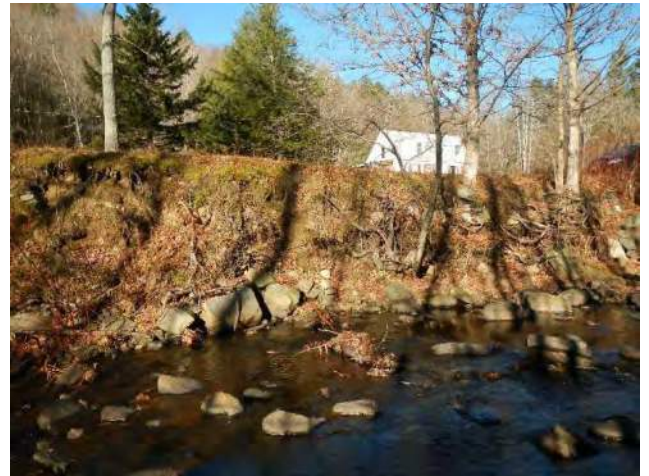
Figure 4.13: Bank erosion near Holbrook Road on segment M06.A.

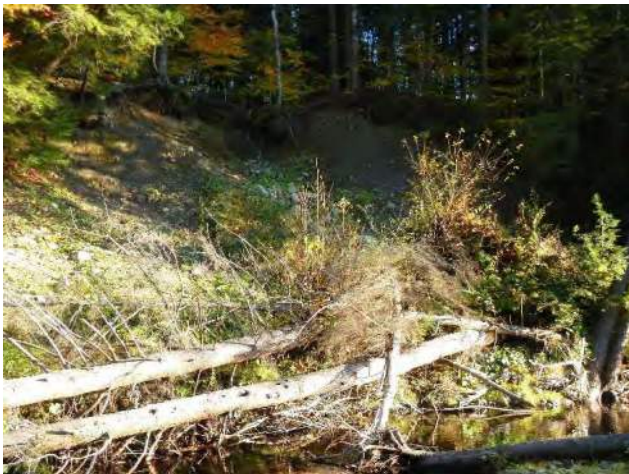
Figure 4.14: Mass failure on segment M03.C.

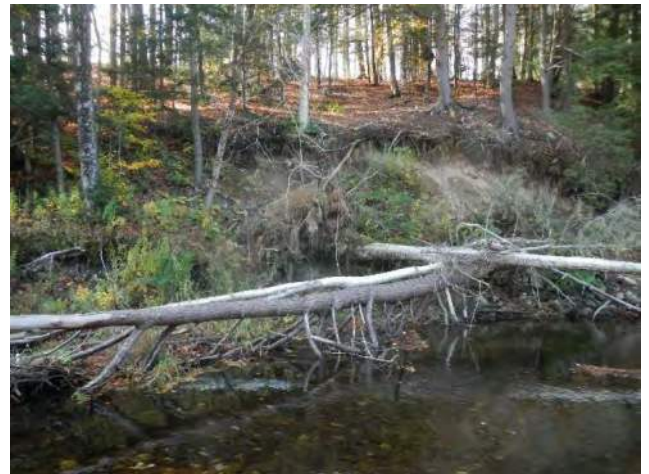
Figure 4.15: Mass failure on reach M05.

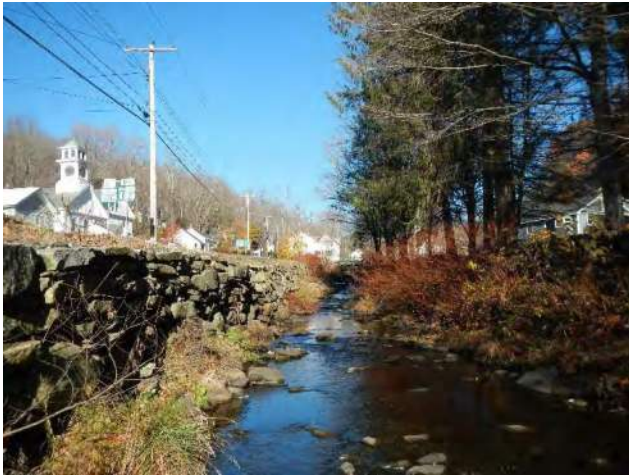
Figure 4.17: Extreme straightening along segment M06.B.

- Extreme channel straightening in segment: M02, M03.A, M04.B, M05, M06.A, M06.B, M07.A, T1.01 (Figure 4.17).
- High straightening in segments: M03.B, M07.B, T1.02 (Figure 4.18).
- Extreme corridor encroachments from berms and adjacent roadways and embankments in segment: M03.A, M04B, M05, M06.A, M06.B, M07.A, T1.01, T1.02. (Figures 4.19 and 4.20).
- Very high corridor encroachments in segment: M02 and M07.B.
- Dredging in segments: M02, M04A, M04.B (Figures 4.21 and 4.22).

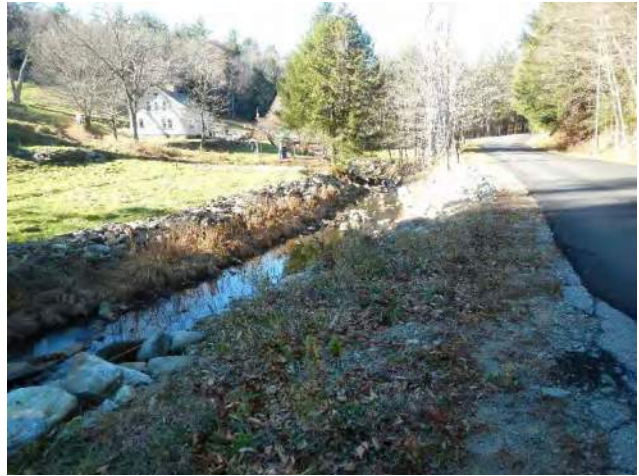
Figure 4.18: Bank armoring, encroachment, and straightening on reach T1.02.

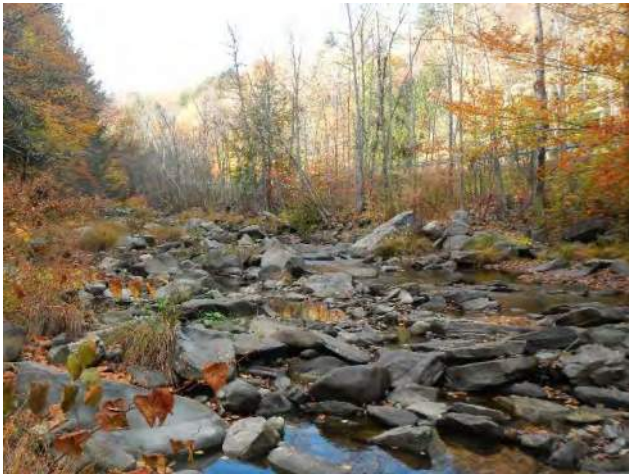
Figure 4.19: Extreme encroachment along VT 112 on segment M03.A.

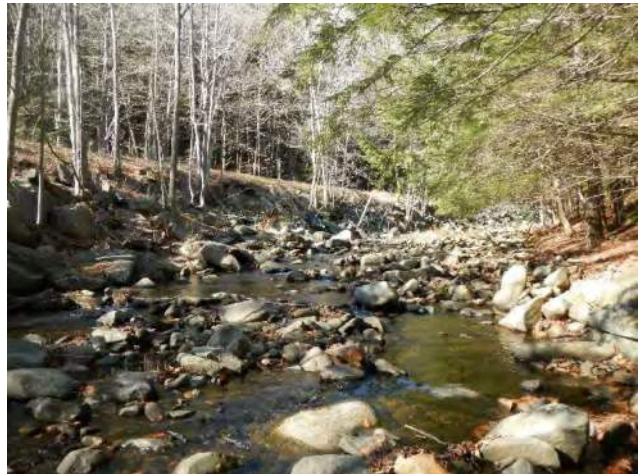
Figure 4.20: Extreme encroachment along Branch Road on reach T1.01.

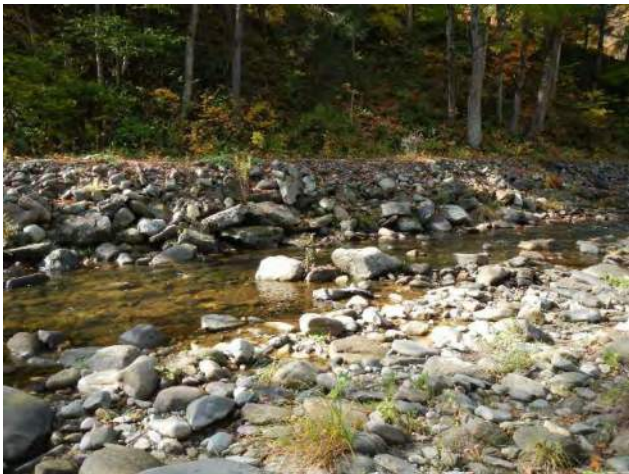
Figure 4.21: Dredging and windrowing on reach M02.

- Dredging in segments: M02, M04.A, M04.B (Figures 4.21 and 4.22).
- High density of riparian buffer width impacts in segments: M02, M03.A, M05, M06.A, M06.B, M07.A, T1.01, T1.02.

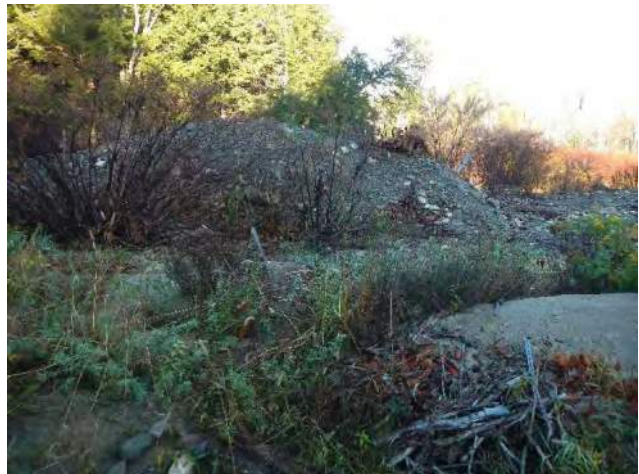
Figure 4.22: Dredging spoils on segment M04.A.

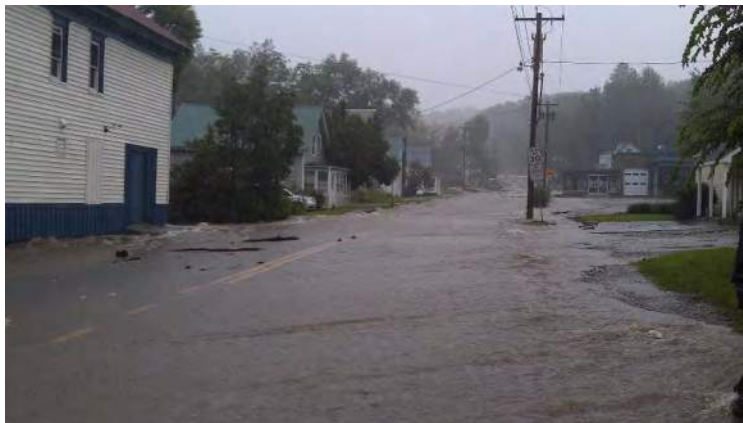
Figure 5.1: Tropical Storm Irene floodwaters overtopping the culvert and bridge at the Whitingham Municipal Center and flowing south down VT 100 (photo courtesy of G. Havreduk).
